OVAL BRACELET WITH SURFACE DECORATIONS OF LINES AND INDENTATIONS MAH ANC. 2662 - LEADED BRONZE - LATE BRONZE AGE - SWITZERLAND

Artefact name	Oval bracelet with surface decorations of lines and indentations MAH anc. 2662
Authors	Marianne. Senn (EMPA, Dübendorf, Zurich, Switzerland) & Christian. Degrigny (HE-Arc CR, Neuchâtel, Neuchâtel, Switzerland)
Url	/artefacts/455/

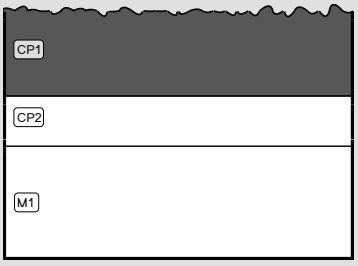
Fig. 4: Stratigraphic representation of the object in cross-section using the MiCorr application. The characteristics of the strata are only accessible by clicking on the drawing that redirects you to the search tool by stratigraphy representation. This representation can be compared to Fig. 7, Credit HE-Arc CR.
