TANG FRAGMENT OF A KNIFE HR-6567 - LEADED BRONZE - LATE BRONZE AGE - SWITZERLAND

Artefact name	Tang fragment of a knife HR-6567
Authors	Marianne. Senn (EMPA, Dübendorf, Zurich, Switzerland) & Christian. Degrigny (HE-Arc CR, Neuchâtel, Neuchâtel, Switzerland)
Url	/artefacts/456/

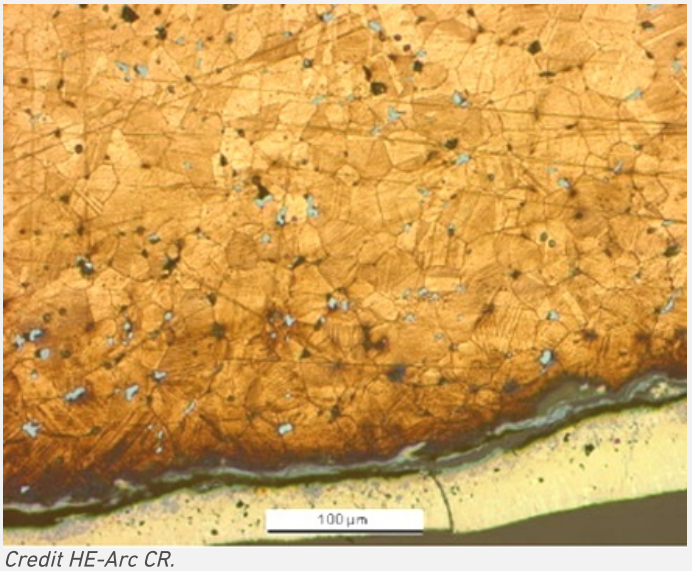
Fig. 6: Micrograph of the metal sample from Fig. 3 (detail), etched, bright field. Angular and twinned grains are revealed as well as copper sulphide inclusions in grey,

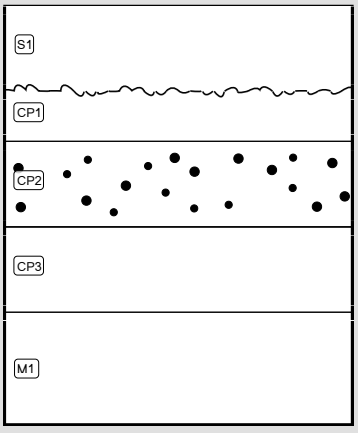
Fig. 4: Stratigraphic representation of the object in cross-section using the MiCorr application. The characteristics of the strata are only accessible by clicking on the drawing that redirects you to the search tool by stratigraphy representation. This representation can be compared to Fig. 9, Credit HE-Arc CR.
