# SITULA EMT09-554.665 – TIN BRONZE – IRON AGE – SWITZERLAND

| **Artefact name** | Situla EMT09-554.665 |

## The object

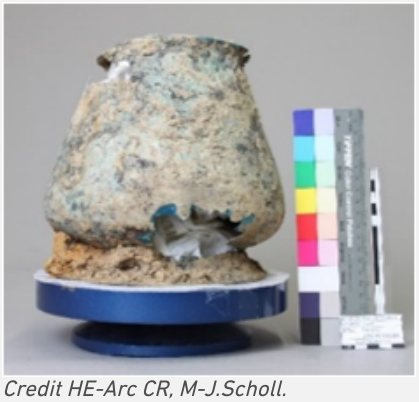
Fig. 1: Tin bronze Celtic situla (Archeodunum (Gollion), 2009) inverted as found in situ,

| **Description of the artefact** | Copper alloy situla (Fig. 1). Attached to two riveted iron loops is an iron handle terminating in two swan heads (not shown here). Dimensions of the main body: Hmax = 340mm, Ømax = 220mm. |

The size and quality of the object makes it likely that is was reserved for important occasions or for ritual use. Secondary use could be a votive offering. Burial condition: inside a 3 meters deep hole in upside-down position.

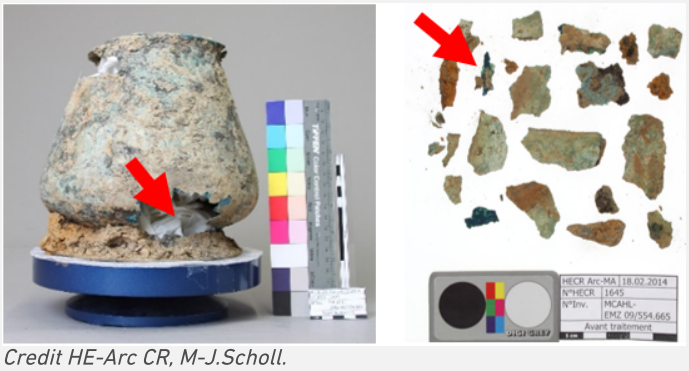
Fig. 2: Location of sampling area and sample selected from detached fragments,

| **Description of sample** | The sample was cut from a detached fragment of the upper part of the main body of the situla in Fig. 2. The cross-section is representative of the entire thickness (0.5 mm) of the object's body where on the outside there is a thicker accumulation of corrosion including curly malachite clusters (Fig. 3). A metallic core is still present inside the corrosion products layers (Fig. 4). |

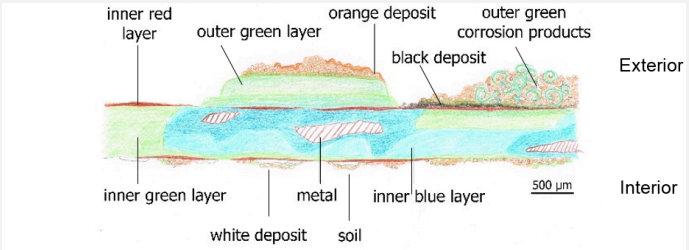
**S**: soil (sediment)
**D1**: black deposit
**D2**: orange deposit
**D3**: white deposit
**CP1e**: outer green corrosion products (might be curly)
**CP2i**: inner red layer
**CP3i**: outer green layer
**CP4i**: inner green layer
**CP5i**: inner blue layer
**M:** metal

Fig. 3: Stratigraphic representation of the situla in cross-section by macroscopic observation,

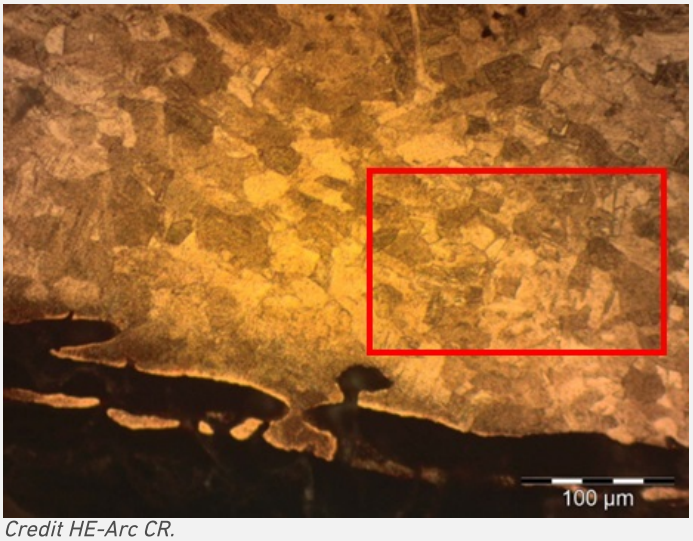
The remaining metal is a dense tin bronze (Fig. 7, Table 1), showing no inclusion. In bright field, the etched alloy shows a structure principally consisting of polygonal alpha phase grains (Fig. 8). Some of the grains include twin lines (Fig. 9). The presence of strain lines (slip lines) indicates a final cold work without annealing (Fig. 9).

Fig. 7: SEM image, BSE-mode, of the metal sample from Fig. 4. Area of Fig. 8 is marked by a rectangle,

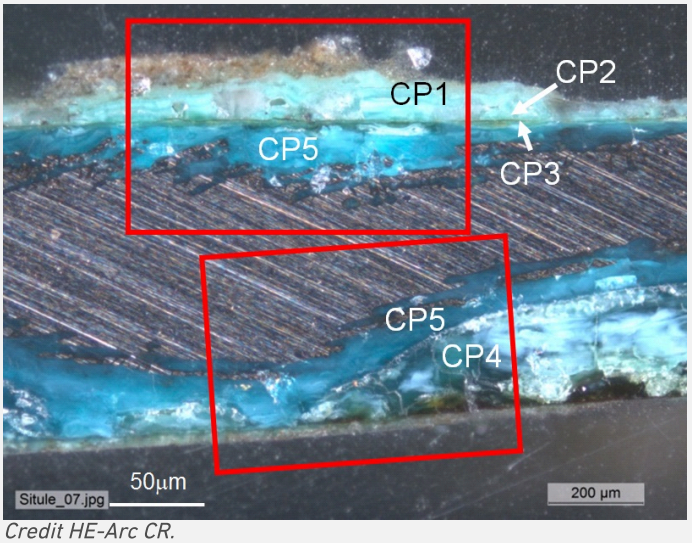
The corrosion crust is heterogeneous and has in places completely replaced the metal. The metal – corrosion products interface is irregular due to transgranular corrosion (Figs 7-8). In most cases, the corrosion crust can be divided in three main layers: an inner compact blue layer directly on the metal core (CP5, Figs. 6, 10 and 11 and CP3, Fig. 5). In areas of extensive corrosion this blue layer coexists with a friable green layer (CP4, Figs. 6, 10 and 11 and CP2, Fig. 5). Depending on the area either a very fine dark green (CP3, Fig. 6 and Fig. 10) or red corrosion layer (CP2, Fig. 6 and Fig. 10) marks the limit of the original surface. It is followed by an external fourth layer, consisting of friable and sometimes curly pale green corrosion products intermingled with soil products (CP1, Fig. 6 and Fig. 10 and 13). In heavily worked and fragile parts of the object a cleavage between the inner layers of blue and green corrosion is present, rendering the green corrosion vulnerable to loss (Fig. 11).

The inner layers (CP3-CP5) are Sn and O-rich and depleted in Cu (Table 2). The outer layers (CP1 and CP2) are Cu and O-rich, contain no Sn, and are contaminated with Ca, Si, Al and Fe coming from the soil (Fig. 12). The colour of the corrosion crust varies according to the content of Sn (the more Sn, the darker green or blue the corrosion). FTIR on the inner blue (CP5 and Fig. 14) and outer green (CP1 and Fig. 15) layers were difficult to interpret. Only malachite could be identified in both cases. XRD spectra could not be interpreted because of the deficiency of peaks.

Fig. 10: Micrograph of the metal sample from Fig. 4, unetched, dark field, 50x. Areas of Fig. 11 (bottom, corresponding to the stratigraphy of Fig. 5) and Figs. 12 and 13 (top, corresponding to the stratigraphy of Fig. 6) are marked by a rectangle. Codes are those of Fig. 6,

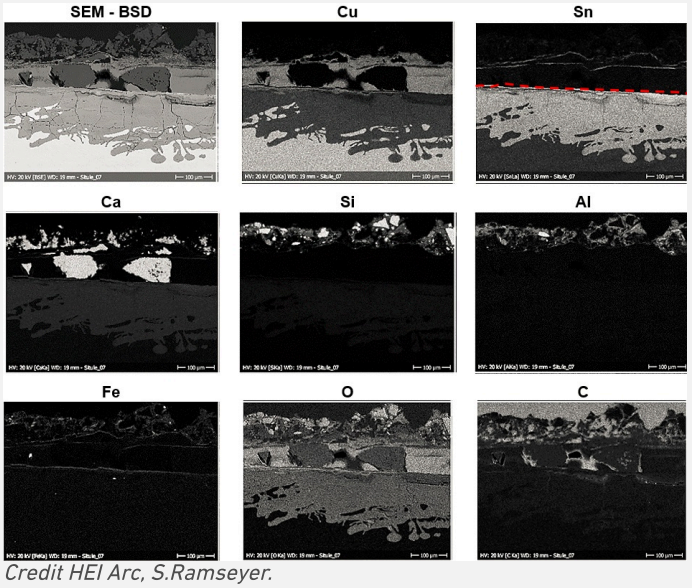
Fig. 11: SEM image, BSE-mode of the metal sample from Fig. 10 (detail) showing cleavage between the inner blue (CP5) and green (CP4) layers of Fig. 6,

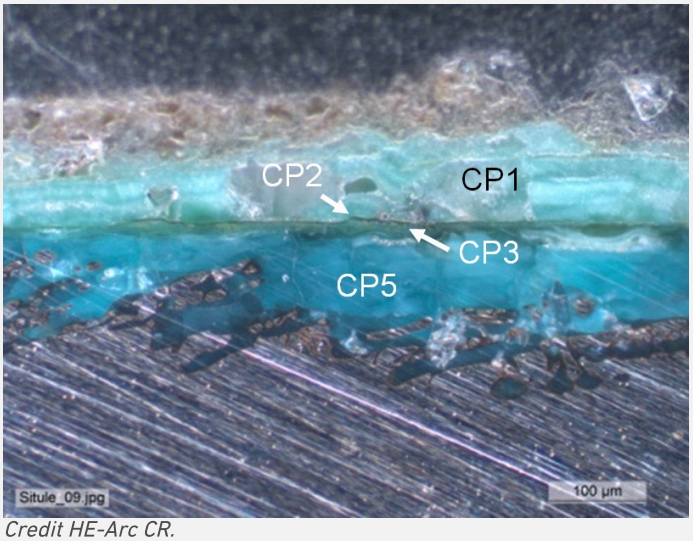
The limit of the original surface is well defined (interface of CP1 and CP2) but due to the fragility of the inner corrosion layers it was difficult to uncover.

Fig. 12: SEM image, SE-mode, and elemental chemical distribution of the selected area of Fig. 10. In red: the limit of the original surface highlighted by the enriched tin layer. Method of examination: SEM-EDS, Lab of Electronic Microscopy and Microanalysis, IMA (Néode), HEI Arc,

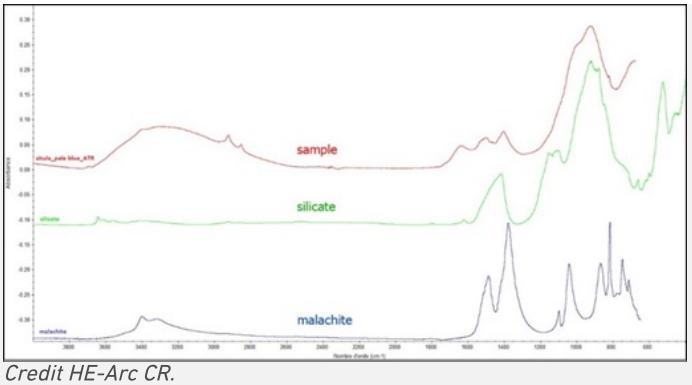
Fig. 14: FTIR spectrum (ATR mode) of the inner blue layer compared to the silicate and malachite standard spectrum. Method of analysis: FTIR spectroscopy, HE- Arc CR,

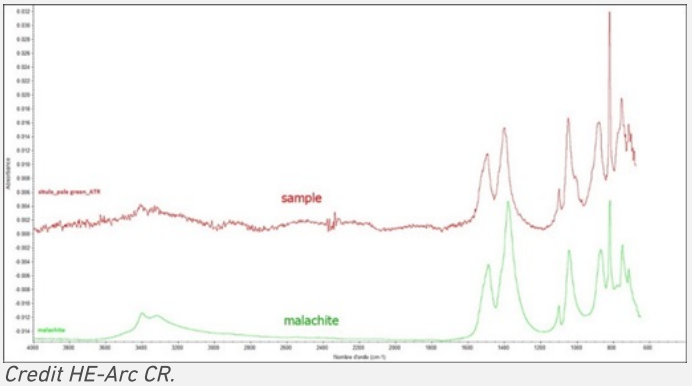
Fig. 15: FTIR spectrum (ATR mode) of the outer green layer compared to the malachite standard spectrum. Method of analysis: FTIR spectroscopy, HE-Arc CR.,

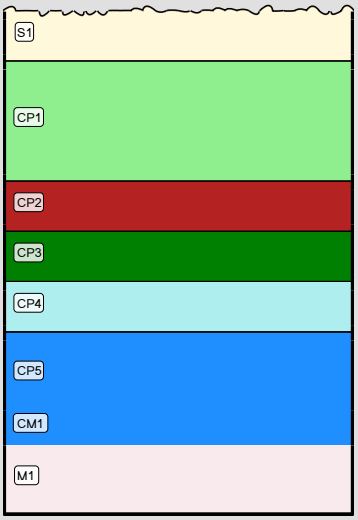
There are 2 stratigraphies (Fig. 5 corresponding to the interior face of the situla and Fig. 6 to its exterior face). The strata are similar in composition but their coding is different: CP1 to CP3 in Fig. 5 correspond to CP3 to CP5 in Fig. 6. Since the stratigraphy of Fig. 6 is more complete, the composition of each of its strata is given below.

Fig. 6: Stratigraphic representation of the object in cross-section using the MiCorr application. The characteristics of the strata are only accessible by clicking on the drawing that redirects you to the search tool by stratigraphy representation. This representation shows the interior face and can be compared to Fig. 10 (top square), Credit HE-Arc CR, M-J.Scholl.

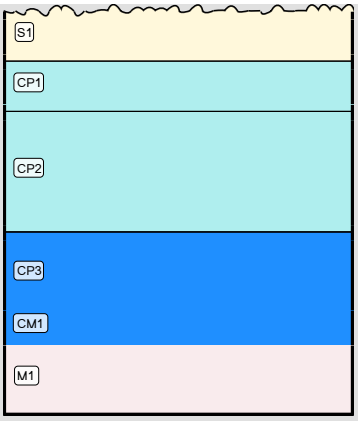
Fig. 5: Stratigraphic representation of the object in cross-section using the MiCorr application. The characteristics of the strata are only accessible by clicking on the drawing that redirects you to the search tool by stratigraphy representation. This representation shows the exterior face and can be compared to Fig. 10 (bottom square), Credit HE-Arc CR, M-J.Scholl.

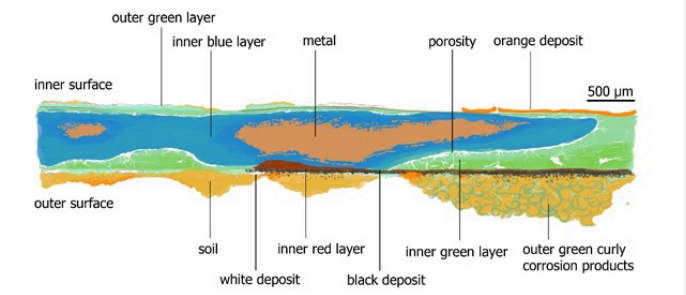
Based on the analyses carried out, the schematic representation of the stratigraphy of corrosion layers (Fig. 3) was corrected (additional e and i within the coding correspond to strata in contact with the environment (e) and internal strata (i)).

Fig. 16: Improved stratigraphic representation of the situla from visual observations and analyses,

The metal structure of this low-tin bronze shows extensive cold work and multiple annealing cycles with a final cold work. The total absence of inclusions highlights a highly developed knowledge in bronze metallurgy. The metal is much corroded. Transgranular corrosion is visible. The majority of the internal corrosion products are composed of copper carbonates that have replaced much of the metal. Curly malachite has developed in clusters on the outside of the surface. This pattern is characteristic of a long-term burial period. The presence of inner enriched Sn layers shows a decuprification phenomenon (dissolution of Cu). Because of the friable nature of the inner green layer that supports the limit of the original surface, as well as its cleavage with the blue layer underneath, the original surface has become very fragile. The corrosion is thought to be of type 1 according to Robbiola et al. 1998.
