SITULA EMT09-554.665 – TIN BRONZE – IRON AGE – SWITZERLAND

Artefact name	Situla EMT09-554.665
Authors	Christian. Degrigny (HE-Arc CR, Neuchâtel, Neuchâtel, Switzerland) & Marie-Jeanne. Scholl (HE-Arc CR, Neuchâtel, Neuchâtel, Switzerland) & Valentin. Boissonnas (HE-Arc CR, Neuchâtel, Neuchâtel, Switzerland)
Url	/artefacts/458/

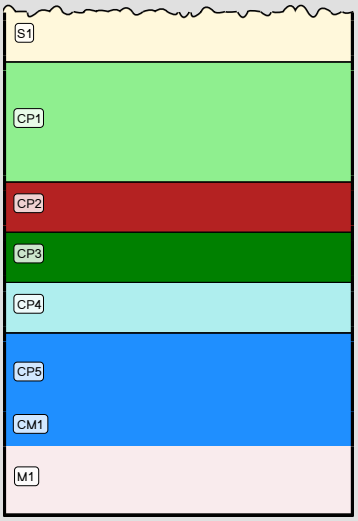
There are 2 stratigraphies (Fig. 5 corresponding to the interior face of the situla and Fig. 6 to its exterior face). The strata are similar in composition but their coding is different: CP1 to CP3 in Fig. 5 correspond to CP3 to CP5 in Fig. 6. Since the stratigraphy of Fig. 6 is more complete, the composition of each of its strata is given below.

Fig. 6: Stratigraphic representation of the object in cross-section using the MiCorr application. The characteristics of the strata are only accessible by clicking on the drawing that redirects you to the search tool by stratigraphy representation. This representation shows the interior face and can be compared to Fig. 10 (top square), Credit HE-Arc CR, M-J.Scholl.

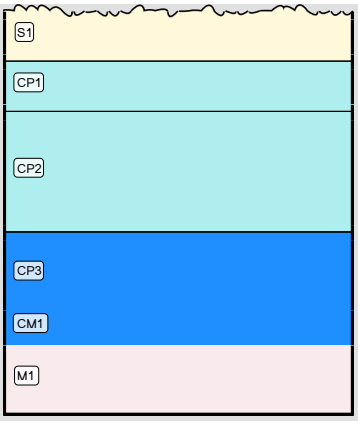
Fig. 5: Stratigraphic representation of the object in cross-section using the MiCorr application. The characteristics of the strata are only accessible by clicking on the drawing that redirects you to the search tool by stratigraphy representation. This representation shows the exterior face and can be compared to Fig. 10 (bottom square), Credit HE-Arc CR, M-J.Scholl.
