SITULA EMT09-554.665 – TIN BRONZE – IRON AGE – SWITZERLAND

Artefact name	Situla EMT09-554.665
Authors	Christian. Degrigny (HE-Arc CR, Neuchâtel, Neuchâtel, Switzerland) & Marie-Jeanne. Scholl (HE-Arc CR, Neuchâtel, Neuchâtel, Switzerland) & Valentin. Boissonnas (HE-Arc CR, Neuchâtel, Neuchâtel, Switzerland)
Url	/artefacts/459/

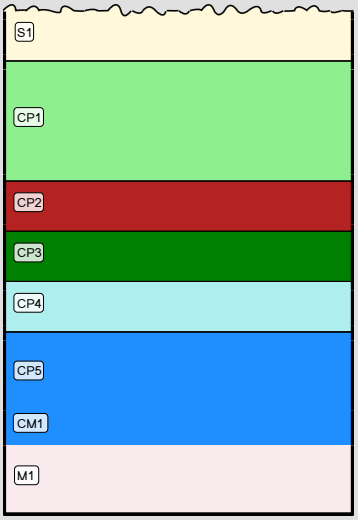
There are 2 stratigraphies (Fig. 5 corresponding to the interior face of the situla and Fig. 6 to its exterior face). The strata are similar in composition but their coding is different: CP1 to CP3 in Fig. 5 correspond to CP3 to CP5 in Fig. 6. Since the stratigraphy of Fig. 6 is more complete, the composition of each of its strata is given below.

Fig. 6: Stratigraphic representation of the object in cross-section using the MiCorr application. The characteristics of the strata are only accessible by clicking on the drawing that redirects you to the search tool by stratigraphy representation. This representation shows the interior face and can be compared to Fig. 10 (top square), Credit HE-Arc CR, M-J.Scholl.

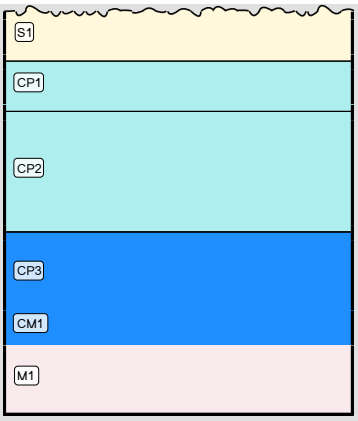
Fig. 5: Stratigraphic representation of the object in cross-section using the MiCorr application. The characteristics of the strata are only accessible by clicking on the drawing that redirects you to the search tool by stratigraphy representation. This representation shows the exterior face and can be compared to Fig. 10 (bottom square), Credit HE-Arc CR, M-J.Scholl.
