FRAGMENTS OF OENOCHOE GV132-01 US26-OBJ.10 - TIN BRONZE - ROMAN TIMES - SWITZERLAND

Artefact name	Fragments of oenochoe GV132-01 US26-obj.10
Authors	Christian. Degrigny (HE-Arc CR, Neuchâtel, Neuchâtel, Switzerland) & S. Gillioz (HE-Arc CR, Neuchâtel, Neuchâtel, Switzerland) & Valentin. Boissonnas (HE-Arc CR, Neuchâtel, Neuchâtel, Switzerland)
Url	/artefacts/460/

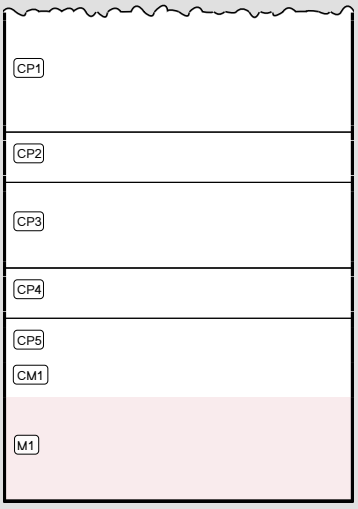
Fig. 5: Stratigraphic representation of the object in cross-section using the MiCorr application. The characteristics of the strata are only accessible by clicking on the drawing that redirects you to the search tool by stratigraphy representation. This representation can be compared to Fig. 11, Credit HE-Arc CR, C.Degrigny.

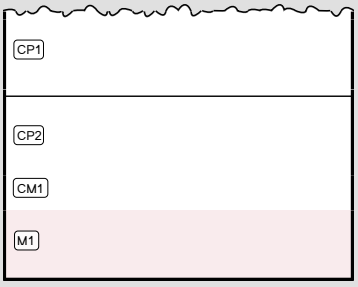
The corrosion crust on the metal has an average thickness of about 70 µm (Fig. 13). It consists of two sub-layers. The inner corrosion layer (CP2) is thin and dark brown in dark field or light grey in bright field. It has penetrated into the metal structure in some areas (Fig. 9). In dark field, the outer corrosion layer (CP1) is constituted of a heterogeneous light grey corrosion crust (Fig.13). The inner brown corrosion layer is enriched in Sn and O but also contains P, while the outer light grey corrosion layer is mainly composed of Pb and O but also contains P and Fe (Fig. 12). The outer light grey layer is probably due to the presence of a soft solder used to assemble the base to the body.

Fig. 6: Stratigraphic representation of the object in cross-section using the MiCorr application. The characteristics of the strata are only accessible by clicking on the drawing that redirects you to the search tool by stratigraphy representation. This presentation can be compared to Fig. 13, Credit HE-Arc CR, C.Degrigny.
