FRAGMENT OF A BED STRUCTURE 03 12751-20.2.5 - TIN BRONZE - ROMAN TIMES - SWITZERLAND

Artefact name	Fragment of a bed structure 03 12751-20.2.5
Authors	Marianne Senn. (Empa, None) & Christian. Degrigny (HE-Arc CR, Neuchâtel, Neuchâtel, Switzerland)
Url	/artefacts/462/

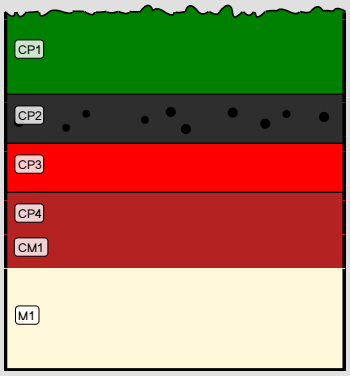
Fig. 4: Stratigraphic representation of the object in cross-section using the MiCorr application. The characteristics of the strata are only accessible by clicking on the drawing that redirects you to the search tool by stratigraphy representation. This representation can be compared to Fig. 8, Credit HE-Arc CR.
