ARMATURE FROM A CLOCK MOVEMENT MIH IV-212 – ZN AL SN CU ALLOY – MODERN TIMES

Artefact name	Armature from a clock movement MIH IV-212
Authors	Marianne. Senn (EMPA, Dübendorf, Zurich, Switzerland) & Christian. Degrigny (HE-Arc CR, Neuchâtel, Neuchâtel, Switzerland)
Url	/artefacts/463/

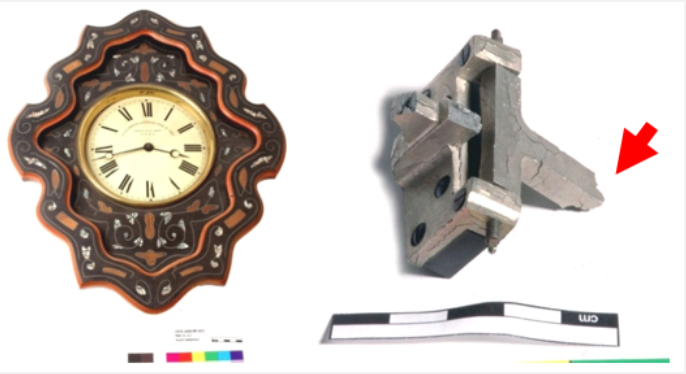
Fig. 1: Wooden wall clock, zinc alloy armature from the clock movement (after Seematter 2009),

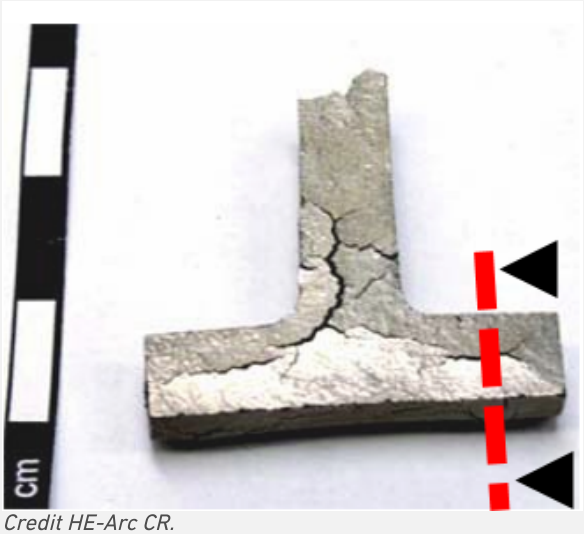
Fig. 2: Location of sampling area,

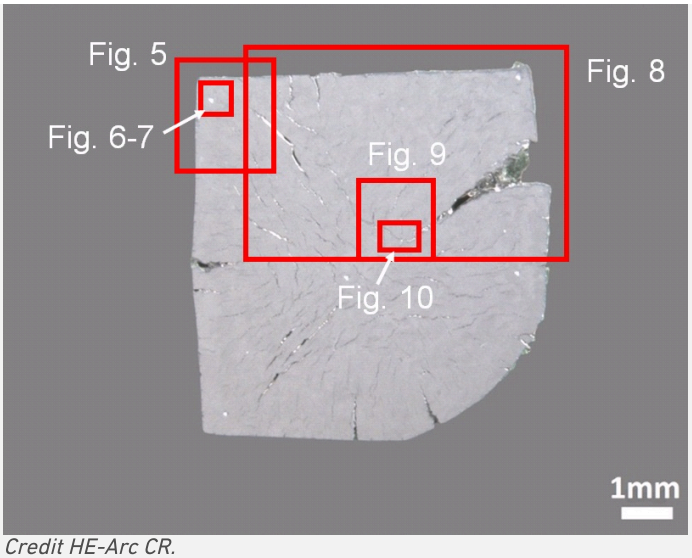
Fig. 3: Micrograph of the cross-section showing the location of Figs. 5 to 10,

Description of sample	This sample is the complete cross-section from an element of the armature (Fig. 2). The metal has huge cracks radiating from the centre to the outside which have deformed the armature (Fig. 3). The metal is covered with a Ni coating.
Alloy	Zn Al Sn Cu Alloy
Technology	As-cast
Lab number of sample	MIH-VI-212
Sample location	HE-Arc CR, Neuchâtel, Neuchâtel
Responsible institution	International museum of horology (IMH), La Chaux-de-Fonds, Neuchâtel
Date and aim of sampling	2009, metal analysis

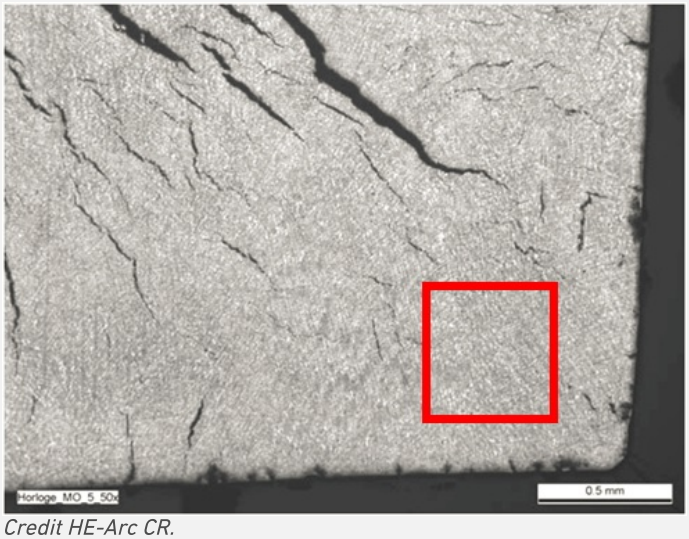
The metal is a Zn-Al-Sn-Cu alloy (Table 1) with an average hardness of HV1 105. A fine dendritic structure is observed (Fig. 5) which consists of clearly separated Zn, Al-Cu and Sn-rich phases (Figs. 6 and 7). Pb is associated with Sn but also forms tiny nodules.

Elements	Zn	Al	Sn	Cu	Pb	Total
Metal	67	17	11	4	<1	99

Table 1: Chemical composition (mass %) of the metal (oxygen not shown). Method of analysis: SEM/EDS, Lab of Electronic Microscopy and microanalysis, IMA (Néode), HEI Arc.

The Zn-rich phase is heavily oxidised internally (Fig. 7). The corrosion has developed throughout the entire metal body, generating cracks (Figs. 8 and 9). The cracks are Zn, O and C-rich (Fig. 10) and could be composed of zinc carbonate.

The armature of the clock mechanism is constituted of a ZnAlSnCu alloy. The absence of cohesion between the different phases has led to the penetration of O during the manufacturing of the alloy. Small original cracks have developed further eventually causing the armature to break. This phenomenon, known since the 1920's, is called zinc pest. It develops mainly on cast objects, starting with localised modifications (blisters and pits, Cramer and Covino 2005).

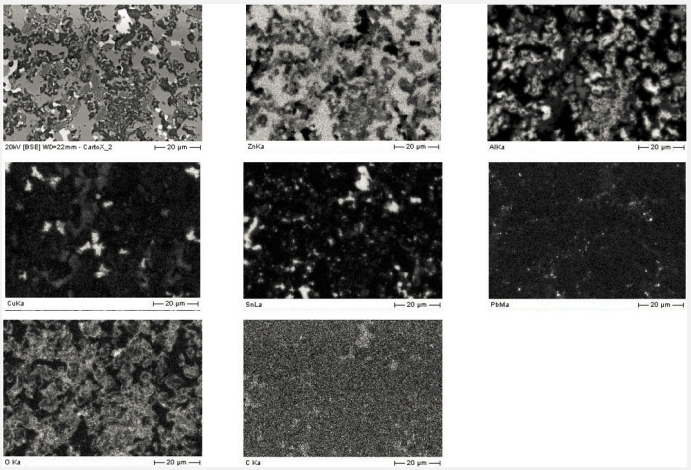
Fig. 6: SEM image, BSE-mode, detail from Fig. 5 (detail), unetched, bright field. Three phases appear: in light-grey the Zn-rich phase, in dark-grey the Al and Cu-rich phase and in white the Sn-rich phase,

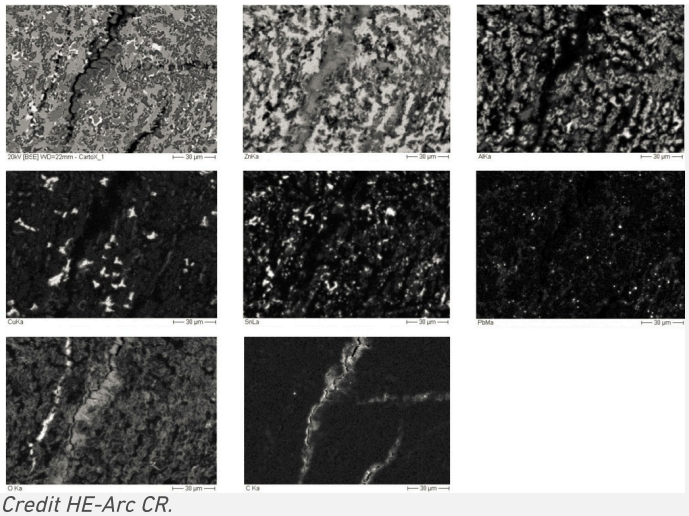
Fig. 10: SEM image, BSE-mode, and elemental chemical distribution of the selected area from Fig. 9 (detail). Method of examination: SEM/EDX, Lab of Electronic Microscopy and microanalysis, IMA (Néode), HEI Arc,
