AIRCRAFT FRONT FASTENING PLATE VHS-497 (2) – AL CU SN ZN SI ALLOY – MODERN TIMES

Artefact name	Aircraft front fastening plate VHS-497 (2)
Authors	Marianne. Senn (EMPA, Dübendorf, Zurich, Switzerland) & Christian. Degrigny (HE-Arc CR, Neuchâtel, Neuchâtel, Switzerland)
Url	/artefacts/465/

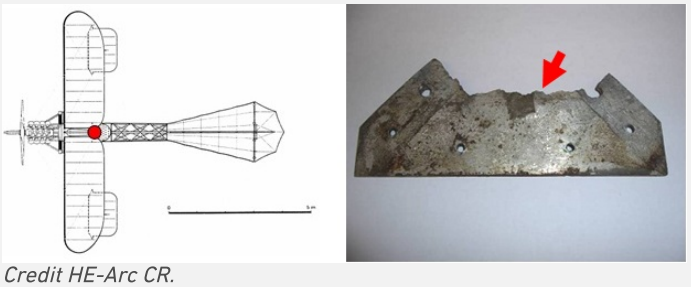
Fig. 1: Photograph of the aeroplane showing the location of the fixation plate (red dot) (www.hepta.aero),

Description of the artefact	Fixation plate for the wooden construction, broken by use (Fig. 1).
Type of artefact	Aeroplane part
Origin	Dufaux IV aeroplane
Recovering date	Biplane built by Henri and Armand Dufaux in 1909/10
Chronology category	Modern Times
chronology tpq	1909 A.D.
chronology taq	1910 A.D.
Chronology comment	
Burial conditions / environment	Outdoor to indoor atmosphere
Artefact location	Swiss Museum of Transport, Luzern, Lucerne
Owner	Swiss Museum of Transport, Luzern, Lucerne
Inv. number	VHS-497 (2)
Recorded conservation data	Not known

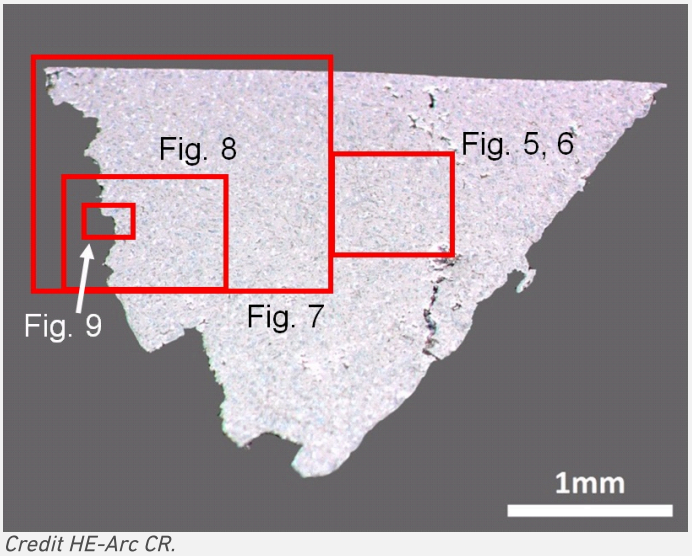
Fig. 2: Location of sampling area,

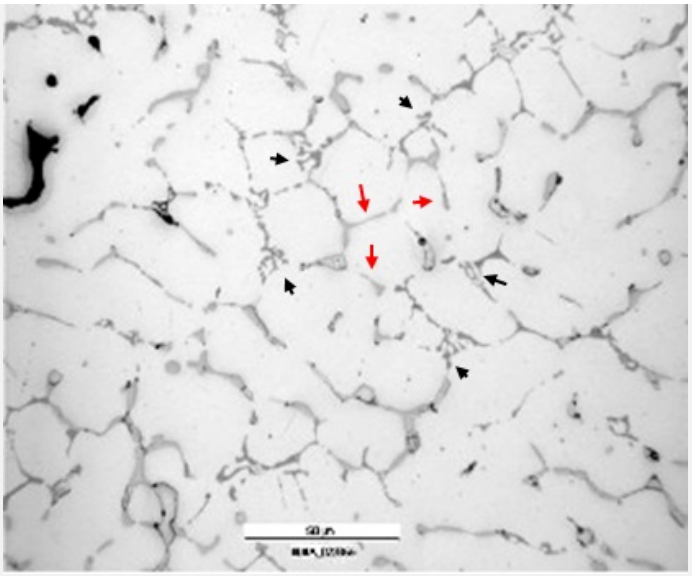
Fig. 3: Micrograph of the cross-section showing the location of Figs. 5 to 9,

Description of sample	The top part has been cut during sampling (Fig. 2). The more regular right side is the plate surface and the irregular side is the broken edge (Fig. 3). Dimensions: L = 4mm ; W = 4mm.
Alloy	Al Cu Sn Zn Si Alloy
Technology	As-cast
Lab number of sample	DUF-4
Sample location	Empa (Marianne Senn)
Responsible institution	Swiss Museum of Transport, Luzern, Lucerne
Date and aim of sampling	September 2007, metallography and alloy composition

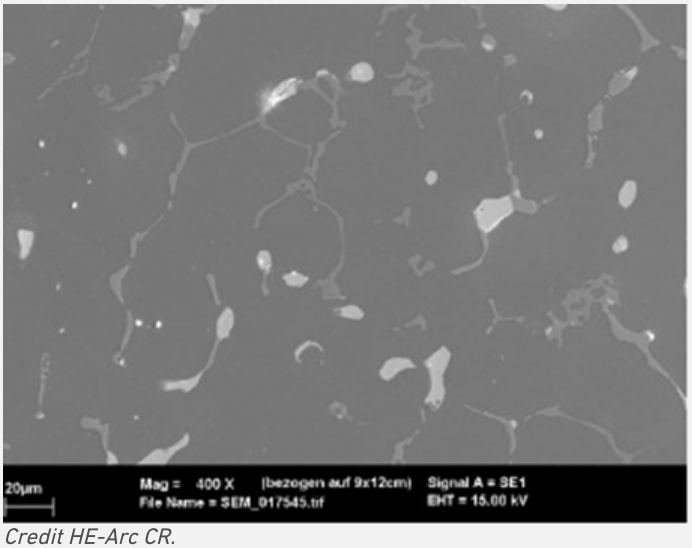
The metal is an aluminium alloy containing Cu, Sn, Zn and Si (Table 1). The unetched metal shows an as-cast structure consisting of the aluminium matrix with Sn (not soluble in Al) inclusions (Figs. 5 and 6), intermetallic compounds such as Al_2Cu (Fig. 5, red arrows) and clusters of Al,Fe,Cu & Si phases (Fig. 5, black arrows). There are porosities in the metal (Figs. 3 and 5). The average hardness of the metal is HV1 80.

Fig. 5: Micrograph of the metal sample from Fig. 3 (detail), unetched, bright field. The cast structure is revealed by light grey intermetallic compounds (Al2Cu, red arrows), dark-grey Al,Fe,Si & Cu phase clusters (black arrows) and Sn inclusions (nodules). On the top left some pores can be seen,

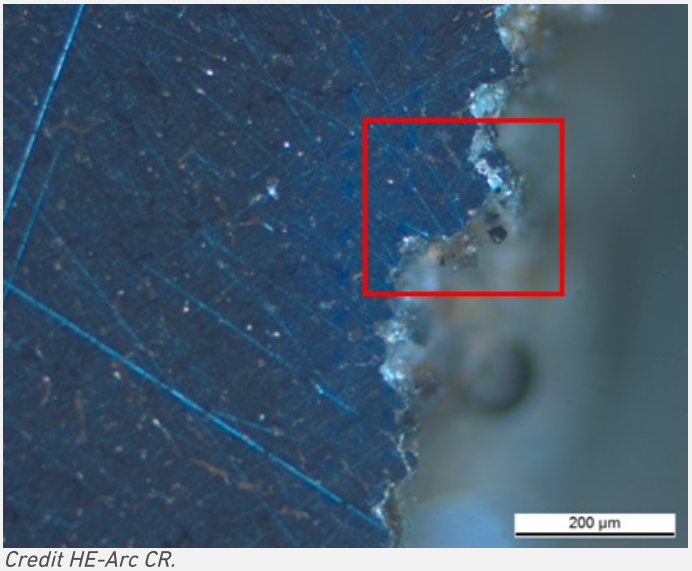
No corrosion layer can be seen on the metal surface (Figs. 3 and 7). Under polarized light small white and brown particles are visible on the broken edge (D1, Fig. 8). Their analysis reveals the presence of silica particles surrounded by dirt (Table 2 and Fig. 9). The metal surface is covered by a thin oxygen bearing skin (CP1, Fig. 9).

Fig. 7: Micrograph showing the metal - “corrosion products” interface from Fig. 3 (reversed picture, detail), unetched, bright field. We observe in white the metal matrix, in dark-grey Al,Fe, Si & Cu phase and light-grey Al2Cu intermetallic compounds. The micrograph of Fig. 8 is marked by a rectangle,

Fig. 8: Micrograph from Fig. 7 (detail) and corresponding to the stratigraphy of Fig. 4, unetched, polarised light. We observe in grey the metal matrix and blue-brown the adherent material. The micrograph of Fig. 9 is marked by a rectangle,

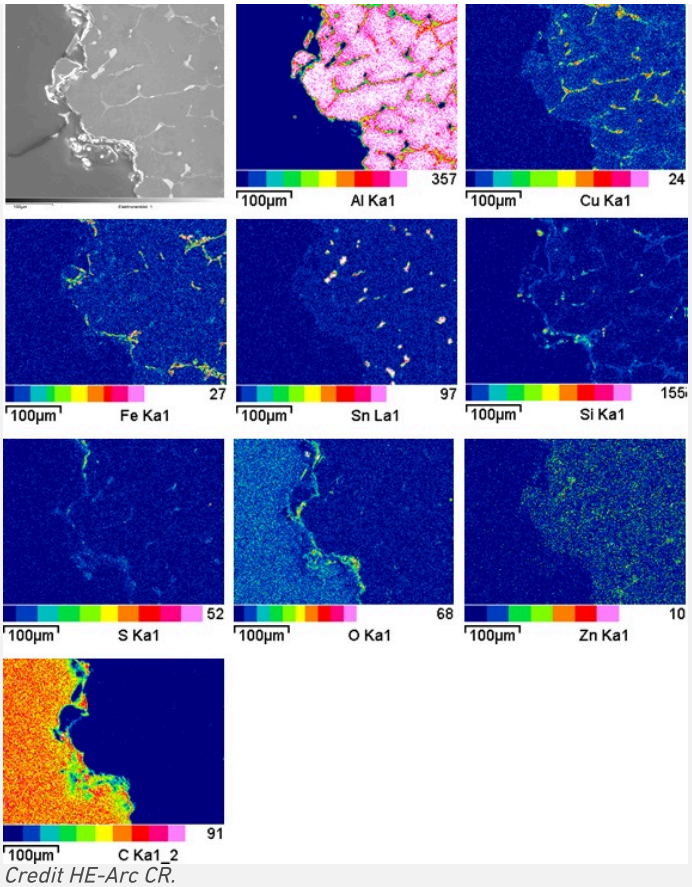
Fig. 9: SEM image, BSE-mode, and elemental chemical distribution of the selected area from Fig. 8 (reversed picture, detail). Method of examination: SEM/EDS, Laboratory of Analytical Chemistry, Empa,

Although not common at the beginning of the 20th, this Al-Cu-Sn-Zn-Si cast alloy was extensively used on the Dufaux IV plane. No corrosion layer has been found on the metal surface except adherent silica-rich particles and the thin oxidised skin typical of Al alloys. The presence of these materials might be explained by the regular maintenance of the metal using abrasive silicon carbide paper.

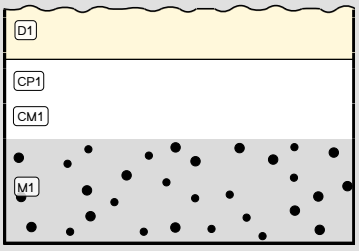
Fig. 4: Stratigraphic representation of the object in cross-section using the MiCorr application. The characteristics of the strata are only accessible by clicking on the drawing that redirects you to the search tool by stratigraphy representation. This representation can be compared to Fig. 8, Credit HE-Arc CR.
