AIRCRAFT FRONT FASTENING PLATE VHS-497 (2) – AL CU SN ZN SI ALLOY – MODERN TIMES

Artefact name	Aircraft front fastening plate VHS-497 (2)
Authors	Marianne. Senn (EMPA, Dübendorf, Zurich, Switzerland) & Christian. Degrigny (HE-Arc CR, Neuchâtel, Neuchâtel, Switzerland)
Url	/artefacts/465/

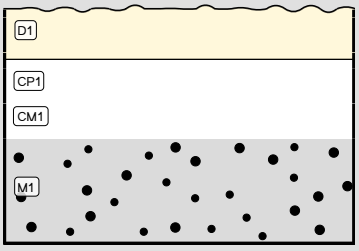
Fig. 4: Stratigraphic representation of the object in cross-section using the MiCorr application. The characteristics of the strata are only accessible by clicking on the drawing that redirects you to the search tool by stratigraphy representation. This representation can be compared to Fig. 8, Credit HE-Arc CR.
