FITTING ON BACK PANEL OF A MILITARY CARRIAGE – THOMAS STEEL – MODERN TIMES – SWITZERLAND

Artefact name	Fitting on back panel of a military carriage
Authors	Marianne. Senn (EMPA, Dübendorf, Zurich, Switzerland) & Christian. Degrigny (HE-Arc CR, Neuchâtel, Neuchâtel, Switzerland)
Url	/artefacts/467/

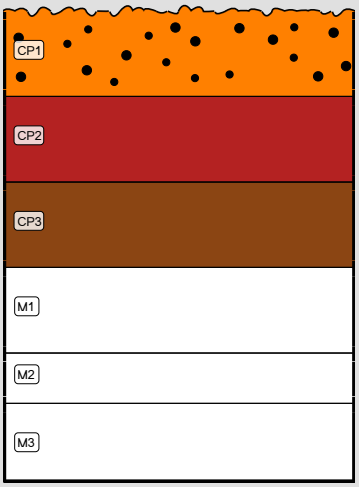
Fig. 4: Stratigraphic representation of the object in cross-section using the MiCorr application. The characteristics of the strata are only accessible by clicking on the drawing that redirects you to the search tool by stratigraphy representation. This representation showing for the metal part a welding seam (M2) can be compared to Fig. 10, Credit HE-Arc CR.
