SHOE NAIL 2637 1370.B. - HYPOEUTECTOID STEEL - ROMAN TIMES - SWITZERLAND

Artefact name Shoe nail 2637 1370.B.

Authors Christian. Degrigny (HE-Arc CR, Neuchâtel, Neuchâtel, Switzerland) & Valentin. Boissonnas (HE-Arc CR, Neuchâtel, Neuchâtel, Switzerland) & Vincent Chappuis. (HE-Arc CR, Neuchâtel, Neuchâtel, Switzerland)

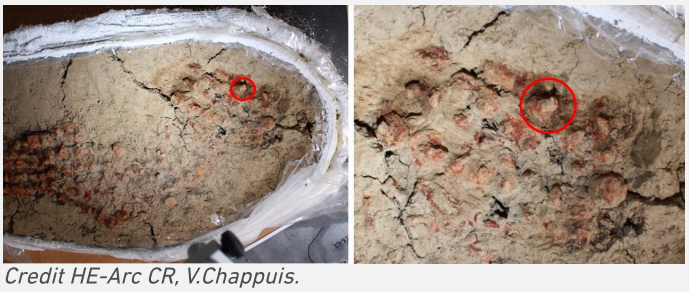
Fig. 2: Incomplete shoe from which the nail was sampled (in red circle),

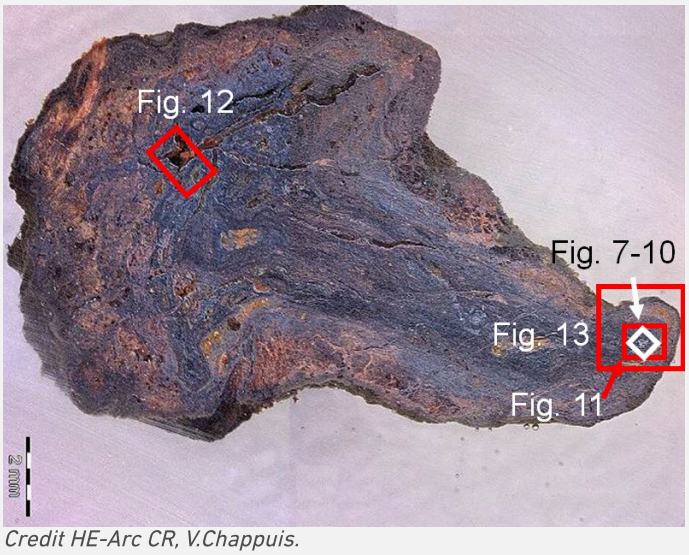
Fig. 4: Micrograph of the cross-section showing the location of figs. 7 to 13,

Description of sample	A longitudinal cut through the nail (Fig. 4). Dimensions: L = 16.4mm; W = about 12.0mm.
Alloy	Hypoeutectoid steel
Technology	Forged
Lab number of sample	HE-Arc CR 1457-S1.
Sample location	HE-Arc CR, Neuchâtel, Neuchâtel
Responsible institution	HE-Arc CR, Neuchâtel, Neuchâtel
Date and aim of sampling	2013, metallography and elementary composition of the metal

The metal is heavily corroded and the thickness of the corrosion crust is irregular, varying from 0.8 to 3.8mm, with an average of about 2mm. The corrosion has replaced most of the metal (Fig. 4). Between corrosion layers the limit of the original structure is visible. Some leather fibers seem to be preserved as pseudomorphic structures in voids of the metal core (POM1, Figs. 11 and 12). The carbon mapping (Fig.13) shows the presence of carbon in these areas. This can also be due to the penetration of the mounting resin in the cracks.

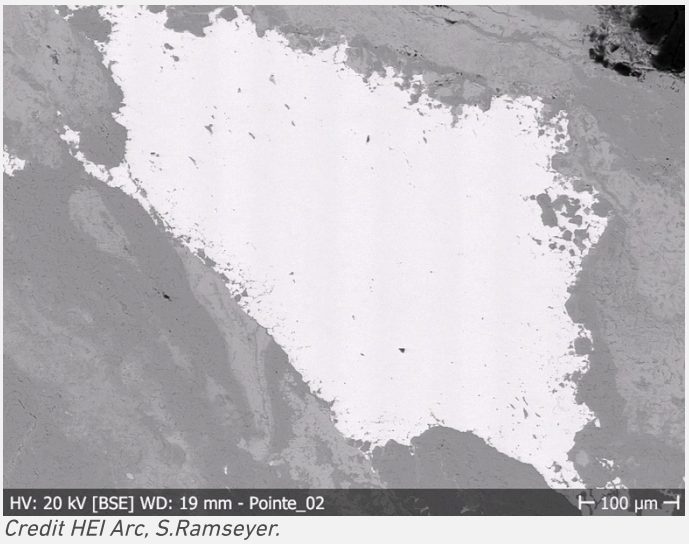
The remaining metal is an hypoeutectoid steel (Fig. 7 and 8), containing Fe, Si and O slags inclusions (possibly fayalite FeO,SiO2), and consisting of less than 1% of the total volume of the highly mineralized nail. After Nital etching, it shows intergranular corrosion on one of its sides (Figs. 9 and 10).

Fig. 7: SEM, BSE-mode picture of remaining metal,

Fig. 8: SEM, BSE-mode picture of inclusions in remaining metal,

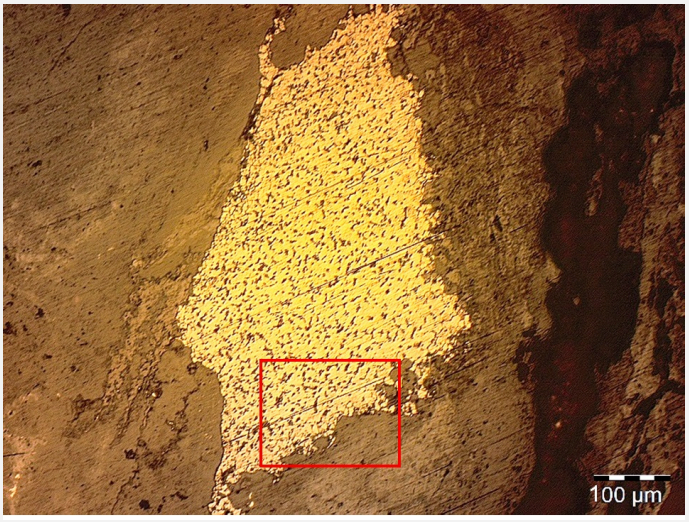
Fig. 9: Micrograph of the metal sample from Fig. 7 (detail, rotated 90°), Nital etched, bright field,

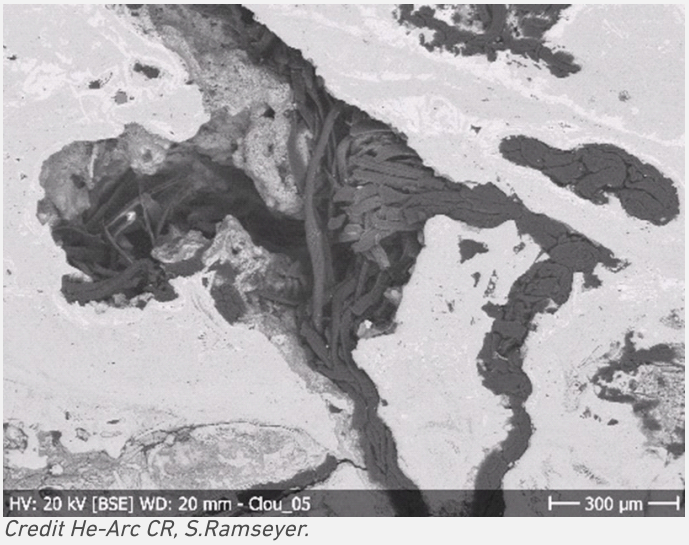
Fig. 11: Micrograph of the metal sample, bright field. The deliminated zone shows what could be leather pseudomorphic fibers filling a void,

Fig. 12: Micrograph (SEM - BSE-mode) of another void filled with fibers in the head of the nail,
