SHOE NAIL 2637 1370.B. - HYPOEUTECTOID STEEL - ROMAN TIMES - SWITZERLAND

Artefact name Shoe nail 2637 1370.B.

Authors Christian. Degrigny (HE-Arc CR, Neuchâtel, Neuchâtel, Switzerland) & Valentin. Boissonnas (HE-Arc CR, Neuchâtel, Neuchâtel, Switzerland) & Vincent Chappuis. (HE-Arc CR, Neuchâtel, Neuchâtel, Switzerland)

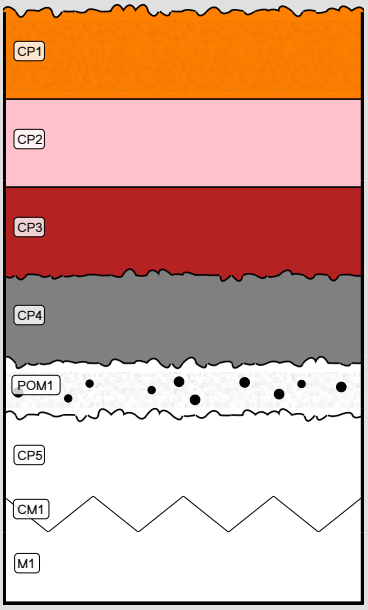
Fig. 6: Stratigraphic representation of the object in cross-section using the MiCorr application. The characteristics of the strata are only accessible by clicking on the drawing that redirects you to the search tool by stratigraphy representation. This representation can be compared to Fig. 14, Credit HE-Arc CR, V.Chappuis.

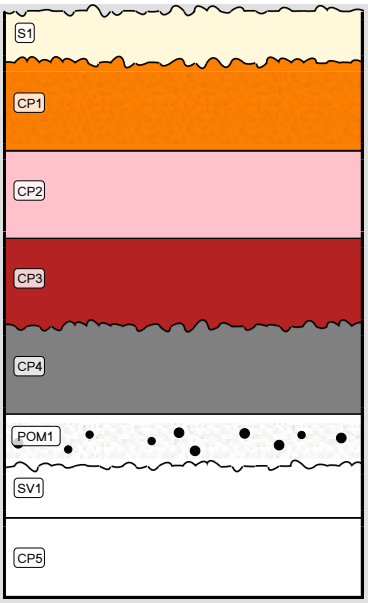
Fig. 5: Stratigraphic representation of the object in cross-section using the MiCorr application. The characteristics of the strata are only accessible by clicking on the drawing that redirects you to the search tool by stratigraphy representation. This representation can be compared to Fig. 14, Credit HE-Arc CR, V.Chappuis.
