VOTIVE FIGURE OF A BAT IVB4168 – GILDED BRASS – MODERN TIMES

Artefact name Votive figure of a bat IVb4168

Authors Christian. Degrigny (HE-Arc CR, Neuchâtel, Neuchâtel, Switzerland) & Naima. Gutknecht (HE-Arc CR, Neuchâtel, Neuchâtel, Switzerland) & Valentin. Boissonnas (HE-Arc CR, Neuchâtel, Neuchâtel, Switzerland)

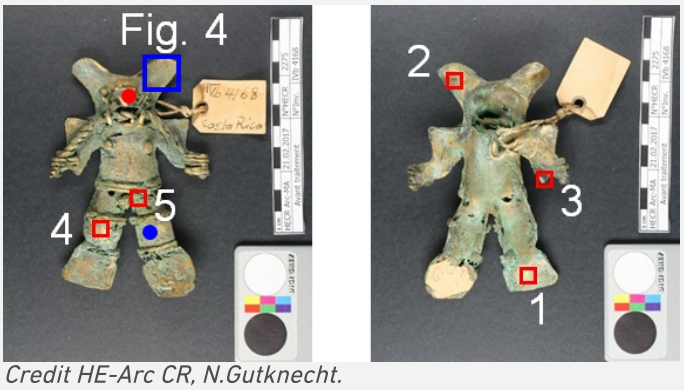
Fig. 1: Votive figure of a bat, front (left) and back (right) view,

Description of the artefact The object represents a bat-like figure holding and chewing a rope (Fig. 1). The copper alloy was most likely cast using the lost wax process. There are remains of a surface gilding. The object has a red-brown adherent layer where the gold has flaked off with a heterogenous green and white loosely bound layer on top. Dimensions: Length = 110 mm; Width = 73mm; Height = 25mm; WT = 60g.

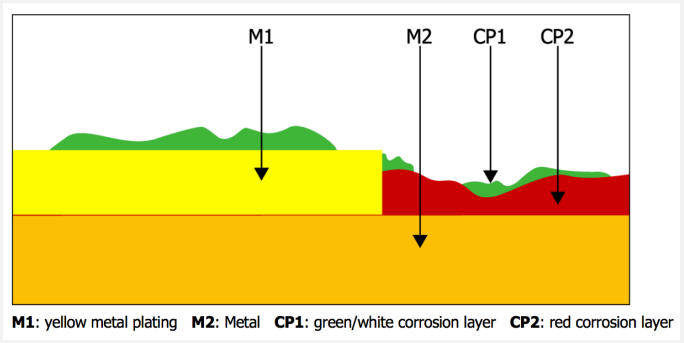
Fig. 3: Stratigraphic representation of the bat in cross-section by macroscopic observation,

The schematic representation below gives an overview of the corrosion layers encountered on the object from visual macroscopic observation.

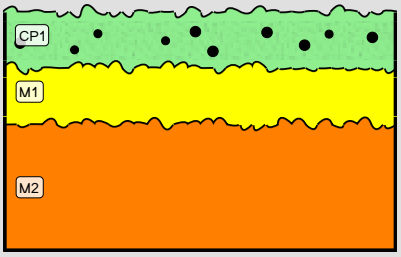
Fig 5: Stratigraphic representation 1 from Fig. 4 using the MiCorr application. The characteristics of the strata are only accessible by clicking on the drawing that redirects you to the search tool by stratigraphy representation, Credit HE-Arc CR, N.Gutknecht.

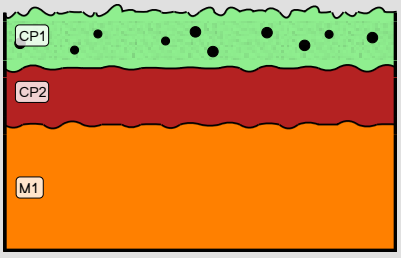
Fig. 6: Stratigraphic representation 2 from Fig. 4 using the MiCorr application. The characteristics of the strata are only accessible by clicking on the drawing that redirects you to the search tool by stratigraphy representation, Credit HE-Arc CR, N.Gutknecht.

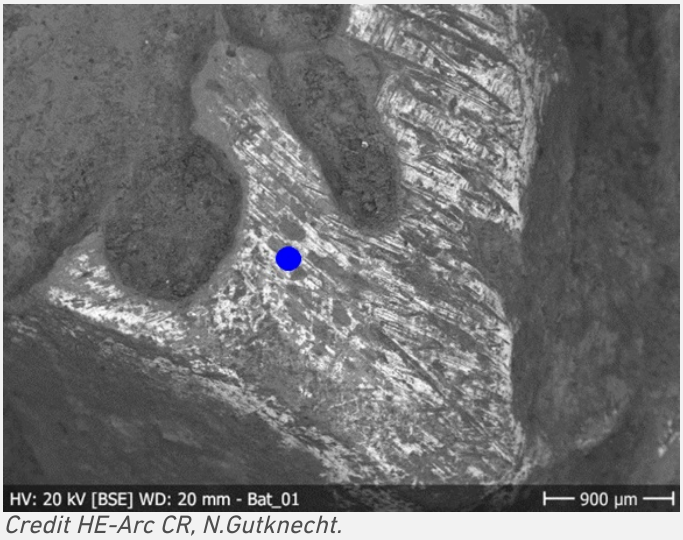
The metal seems to have been heavily attacked (acid dissolution). There are several perforations on the lower part of the object, and where the gold layer is absent the surface is unevenly pitted by corrosion (Figs. 1, 2 and 7). The submetallic core is not visible from the surface.
There are two corrosion products (Figs. 7 and 8). The red one (CP2) has a submetallic brightness and is opaque, non-magnetic, compact, hard and adherent. It is very thin (less than a few microns thick) and only appears where the gold layer has been lost. The EDX spectrum (Fig. 9) shows that it is a Cu- and O rich product, probably cuprite (Cu2O).
The light green to white corrosion product (CP1) has a waxy consistency and is thin, translucent, non-magnetic, powdery and very soft. It is very loosely bound. It is distributed on the whole object (front and back) as disparate clumps. It is mainly located on the cavities and irregularities of the surface. FTIR analyses (ATR mode) of both green and white areas of CP1 have similar spectra and were identified as copper nitrate (Fig. 10).

Fig. 7: Binocular image of the nose of the bat showing detail of Fig. 8,

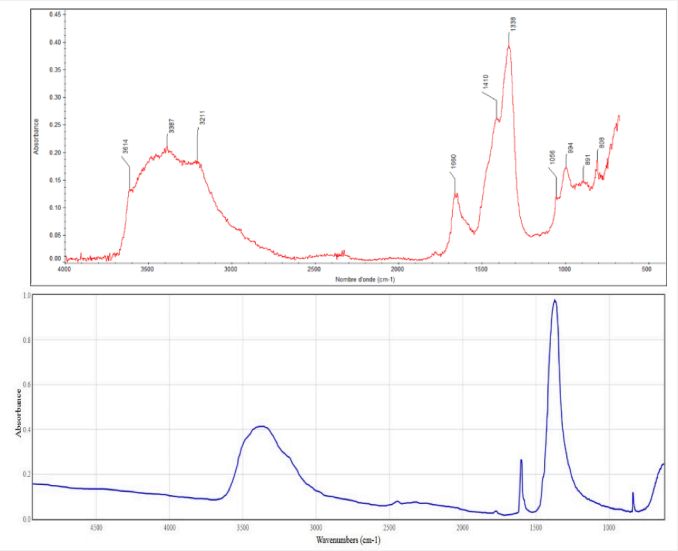
Fig. 9: EDS analysis of the red corrosion product. Method of analysis: SEM-EDS, Lab of Electronic Microscopy and Microanalysis, Néode, HEI Arc,

Fig. 10: FTIR spectrum (ATR mode) of the white corrosion product product (top), and of synthesized copper nitrate (Cu(NO3)2 * 3H2O) (bottom),
