FRAGMENT OF AN AEGIS OF NEÏTH 1886.305.0096 - LEADED BRONZE

Artefact name Fragment of an Aegis of Neïth 1886.305.0096

Authors Line. Pedersen (HE-Arc, Neuchâtel, Neuchâtel, Switzerland) & Christian. Degrigny (HE-Arc CR, Neuchâtel, Neuchâtel, Switzerland) & Valentin. Boissonnas (HE-Arc CR, Neuchâtel, Neuchâtel, Switzerland)

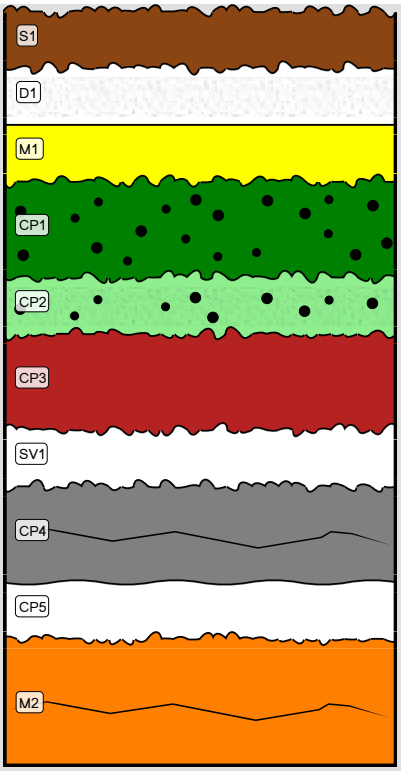
Fig.9: Schematic representation combining stratigraphies 1 and 2 using the MiCorr application. The characteristics of the strata are only accessible by clicking on the drawing that redirects you to the search tool by stratigraphy representation, Credit He-Arc CR, L.Pedersen.

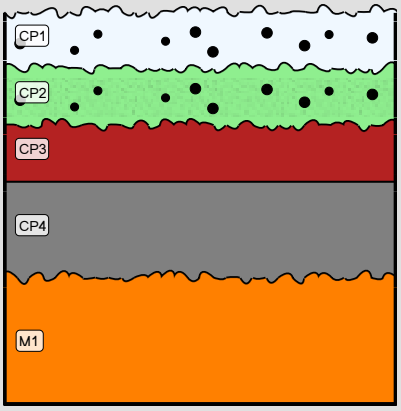
Fig.10: Schematic representation of stratigraphy 3 using the MiCorr application. CP1 is CP6 in Fig. 8. The characteristics of the strata are only accessible by clicking on the drawing that redirects you to the search tool by stratigraphy representation, Credit He-Arc CR, L. Pedersen.
