SHINGLE OF A ROOF – CU ALLOY – MODERN TIMES – SWITZERLAND

Artefact name	Shingle of a roof
Authors	Marianne. Senn (EMPA, Dübendorf, Zurich, Switzerland) & Christian. Degrigny (HE-Arc CR, Neuchâtel, Neuchâtel, Switzerland)
Url	/artefacts/506/

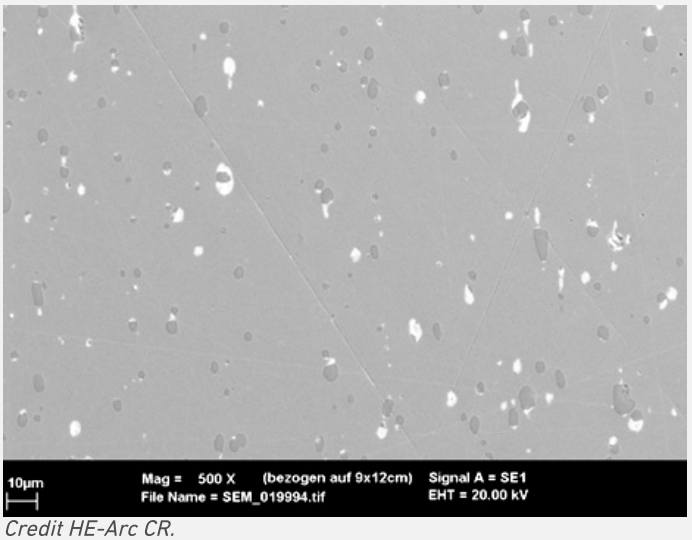
The remaining metal is a copper alloy (Table 1). The evenly distributed inclusions observed under SEM, SE-mode, are either light-grey or white (Fig. 5). The oval shape of the light-grey inclusions is due to deformation, probably by hot rolling (a common technique in the 18th century). Under polarised light they look red (Fig. 7) and their analysis reveals a composition similar to cuprite/Cu2O (Table 2). The white inclusions are rich in Pb and are remnants of the refining process (Table 2). The etched copper shows a structure of polygonal and twinned grains (Fig. 6). The grain size is variable. The average hardness of the metal is about HV1 70.

Fig. 5: SEM image, SE-mode, of the metal sample from Fig. 3 (detail). Light-grey and white inclusions are distributed evenly,

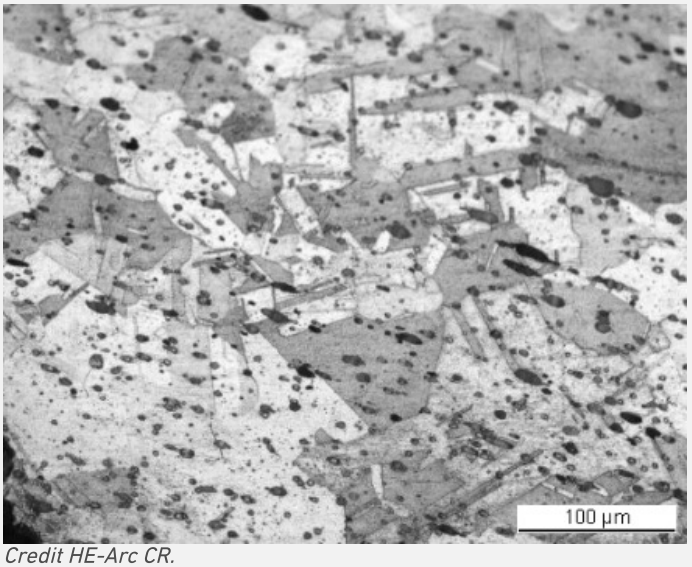
Fig. 6: Micrograph of the metal sample from Fig. 3 (detail), etched, bright field. The metal shows a structure of polygonal and twinned grains. Cuprite inclusions appear as dark spots,

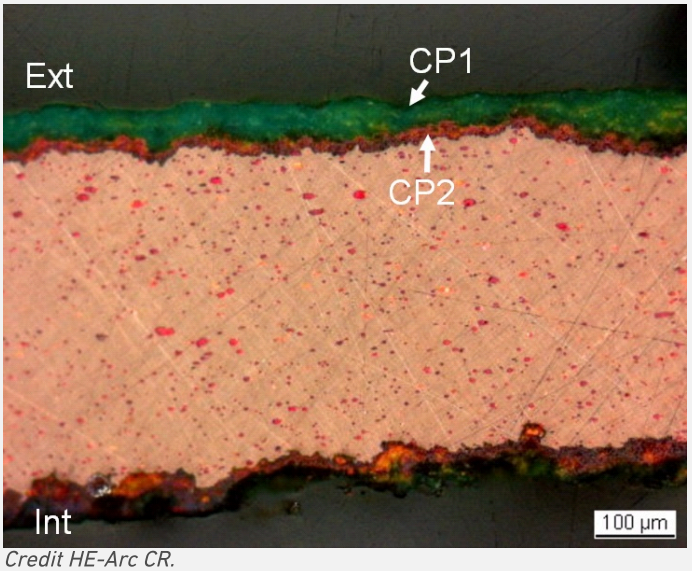
The corrosion crusts of the external and internal sides are distinctively different (Fig. 7). On the internal side an irregular red-orange corrosion layer has developed, and pitting corrosion has occurred. The more uniform corrosion layers on the external side are composed of a red-orange layer, followed by a thicker green outer layer. In some areas, dark-red corrosion products can be observed between the green and red-orange sub-layers. The same dark-red sub-layer can be seen in areas on the internal side covering the red-orange corrosion products. The red-orange corrosion layer on both sides (CP2) has a chemical composition similar to cuprite/Cu_2O, while the green layer on the external side (CP1) contains Cu, S and O and is enriched on its upper surface with Si (Table 3 and Fig. 8). XRD analysis of the corrosion products on the external side of another shingle fragment from the same roof identified brochantite/$Cu_4SO_4(OH)_6$ and cuprite as corrosion products (Rapport d'analyse no. MAH 98-257). These results are confirmed by Raman spectroscopy of the external side of this sample where the same compounds were clearly identified (Figs. 9 and 10).

Fig. 7: Micrograph of the metal sample from Fig. 3 and corresponding to the stratigraphy of Fig. 4, polarised light. External side: the regular corrosion crust with outer green, inner red-orange corrosion products and intermediate dark-red corrosion products. Internal side: the irregular corrosion crust with inner red-orange and outer dark-red corrosion products,

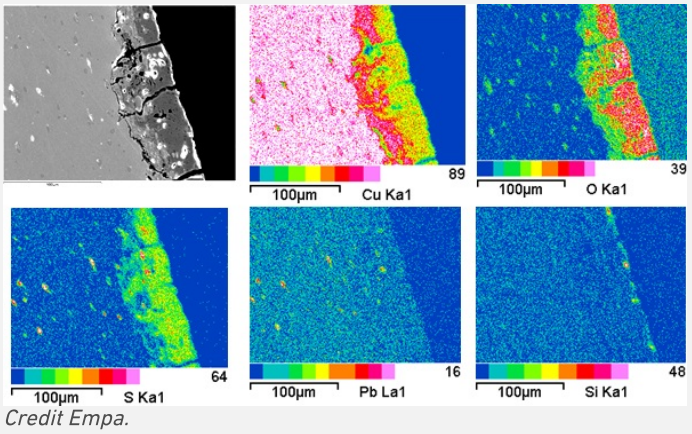
Fig. 8: SEM image, SE-mode, and elemental chemical distribution of the selected area of Fig. 3 (rotated image, detail). Method of examination: SEM/EDS, Laboratory of Analytical Chemistry, Empa,

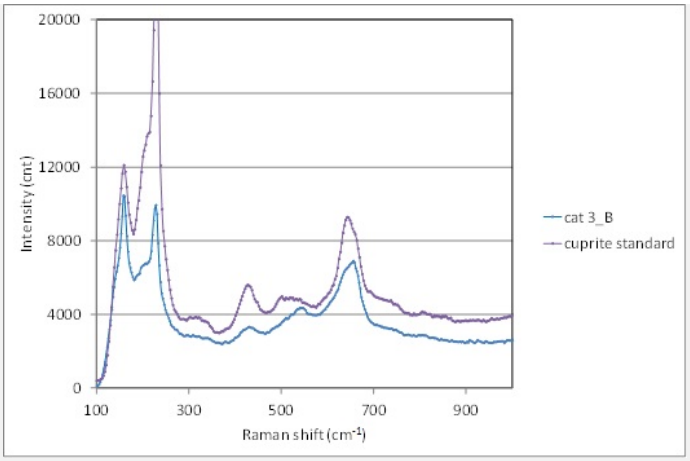
Fig. 9: Raman spectrum of the red-orange inner corrosion layer (CP2) of the external side (cat3_B) compared to a cuprite standard spectrum. Settings: laser wavelength 532nm, acquisition time 100s, one accumulation, filter D2 (0.75-0.8 mW), hole 500, slit 80, grating 600. Method of analysis: Raman spectroscopy, Lab Swiss National Museum, Affoltern a. Albis ZH,

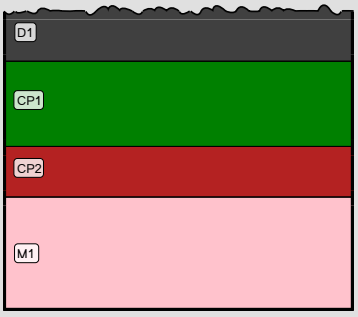
Fig. 4: Stratigraphic representation of the sample taken from the shingle in cross-section using the MiCorr application. The characteristics of the strata are only accessible by clicking on the drawing that redirects you to the search tool by stratigraphy representation. This representation can be compared to Fig. 7, Credit HE-Arc CR.
