SHINGLE OF A ROOF – CU ALLOY – MODERN TIMES – SWITZERLAND

Artefact name	Shingle of a roof
Authors	Marianne. Senn (EMPA, Dübendorf, Zurich, Switzerland) & Christian. Degrigny (HE-Arc CR, Neuchâtel, Neuchâtel, Switzerland)
Url	/artefacts/506/

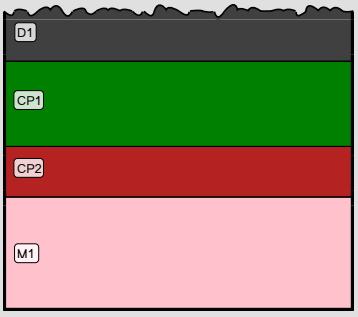
Fig. 4: Stratigraphic representation of the sample taken from the shingle in cross-section using the MiCorr application. The characteristics of the strata are only accessible by clicking on the drawing that redirects you to the search tool by stratigraphy representation. This representation can be compared to Fig. 7, Credit HE-Arc CR.
