FRAGMENT OF THE SUPPORT STRUCTURE OF AN ENGINE VHS-404 - GREY CAST IRON - MODERN TIMES

Artefact name	Fragment of the support structure of an engine VHS-404
Authors	Marianne. Senn (EMPA, Dübendorf, Zurich, Switzerland) & Christian. Degrigny (HE-Arc CR, Neuchâtel, Neuchâtel, Switzerland)
Url	/artefacts/508/

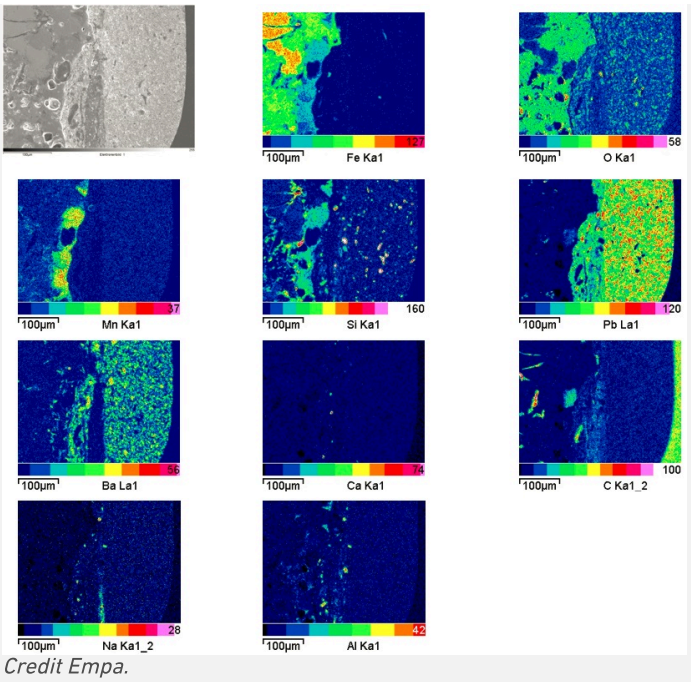
Elements	O	Mg	Si	P	S	Mn	Fe	Ba	Pb	Total
Inner light-grey corrosion layer (Fig. 12)	20	<	<	<	<	1.3	76	<	<	98
Dark-grey casting skin (Fig. 12)	27	<	14	<	<	21	33	<	<	95
Paint system (Fig. 12)	20	<	<	<	<	<	<	18	55	93
Grey corrosion layer (Fig. 11)	35	<	1.1	<	0.6	<	59	<	<	97

Fig. 12: SEM image, SE-mode, and elemental chemical distribution of the selected area from Fig. 3 (detail). Method of examination: SEM/EDS, Laboratory of Analytical Chemistry, Empa,
