AIRCRAFT FRONT FASTENING PLATE VHS-497 (2) - AL CU SN ZN SI ALLOY - MODERN TIMES

Artefact name	Aircraft front fastening plate VHS-497 (2)
Authors	Marianne. Senn (EMPA, Dübendorf, Zurich, Switzerland) & Christian. Degrigny (HE-Arc CR, Neuchâtel, Neuchâtel, Switzerland)
Url	/artefacts/510/

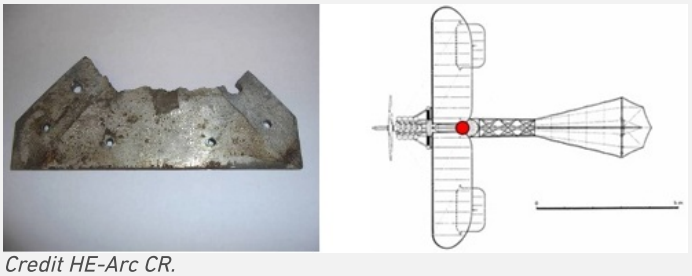
Fig. 1: Fastening plate from the front of the Dufaux IV (left) and top view of the aeroplane showing its location (red dot, right) (www.hepta.aero),

Description of the artefact	Metal fastening plate for the wooden construction of the front of the aeroplane, broken by use (Fig. 1).
Type of artefact	Aeroplane part
Origin	Dufaux IV aeroplane
Recovering date	Biplane built by Henri and Armand Dufaux in 1909/10
Chronology category	Modern Times
chronology tpq	1909 A.D.
chronology taq	1910 A.D.
Chronology comment	
Burial conditions / environment	Outdoor to indoor atmosphere
Artefact location	Swiss Museum of Transport, Luzern, Lucerne
Owner	Swiss Museum of Transport, Luzern, Lucerne
Inv. number	VHS-497 (2)
Recorded conservation data	Not known

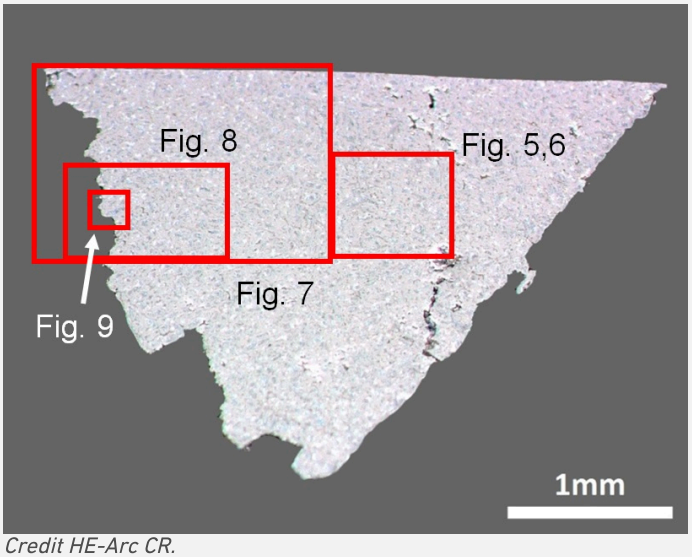
Fig. 3: Micrograph of the cross-section of the sample taken from the front fastening plate showing the location of Figs. 5 to 9,

Description of sample	The top part has been cut during sampling (Fig. 2). The more regular right side is the plate surface and the irregular side is the broken edge (Fig. 3). Dimensions: L = 4mm ; W = 4mm.
Alloy	Al Cu Sn Zn Si Alloy
Technology	As-cast
Lab number of sample	DUF-4
Sample location	Empa (Marianne Senn)
Responsible institution	Swiss Museum of Transport, Luzern, Lucerne
Date and aim of sampling	September 2007, metallography and alloy composition

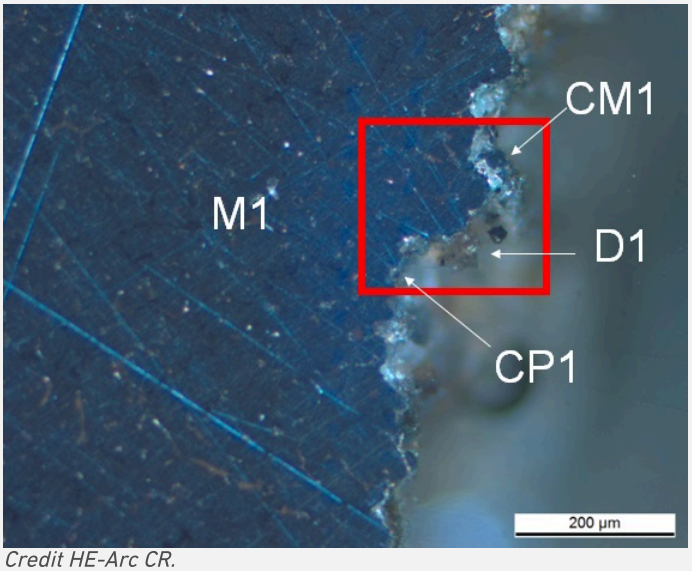
Fig. 8: Micrograph from Fig. 7 (detail) and corresponding to the stratigraphy of Fig. 4, unetched, polarised light. We observe in grey the metal matrix and blue-brown the adherent material. The area selected for elemental chemical distribution (Fig. 9) is marked by a rectangle,

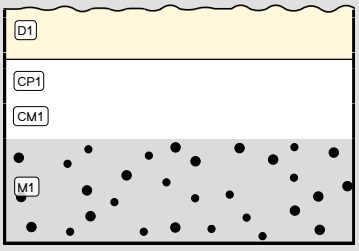
Fig. 4: Stratigraphic representation of the sample taken from the front fastening plate in cross-section using the MiCorr application. The characteristics of the strata are only accessible by clicking on the drawing that redirects you to the search tool by stratigraphy representation. This representation can be compared to Fig. 8, Credit HE-Arc CR.
