FITTING ON BACK PANEL OF A MILITARY CARRIAGE – THOMAS STEEL – MODERN TIMES – SWITZERLAND

Artefact name	Fitting on back panel of a military carriage
Authors	Marianne. Senn (EMPA, Dübendorf, Zurich, Switzerland) & Christian. Degrigny (HE-Arc CR, Neuchâtel, Neuchâtel, Switzerland)
Url	/artefacts/512/

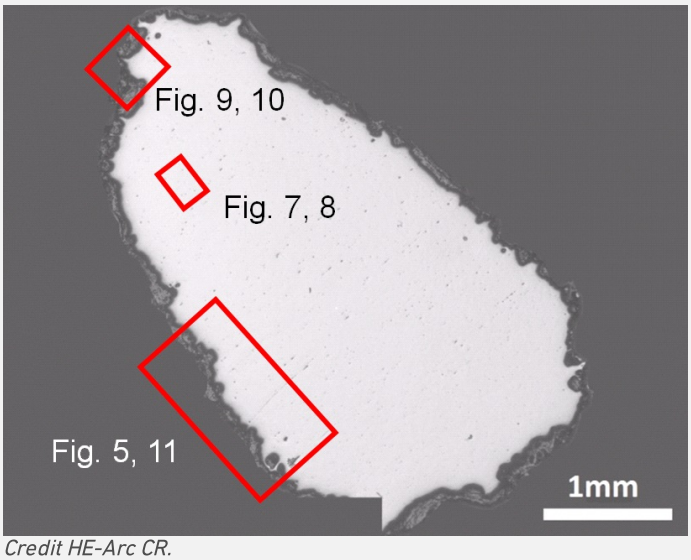
Fig. 3: Micrograph of the cross-section of the sample taken from the fitting showing the location of Figs. 5 and 7 to 11,

This sample is a cut from the corner of one of the two fittings on the back panel (Fig. 2). The metal is covered by a thin corrosion layer (Fig. 3).
Alloy	Thomas steel
Technology	Piled from several strips, hot rolled and annealed
Lab number of sample	POINT-Fe2
Sample location	Empa (Marianne Senn)
Responsible institution	Historical Swiss Army Material Foundation, Burgdorf, Bern
Date and aim of sampling	05/2009 metallography

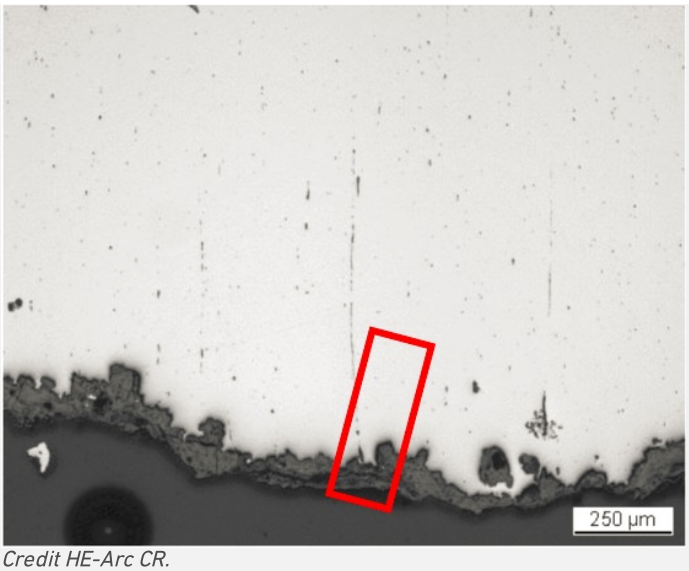
The remaining metal is a Mn-rich soft steel (C content around 0.1 mass%) containing manganese sulphide inclusions with a varying Fe content (Tables 1 and 2). The numerous inclusions form parallel rows (Fig. 5). This orientation is typical for hot rolled metal. After etching with Oberhoffer's reagent, three main welding seams (P-rich) become visible (Fig. 6). Near the surface they are also outlined by corrosion (Figs. 5 and 11). After nital etching, the metal shows a ferritic structure with tertiary cementite and lamellar pearlite at the grain boundaries (Figs. 7 and 8). The grains are small with an ASTM grain size of 10 and are recrystallized due to annealing after hot rolling. The average hardness of the metal is HV1 165. The hardness is slightly high for such a structure and this is due to the Mn content of the metal. The chemical composition, especially the Mn content and the presence of carbo-nitrides (not analysed here), is typical for Thomas steel.

Fig. 5: Micrograph of the metal sample from Fig. 3 (rotated by 270°, detail), unetched, bright field. We observe the metal including welding seams outlined by corrosion products and MnS inclusions. The area selected for elemental chemical distribution (Fig. 11) is marked by a red rectangle,

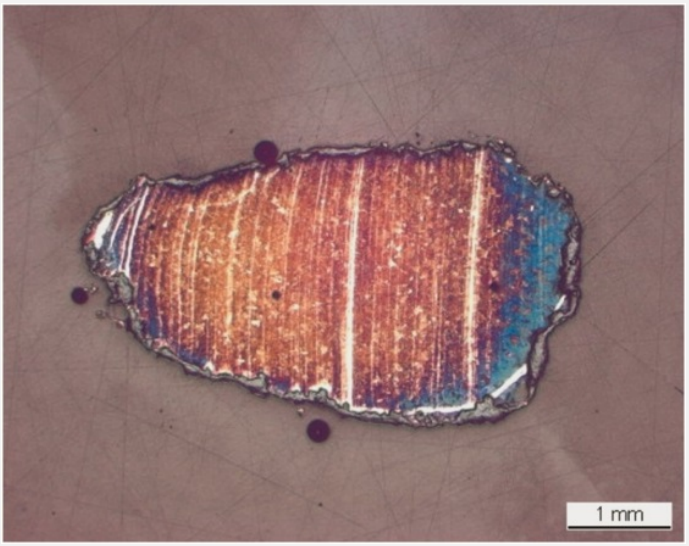
Fig. 6: Micrograph of the metal sample from Fig. 3, etched with Oberhoffer's reagent, bright field. We observe three P-rich welding seams in white,

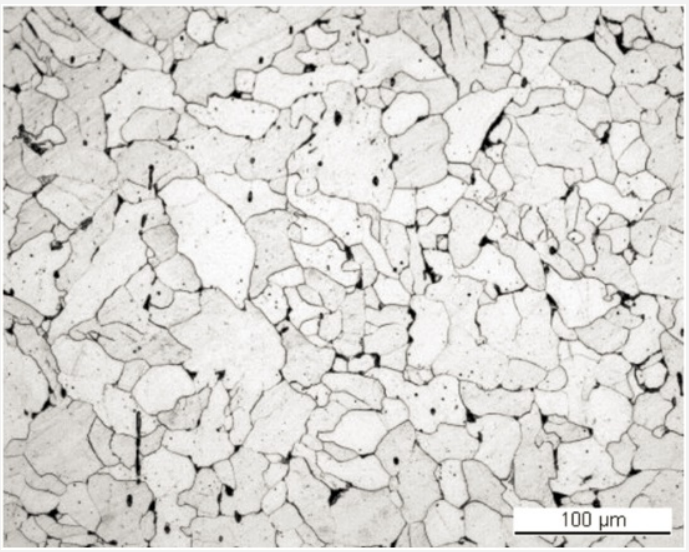
Fig. 7: Micrograph of the metal sample, nital etched, bright field. We observe tertiary cementite (black) on the grain boundaries,

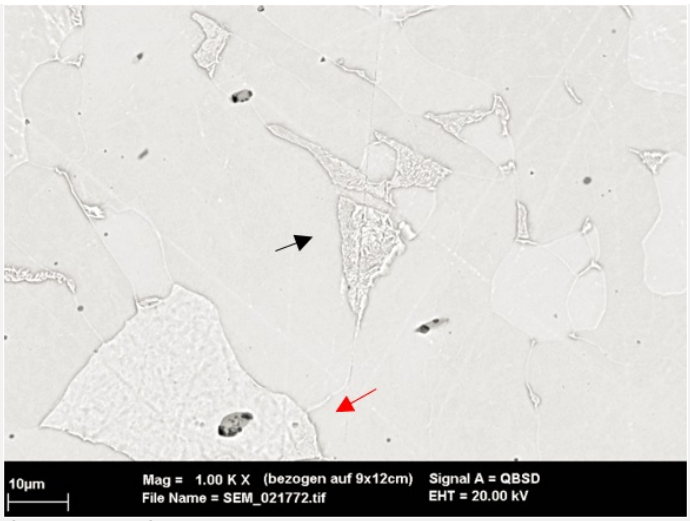
Fig. 8: SEM image of the metal sample from Fig. 3 (detail), BSE-mode, nital etched, bright field. The white ferrite grains contain lamellar pearlite (black arrow) and lenticular grey MnS inclusions (red arrow) in between the grain boundaries,

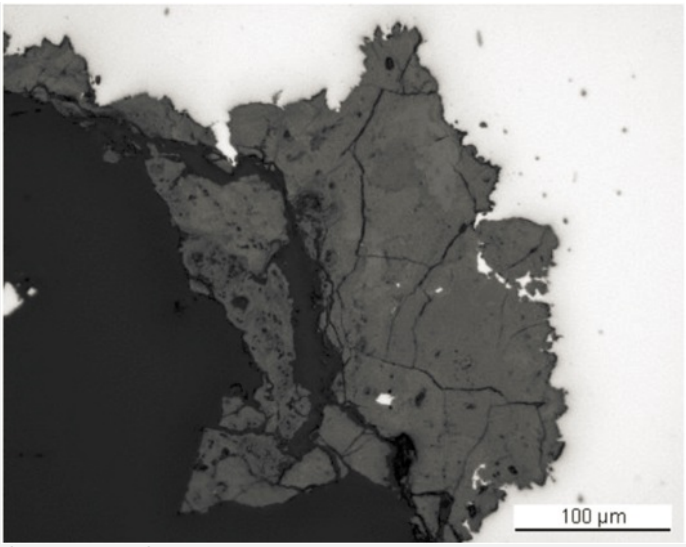
The average thickness of the corrosion products is about 80µm (Figs. 5 and 9). In bright field they appear grey, marbled and heavily cracked (Fig. 9). Under polarised light, the corrosion products appear orange to dark-brown (Fig. 10). At the metal - corrosion products interface they are dark-brown (CP3). The middle part (CP2) is red-orange and the outer part is bright orange (CP1). The elemental mapping of the corrosion layers shows no distinctive stratification, but areas near the metal - corrosion crust interface (CP3) as well as the top surface of the corrosion layer (CP1) seem to have a lower O content (Fig. 11). The O content indicates the presence of iron hydroxides (Table 3). Soil materials (such as rock fragments and dust) are found in the welding seams near the surface.

Fig. 9: Micrograph showing the metal - corrosion crust interface from Fig. 3 (rotated by 270°, detail), unetched, bright field. We observe in white the metal, in grey the corrosion products and in black the resin,

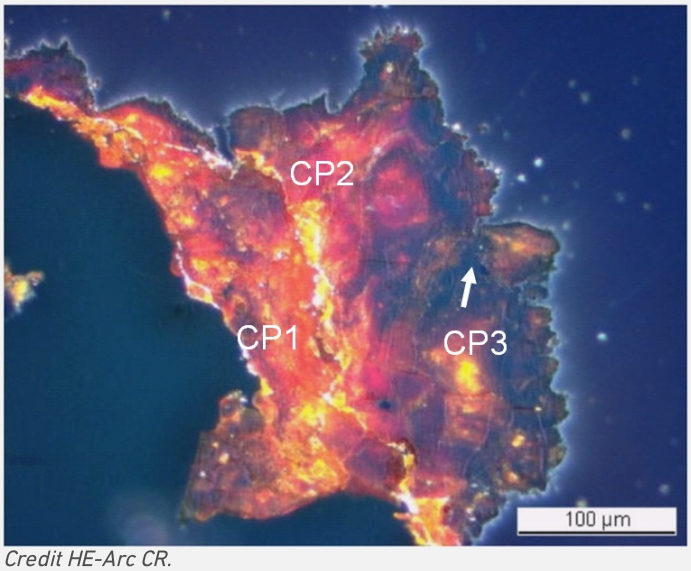
Fig. 10: Micrograph showing the metal - corrosion crust (same as Fig. 9) and corresponding to the stratigraphy of Fig. 4, unetched, polarised light. The corrosion products are dark-brown at the metal - corrosion crust interface and red-orange on the outside,

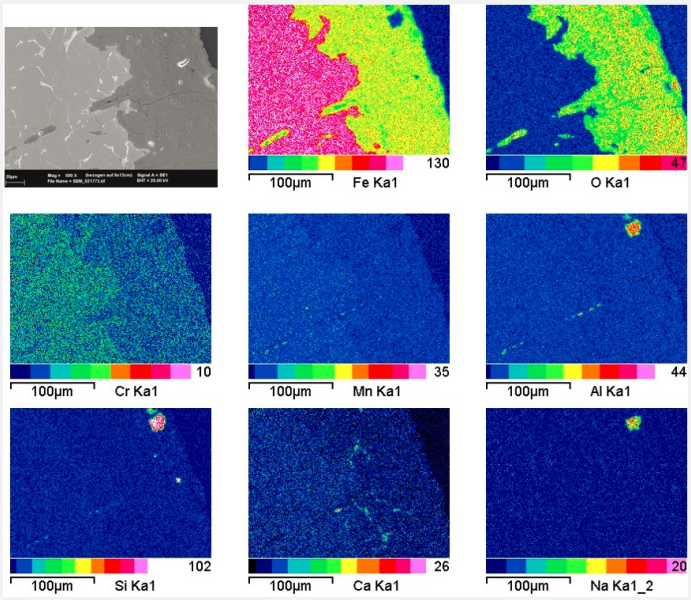
Table 3: Chemical composition (mass %) of the corrosion layer (from Fig. 11). Method of analysis: SEM/EDS, Laboratory of Analytical Chemistry, Empa.

Fig. 11: SEM image, BSE-mode, and elemental chemical distribution of the selected area from Fig. 5 (rotated by 270°, detail). Method of examination: SEM/EDS, Laboratory of Analytical Chemistry, Empa.

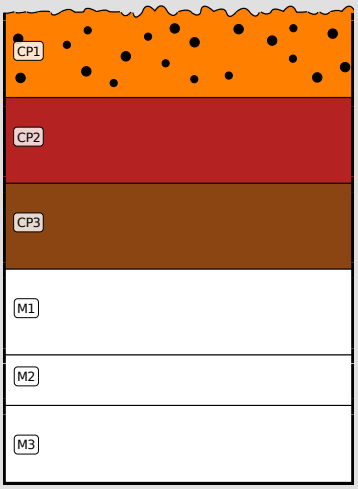
Fig. 4: Stratigraphic representation of the sample taken from the fitting in cross-section using the MiCorr application. The characteristics of the strata are only accessible by clicking on the drawing that redirects you to the search tool by stratigraphy representation. This representation showing for the metal part a welding seam (M2) can be compared to Fig. 10, Credit HE-Arc CR.
