CURVED PIN OR TANG FK 2670.20 – TIN BRONZE – LATE BRONZE AGE – SWITZERLAND

Artefact name	Curved pin or tang FK 2670.20
Authors	Marianne. Senn (EMPA, Dübendorf, Zurich, Switzerland) & Christian. Degrigny (HE-Arc CR, Neuchâtel, Neuchâtel, Switzerland)
Url	/artefacts/515/

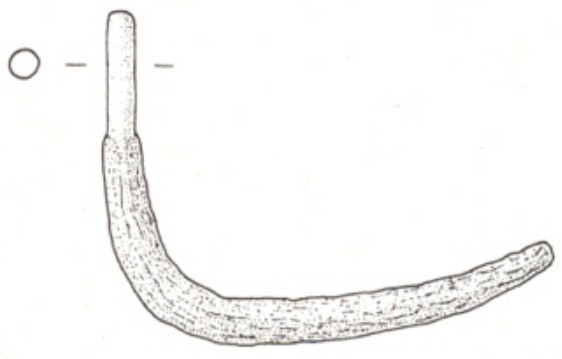
Fig. 1: Curved pin or tang (after Fischer 1997, plate 43),

Description of the artefact	Curved pin or tang (Fig. 1). Several samples were taken. Only one is presented here (Fig. 2). The metal is covered with black corrosion products attributed to a burning process mixed with green corrosion products. Dimensions: L = 114mm; Ø = 4.6mm; WT = 16.7g.
Type of artefact	Not defined
Origin	Steinmöri, Neftenbach / Dorf Neftenbach, Zurich, Switzerland
Recovering date	Excavation in 1991?, grave 18
Chronology category	Late Bronze Age
chronology tpq	1400 B.C.
chronology taq	1300 B.C.
Chronology comment	14th Century BC, Bronze Age D
Burial conditions / environment	Soil
Artefact location	Kantonsarchäologie, Dübendorf, Zurich
Owner	Kantonsarchäologie, Dübendorf, Zurich
Inv. number	FK 2670.20

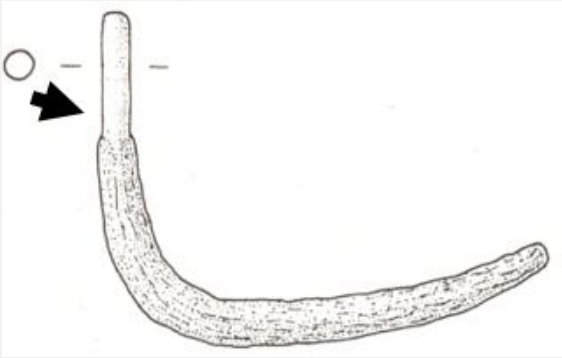
Fig. 2: Location of sampling area,

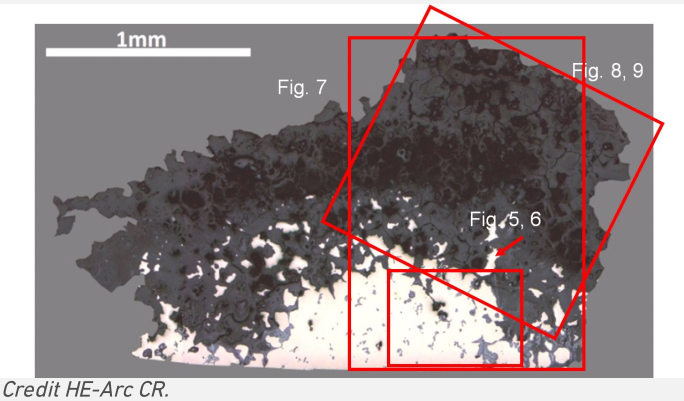
Fig. 3: Micrograph of the cross-section of the sample taken from the curved pin or tang showing the location of Figs. 5 to 9,

Description of sample	The sample (Fig. 3) is a section from the pin (or tang). The metal is covered by a thick corrosion crust (blue layer adhering to the metal, topped by a green layer mixed with black corrosion products - Museum report (1992)). Dimensions: L = 1.8mm; W = 1.2mm.
Alloy	Tin Bronze
Technology	Secondary recrystallization (produced by burning)

The corrosion crust has an average thickness of 500µm but can in areas be much thicker (Fig. 3). It is divided in two layers. The inner layer is itself divided in two sub-layers: a thin light-grey sub-layer at the interface with the remaining metal surface (CP4, in bright field) which appears red-orange in polarised light (Fig. 7) topped by a medium-grey sub-layer (in bright field) that contains remnant metal (CP3). It turns dark-blue in polarised light (Fig. 7). The outer corrosion layer can also be divided into two sub-layers: a porous sub-layer (CP2) followed by a dark-grey sub-layer in which crystals are outlined by cracks (CP1, in bright field). Under polarized light, the latter turns blue-green while on top it appears olive and brown (Fig. 7). Chemically the corrosion crust is Sn enriched and Cu-depleted (Table 3, Figs. 8 and 9). The maximum of the Sn enrichment occurs on the outer olive and brown sub-layer (CP2). The corrosion layer also contains P, Si, C and O. Inclusions containing Fe or Ag can be found in the corrosion crust (Figs. 8 and 9).

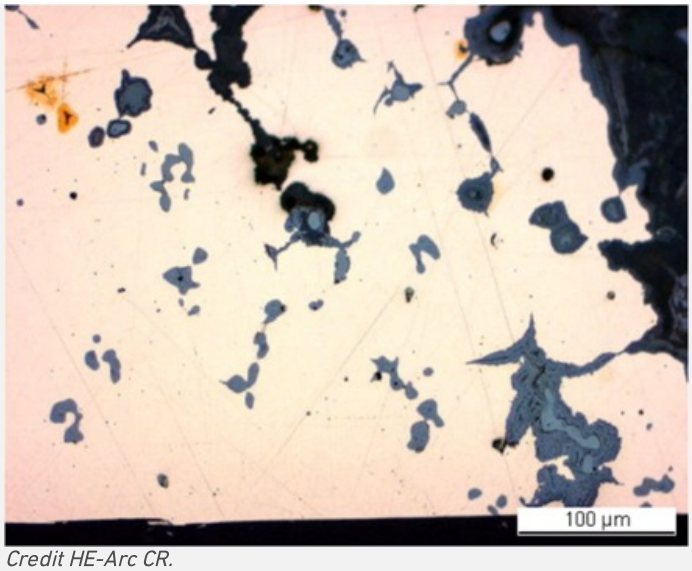
The remaining metal is a tin bronze (Table 1) with copper sulphide inclusions that contain some Fe (Figs. 5 and 6, Table 2). After etching, the tin bronze shows polygonal grains with few twins (Fig. 6). The grain size varies between 70 and 180µm indicating grain growth due to an extended or excessively hot annealing process. The copper sulphide inclusions appear in blue. The average hardness of the metal is HV1 70.

Fig. 5: Micrograph of the metal sample from Fig. 3 (detail), unetched, bright field. In pink the metal, in light-blue the copper sulphide inclusions and in dark- blue corrosion products,

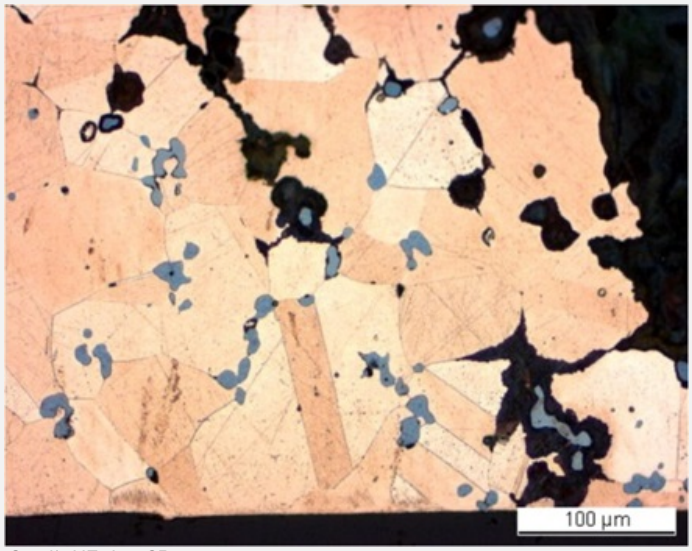
Fig. 6: Micrograph of the metal sample from Fig. 3 (same as Fig. 5), etched, bright field. In pink the metal with few twins, in black the resin and the corrosion products, in light-blue the copper sulphide inclusions,

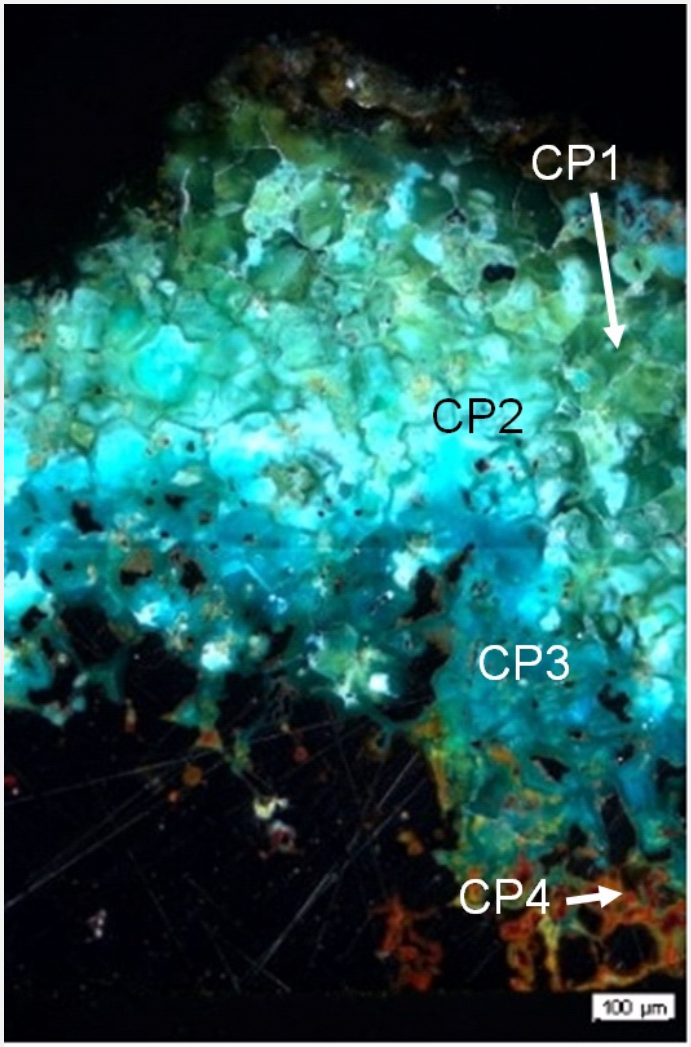
Table 3: Chemical composition (mass %) of the corrosion crust from Fig. 7. Method of analysis: SEM/EDS, Laboratory of Analytical Chemistry, Empa.

Fig. 7: Micrograph of the metal sample from Fig. 3 (detail) and corresponding to the stratigraphy of Fig. 4, unetched, polarised light. At the metal - corrosion products interface the colour of the corrosion layer is dark-blue, changing to green-blue in the outer part. The top surface of the corrosion crust is olive to brown,

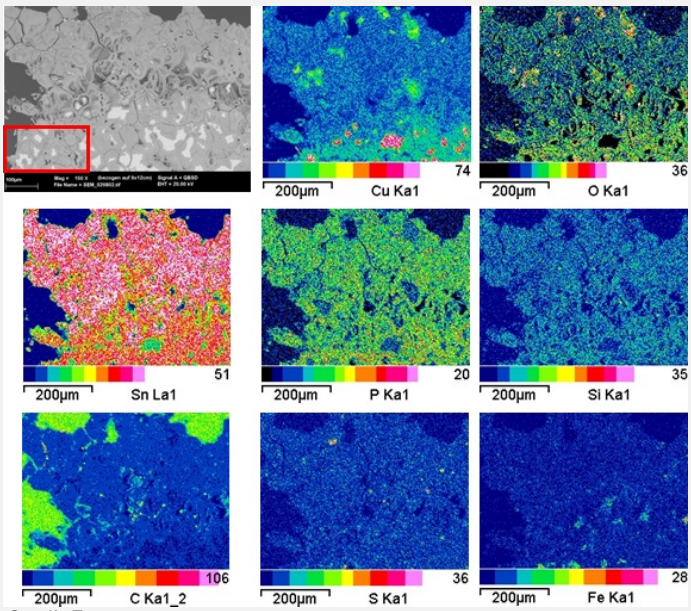
Fig. 8: SEM image, BSE-mode, and elemental chemical distribution of the selected area from Fig. 3 (due to repolishing before SEM/EDX investigation, the SEM image is slightly different from the area indicated in Fig. 3). The rectangle in the SEM image marks the detail mapping of Fig 9. Method of examination: SEM/EDS, Laboratory of Analytical Chemistry, Empa,

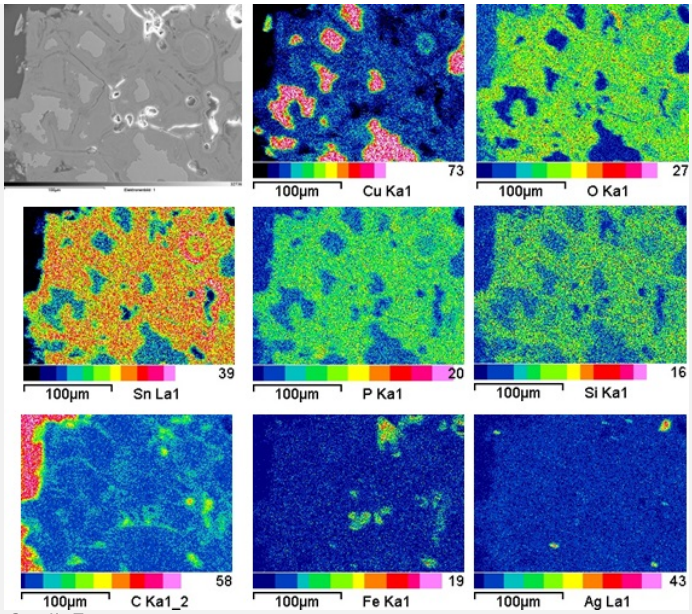
Fig. 9: SEM image, SE-mode, and elemental chemical distribution of the selected area from Fig. 8. Method of examination: SEM/EDS, Laboratory of Analytical Chemistry, Empa,

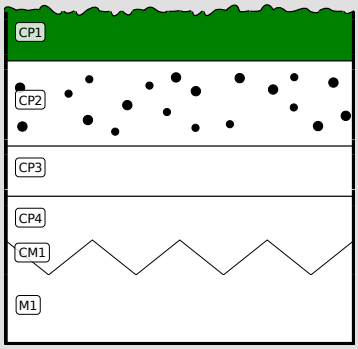
Fig. 4: Stratigraphic representation of the sample taken from the curved pin or tang in cross-section using the MiCorr application. The characteristics of the strata are only accessible by clicking on the drawing that redirects you to the search tool by stratigraphy representation. This representation can be compared to Fig. 7, Credit HE-Arc CR.

The tin bronze was exposed to an extended or excessively hot annealing process. This, combined with the extreme thickness of the corrosion crust and the dark surface, confirms that the object originates from a fire burial context. At the metal - corrosion crust interface some copper oxide (cuprite?) occurs. On top copper carbonates (azurite or malachite?) are mixed with tin oxide (cassiterite/SnO2?). Tin oxide dominates in the brown-black extremely Sn-rich outer layer. The P-enrichment in the whole corrosion

layer may be due to an environment rich in organic material (for example bones). The original surface of the metal has been destroyed, presenting a type 2 corrosion layer after Robbiola et al. 1998.
