TANG FRAGMENT OF A KNIFE HR-6246 – TIN BRONZE – LATE BRONZE AGE – SWITZERLAND

Artefact name	Tang fragment of a knife HR-6246
Authors	Marianne. Senn (EMPA, Dübendorf, Zurich, Switzerland) & Christian. Degrigny (HE-Arc CR, Neuchâtel, Neuchâtel, Switzerland)
Url	/artefacts/516/

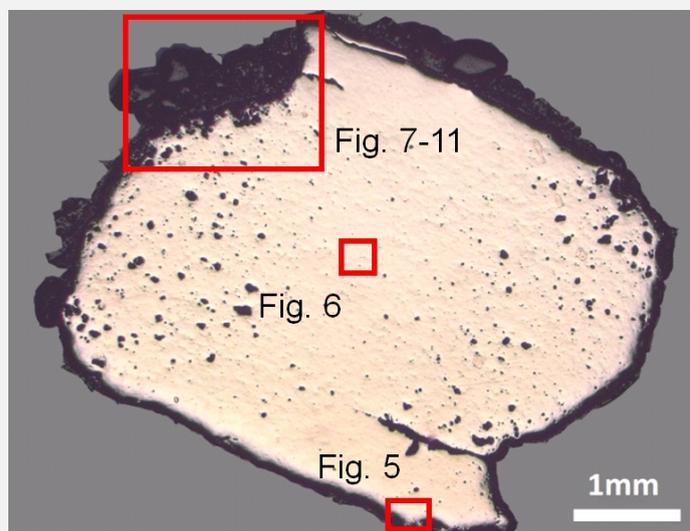
Fig. 1: Tang fragment of a knife with lake and terrestrial crust (after Rychner-Faraggi 1983, plate 35.35),

Description of the artefact	Tang fragment of a knife with lake (shiny brown) and terrestrial (granulated green-blue) crust (Fig. 1). Dimensions: L = 2.7cm; Ø = around 5mm; WT = 5.8g.
Type of artefact	Knife
Origin	Hauterive - Champréveyres, Neuchâtel, Neuchâtel, Switzerland
Recovering date	Excavation 1983-1985, object from layer 1 (layer with material from Bronze Age till 20th cent.)
Chronology category	Late Bronze Age
chronology tpq	1050 B.C.
chronology taq	800 B.C.
Chronology comment	Hallstatt A/B
Burial conditions / environment	Lake
Artefact location	Laténium, Neuchâtel, Neuchâtel
Owner	Laténium, Neuchâtel, Neuchâtel
Inv. number	Hr 6246
Recorded conservation data	Not conserved

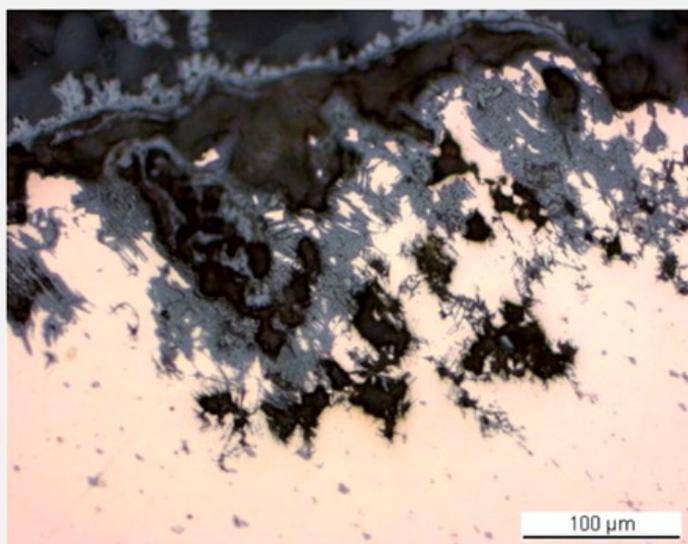
Fig. 3: Micrograph of the cross-section of the sample taken from the tang fragment showing the location of Figs. 5 to 11,

Description of sample	The cross-section corresponds to a lateral cut (Fig. 2). The surface is covered with a thick corrosion crust (Fig. 3).
Alloy	Tin Bronze
Technology	Cold worked after annealing
Lab number of sample	MAH 87-197
Sample location	Musées d'art et d'histoire, Genève, Geneva

The remaining metal is a tin bronze (Table 1) with high porosity and large cracks both on the left and right edges of the sample (Fig. 3). The metal contains small, elongated copper sulphide (Table 2) and Pb inclusions that are oriented parallel to the cracks. Near the metal surface, slip lines are outlined by the development of intergranular corrosion (Fig. 5). The etched metal shows small, elongated grains with slip lines (Fig. 6). Annealing is visible in areas near the surface. The average hardness of the metal is HV1 145, but significant variations are observed, depending on where the measurements are taken.

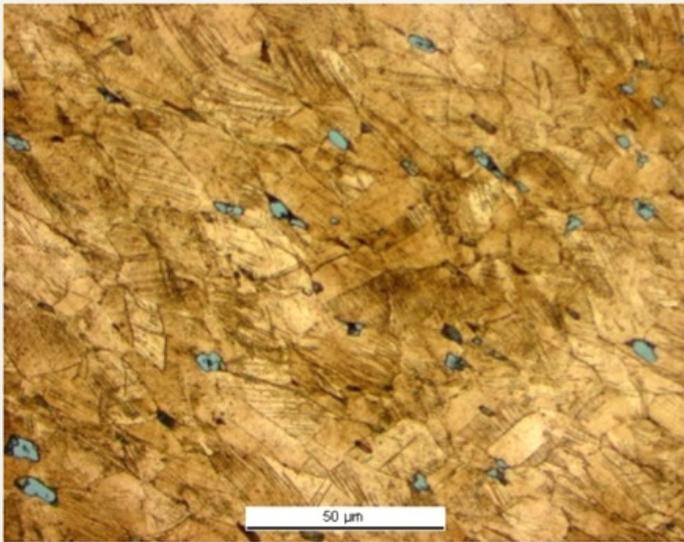
Fig. 5: Micrograph of the metal sample from Fig. 3 (inverted and reversed picture, detail), unetched, bright field. Corrosion products are in dark-grey whereas the metal is in pink. Slip lines are outlined by the development of intergranular corrosion,

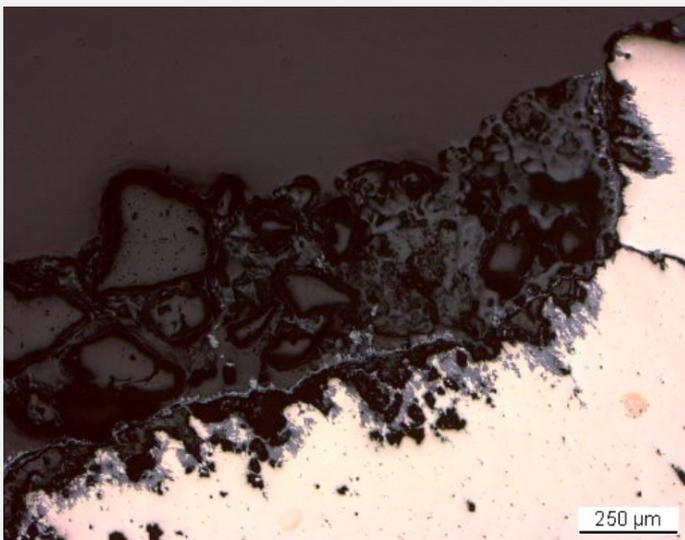
The corrosion crust has a thickness between 0.1mm and 0.7mm (Fig. 3). In bright field (Fig. 7), one can observe that the metal has been replaced by light-grey corrosion products. Adjacent to the metal is a thick, heterogeneous, dark-grey layer with a band of light-grey corrosion products. In polarised light (Fig. 8), all corrosion products which were previously light-grey appear brown-orange, the dark-grey layer turquoise. The elemental chemical distribution of the SEM images (Figs. 9 and 10) reveals that the inner corrosion products are Sn-rich whereas the adjacent band is Cu and S-rich (Fig. 11). The outer layer contains large inclusions (quartz and others, Si, Al and Na, see Figs. 10-11) and is most probably composed of malachite/$Cu_2(CO_3)(OH)_2$ (only Cu and O are detected – Fig. 11). S is distributed throughout this layer. XRD analyses indicated the presence of posnjakite/$Cu_4SO_4(OH)_6H_2O$, chalcocite/CuS and djurleïte/$Cu_{1.93}S$ (Schweizer 1994).

Fig. 7: Micrograph of the metal sample from Fig. 3 (detail), unetched, bright field. The inner light-grey corrosion products extend into the metal surface (in pink) and appear as a line within the dark-grey corrosion layer,

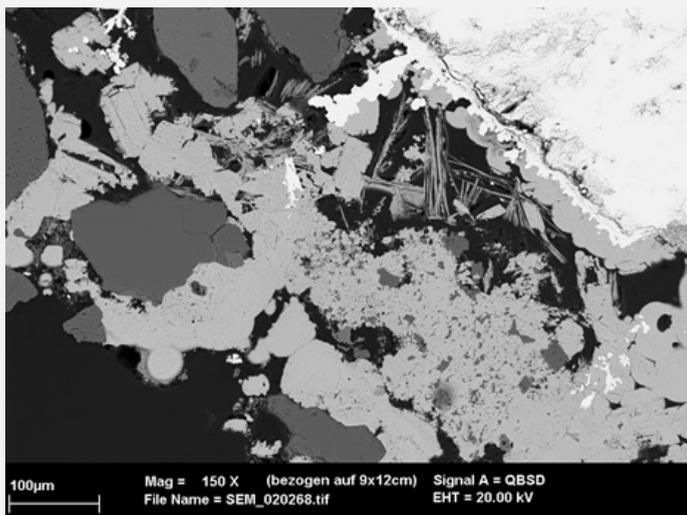
Fig. 8: Micrograph similar to Fig. 7 and corresponding to the stratigraphy of Fig. 4, polarized light. One can see that large mineral features are incorporated only in the corrosion layers above the brown-orange corrosion band,

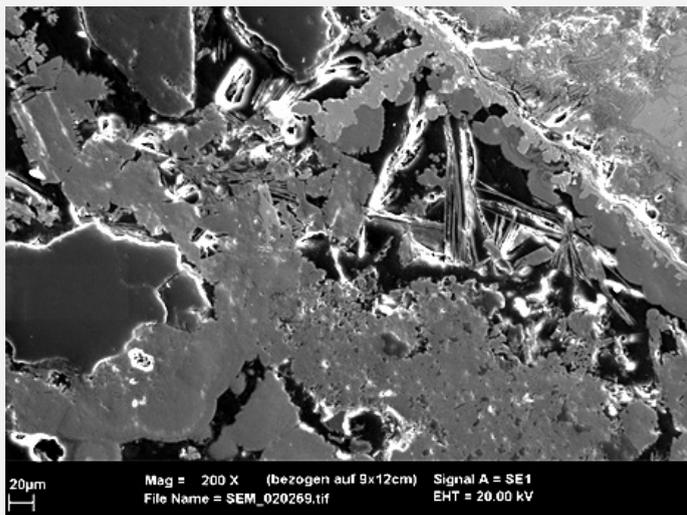
Fig. 9: SEM image (detail of Fig. 7), SE-mode. From bottom to top right: the thick, porous outer corrosion layer, the light-grey band and the remaining metal,

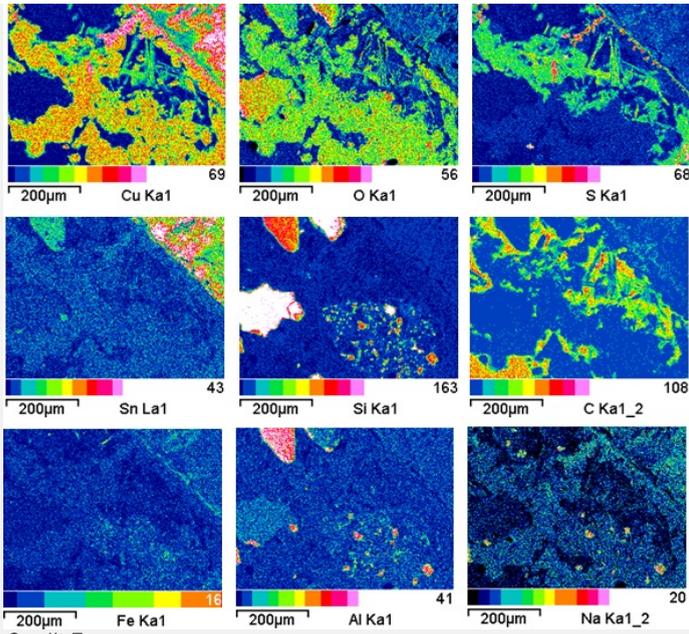
Fig. 11: EDS elemental chemical distribution of the SEM image of Fig. 9. Method of examination: SEM/EDS, Laboratory of Analytical Chemistry, Empa,

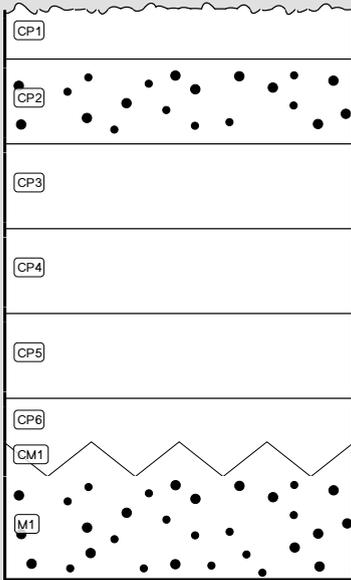
Fig. 4: Stratigraphic representation of the sample taken from the tang fragment in cross-section using the MiCorr application. The characteristics of the strata are only accessible by clicking on the drawing that redirects you to the search tool by stratigraphy representation. This representation can be compared to Fig. 8, Credit HE-Arc CR.
