TANG FRAGMENT OF A KNIFE HR-6246 - TIN BRONZE - LATE BRONZE AGE - SWITZERLAND

Artefact name Tang fragment of a knife HR-6246

Authors Marianne. Senn (EMPA, Dübendorf, Zurich, Switzerland) & Christian. Degrigny (HE-Arc CR, Neuchâtel, Neuchâtel, Switzerland)

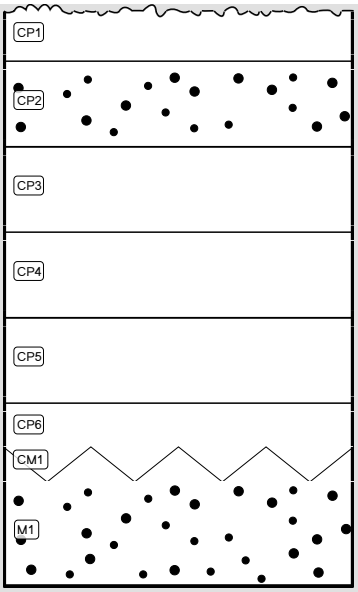
Fig. 4: Stratigraphic representation of the sample taken from the tang fragment in cross-section using the MiCorr application. The characteristics of the strata are only accessible by clicking on the drawing that redirects you to the search tool by stratigraphy representation. This representation can be compared to Fig. 8, Credit HE-Arc CR.
