DEFORMED FRAGMENT OF METAL SHEET WT10-M305 – TIN BRONZE – IRON AGE – SWITZERLAND

Artefact name	Deformed fragment of metal sheet WT10-M305
Authors	Marianne. Senn (EMPA, Dübendorf, Zurich, Switzerland) & Christian. Degrigny (HE-Arc CR, Neuchâtel, Neuchâtel, Switzerland)
Url	/artefacts/519/

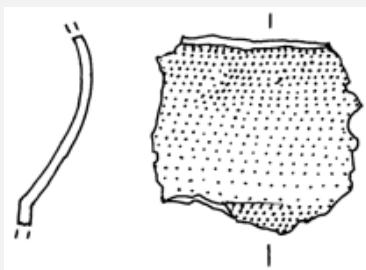
Fig. 1: Sheet fragment with dark green / grey patina (section and front side) (after Department of Prehistory, University of Zurich),

Description of the artefact	Sheet fragment with a dark green and grey powdery surface (patina) that might have been caused by exposure to high temperatures (Fig. 1). A green layer appears below the dark surface. Dimensions: L = 2.4cm; W = 2.3cm; WT = 4.8g.
Type of artefact	Metal sheet
Origin	Ritual place Wartau Ochsenberg, Sankt Gallen, Saint Gallen, Switzerland
Recovering date	Excavation in 1991
Chronology category	Iron Age
chronology tpq	500 B.C. ⌄
chronology taq	401 B.C. ⌄
Chronology comment	5th Century BC
Burial conditions / environment	Soil
Artefact location	Kantonsarchäologie, Sankt Gallen, Saint Gallen
Owner	Kantonsarchäologie, Sankt Gallen, Saint Gallen
Inv. number	WT10-M305
Recorded conservation data	Not conserved

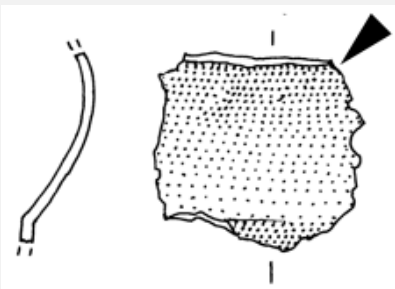
Fig. 2: Location of sampling area,

Description of sample	The sample is a section from the top right corner of the sheet (Fig. 2). Its dimensions are: L = 2.5mm and W = 2.3mm. The metal is surrounded on three sides by corrosion products. Intergranular corrosion has developed throughout the metal section (Fig. 3).
Alloy	Tin Bronze
Technology	Secondary recrystallization (produced by burning) after cold working
Lab number of sample	MAH 92-5-2-003
Sample location	Musées d'art et d'histoire, Genève, Geneva
Responsible institution	Musées d'art et d'histoire, Genève, Geneva

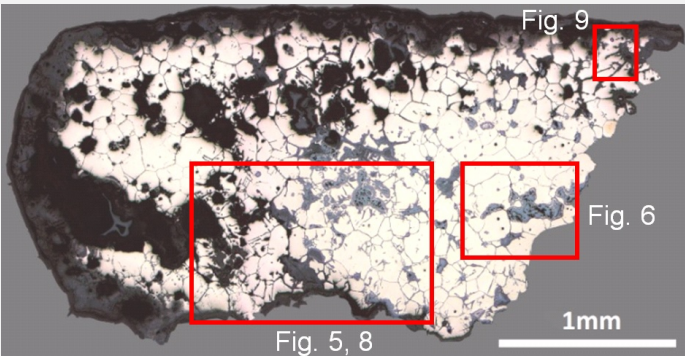
Fig. 3: Micrograph of the cross-section of the sample taken from the sheet fragment with dark green / grey patina showing the location of Figs. 5, 6, 8 and 9,

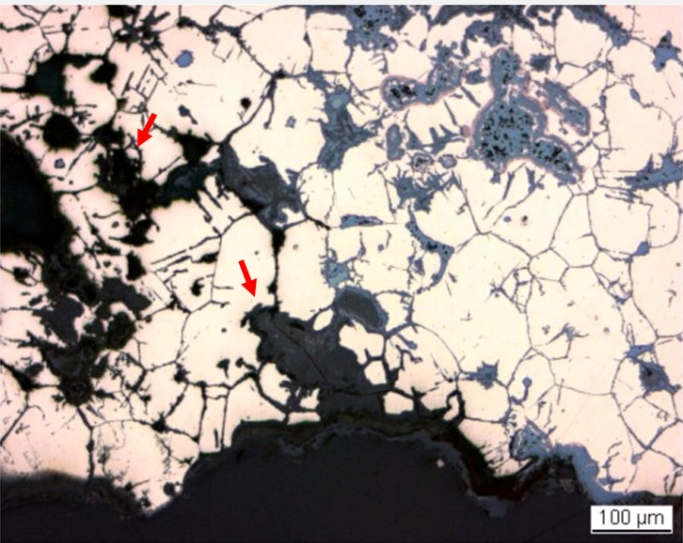
The remaining metal is a porous (red arrows on Fig. 5) tin bronze (Table 1). Five analyses were carried out. S was detected in the non-corroded part of the metal (2 measurements) while P was present only in the corroded metal (3 measurements). As no major difference in the composition was observed (comparison of relative standard deviation, RSD) all analyses were used to calculate the median value. Inter- and transgranular corrosion has developed so extensively that all grain boundaries and twin lines are outlined (Fig. 5). After etching, the metal shows annealed polygonal grains with a few twins and slip lines below the surface (Fig. 6). The slip lines are restricted to the right side of the sample where the metal is best preserved (Fig. 6). The grain size varies between 50 and 170µm, due to an excessively long or hot annealing procedure leading to a grain coarsening. Small copper sulphide inclusions appear in blue (Fig. 6). The average hardness of the metal is HV1 90.

Fig. 5: Micrograph of the metal sample from Fig. 3 (detail), unetched, bright field. Extensive inter- and transgranular corrosion has developed within the metal. Possible large pores are visible (arrows) inside the remaining metal,

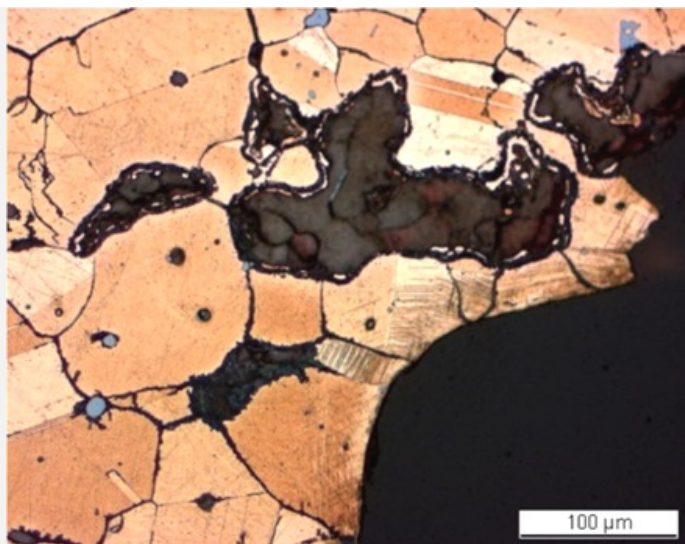
Fig. 6: Micrograph of the metal sample from Fig. 3 (detail), etched, bright field. We observe pink-orange polygonal grains with twins and slip lines as well as copper sulphide inclusions (in blue),

Microstructure	Large polygonal grains with few twins + strain lines
First metal element	Cu
Other metal elements	As, Sn

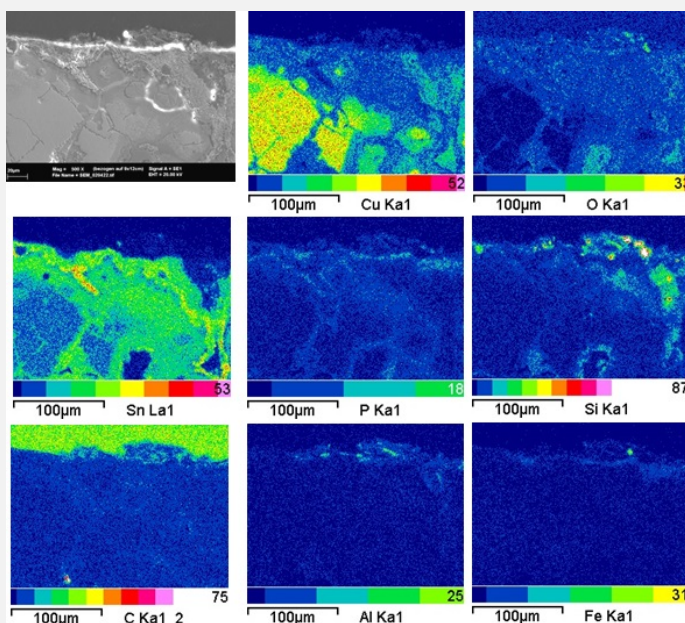
The corrosion crust varies in thickness between 60 and 150µm (Fig. 3). In bright field, it appears dark-grey (Fig. 5) and consists of two layers (CP1 and CP2). The inner layer is dark-grey and dense while the thin outer layer is slightly lighter coloured. Within the metal, the corrosion products are light-grey (CP3, Fig. 5). Under polarized light, the corrosion layer turns blue-green with dark-blue areas (Figs. 7 and 8) whereas corrosion products inside the metal are either light-blue or red-orange (Figs. 7 and 8). The red corrosion products (CP3) have the composition of cuprite/Cu_2O while the orange compounds (also CP3) are enriched in Sn (Table 2). The blue-green corrosion products (CP2) both within the remaining metal and on the surface are even richer in Sn and O, and contain some P (Table 2 and Fig. 9). The thin, irregular dark-grey surface layer (CP1) is enriched in P, Fe, Si and Al (Table 2 and Fig. 9). XRD analyses of powdery particles sampled from the thin, dark surface corrosion layer (CP1) indicate the presence of tenorite/CuO and cassiterite/SnO_2 (Museum report 1992). The Raman spectra of this layer (Fig. 10) confirmed the presence of tenorite.

Fig. 7: Micrograph of the cross-section of the metal sample (same as Fig. 3) and corresponding to the stratigraphy of Fig. 4, polarised light, showing the location of Fig. 8,

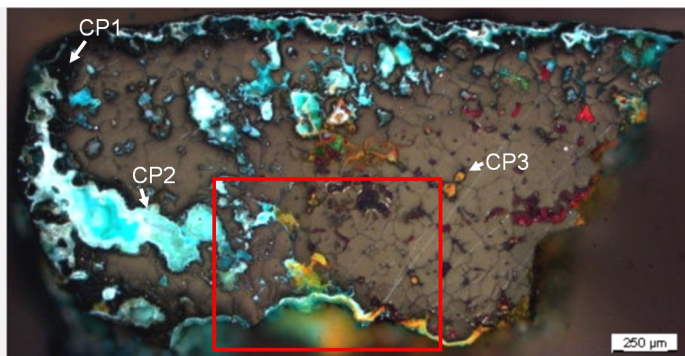
Elements	O	Cu	Sn	Si	Fe	P	As	Total
CP1, outer dark-grey corrosion layer. Fig 7	34	16	49	<	3.4	3.0	0.86	108
CP2, blue-green middle corrosion layer. Fig. 7	40	21	41	1.4	<	1.7	0.58	106
CP3, Red corrosion product (average of 2 similar analyses). Fig. 7	11	95	<	<	<	<	<	106
CP3, Orange corrosion product (average of 2 similar analyses). Fig. 7	24	54	30	0.6	<	<	0.59	109
Blue-green corrosion product. Fig. 8	32	21	51	1.1	<	<	1.0	106
Blue-green inner corrosion layer. Fig. 8	34	22	39	0.8	<	1.4	<	98

Fig. 8: Micrograph of the metal sample (same as Fig. 5), polarised light. In black the metal. Blue-green, orange and red corrosion products are found in the porous metal and along the grain boundaries,

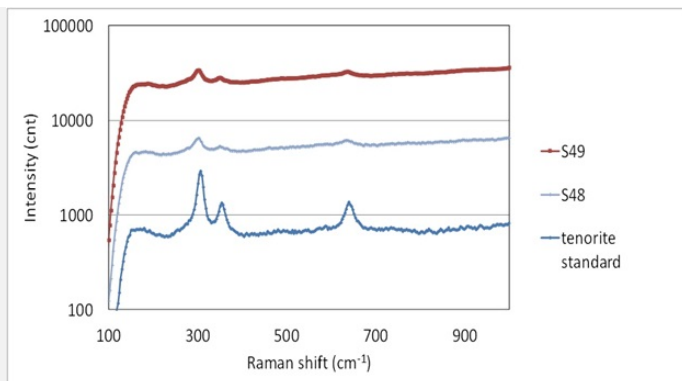
Fig. 10: Raman spectra of the outer dark corrosion layer (S48 and S49) compared to a tenorite standard spectrum. Settings: laser wavelength 532nm, acquisition time 20s for S48 and 100s for S49, one accumulation, filter D1 (7.5-8mW), hole 500, slit 80, grating 600. Method of analysis: Raman spectroscopy, Lab of Swiss National Museum, Affoltern a. Albis ZH,

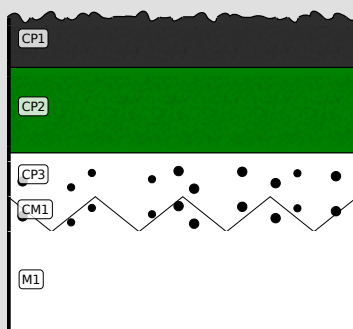
Fig. 4: Stratigraphic representation of the sample taken from the sheet fragment with dark green / grey patina in cross-section using the MiCorr application. The characteristics of the strata are only accessible by clicking on the drawing that redirects you to the search tool by stratigraphy representation. This representation can be compared to Fig. 7, Credit HE-Arc CR.
