TOWEL BAR – AL ALLOY – MODERN TIMES – FRANCE

Artefact name	Towel bar
Authors	Christian. Degrigny (HE-Arc CR, Neuchâtel, Neuchâtel, Switzerland)
Url	/artefacts/521/

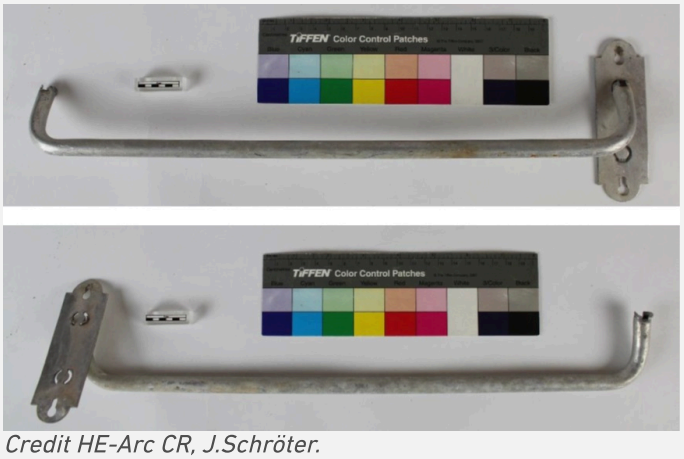
Fig. 1: Front and back sides of a towel bar,

Description of the artefact	Towel bar with traces of use and a broken section (Fig. 1). White deposits have developed on the metal surface. Dimensions: L = 45cm.
Type of artefact	Household implement
Origin	Château de Germolles, Mellecey, Bourgogne, France
Recovering date	Unknown
Chronology category	Modern Times
chronology tpq	1960 A.D.
chronology taq	2000 A.D.
Chronology comment	20th century

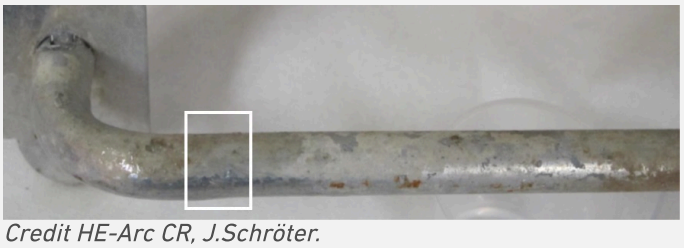
Fig. 2: Detail of the back side of the towel bar showing the location of the sampling area,

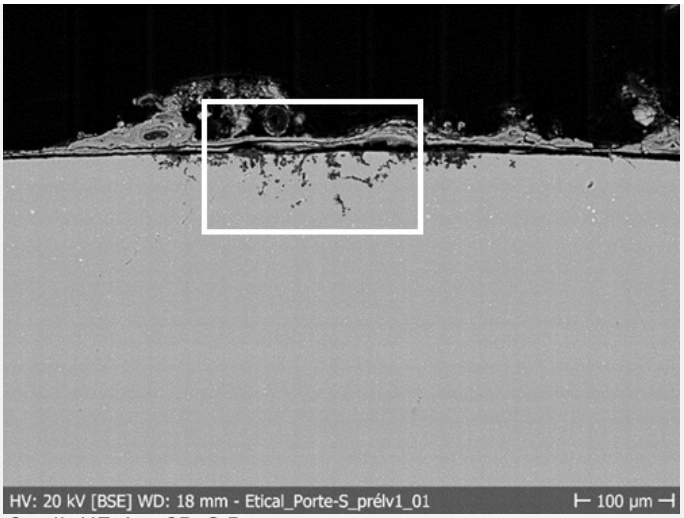
Fig. 3: SEM image of the cross-section of the fragment sampled from the towel bar showing the location of Fig. 5,

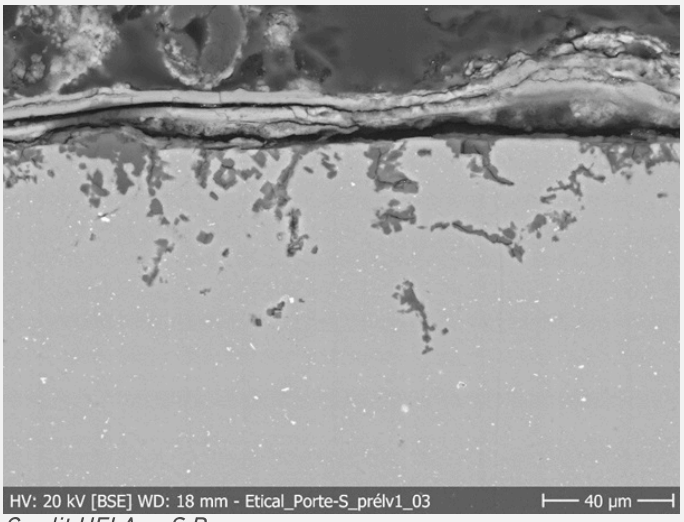
The metal is a relatively pure aluminium alloy with numerous inclusions (Fig. 5). From their chemical composition they can be interpreted as Al3Fe intermetallic compounds (Fig. 6). Pitting corrosion as well as a start of intergranular corrosion developing locally under the deposits, outlining some of the grains (Fig. 5).

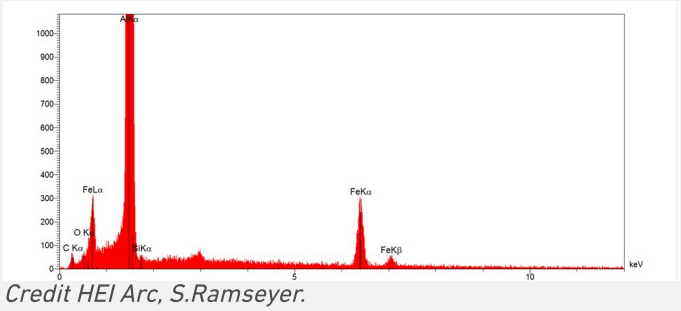
Fig. 5: SEM image of the metal sample from Fig. 3 (detail), BSE-mode. We observe the presence of numerous inclusions,

Fig. 6: EDS spectrum of the inclusions of Fig. 5,

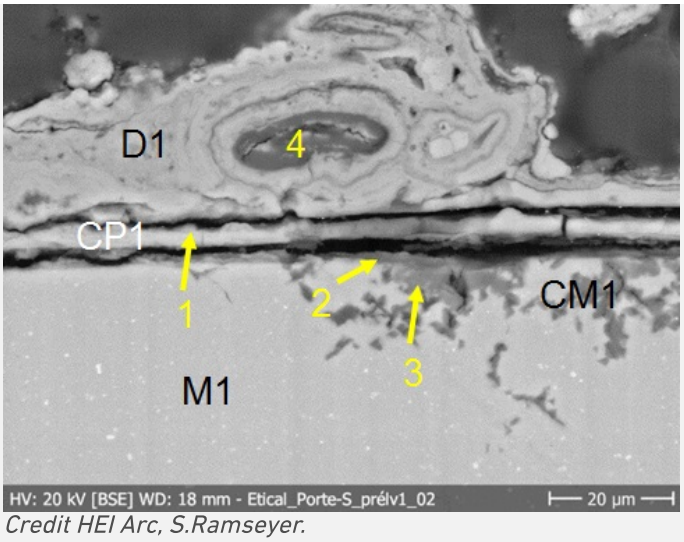
A very thin and loose oxide film has formed on the metal surface (CP1) and is locally covered by white deposits (D1). Intergranular corrosion has developed under the deposits (Fig. 7). EDS-SEM analysis indicates that the oxide layer rich in Al and O is contaminated with P and Si (area 1 on Fig. 7 and Fig. 8). These elements are even more present at the interface between CM1 and CP1 with Cl and S (area 2 on Fig. 7 and Fig. 9). The concentration of P and Si decreases in CM1 (area 3 on Fig. 7 and Fig. 10) while the concentration of S and Cl increases (Fig. 11). The deposit is mainly constituted of Ca, O, C and Si (probably CaCO3 and SiO2, area 4 on Fig. 7 and Fig. 12).

Fig. 7: SEM picture with location of EDS analyses of areas 1 to 4), BSE-mode. From bottom to top: the metal (M1) in light grey, the corroded metal (CM1), CP1 and D1,

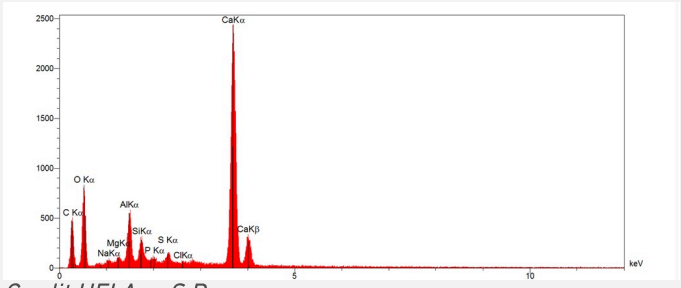
Fig. 8: EDS spectrum of area 1 of Fig. 7,

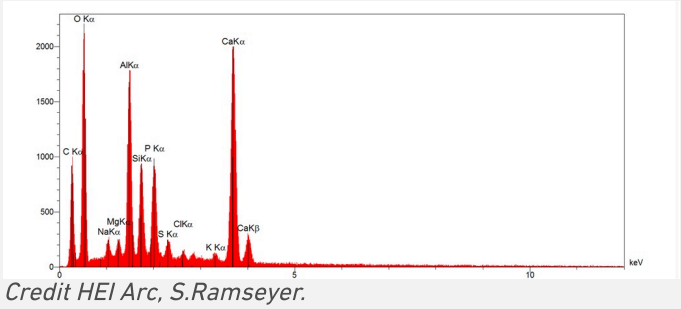
Fig. 9: EDS spectrum of area 2 of Fig. 7,

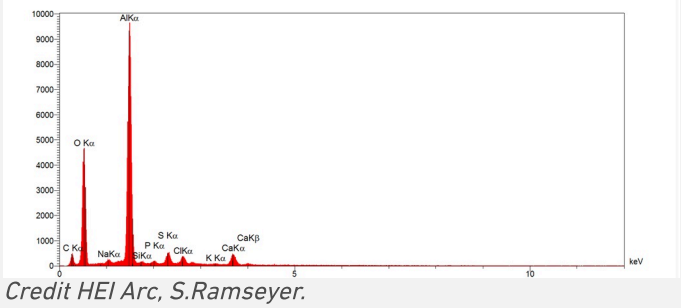
Fig. 10: EDS spectrum of area 3 of Fig. 7,

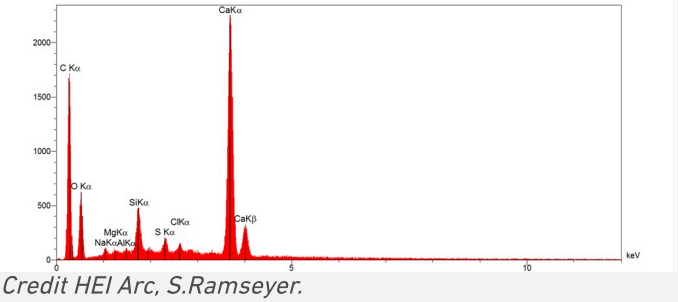
Fig. 11: EDS Linescan from CM1 to M1,

Fig. 12: EDS spectrum of area 4 of Fig. 7,

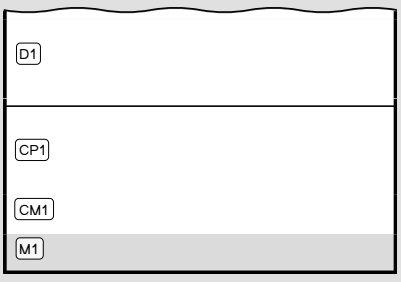
Fig. 4: Stratigraphic representation of the fragment sampled from the towel bar in cross-section using the MiCorr application. The characteristics of the strata are only accessible by clicking on the drawing that redirects you to the search tool by stratigraphy representation. This representation can be compared to Fig. 7, Credit HE-Arc CR, C.Degrigny.
