HEADREST OR HORSE BIT VFIG 2003.7 - LEADED BRONZE - MODERN TIMES

Artefact name	Headrest or horse bit VFig 2003.7
Authors	Christian. Degrigny (HE-Arc CR, Neuchâtel, Neuchâtel, Switzerland) & Valentin. Boissonnas (HE-Arc CR, Neuchâtel, Neuchâtel, Switzerland)
Url	/artefacts/522/

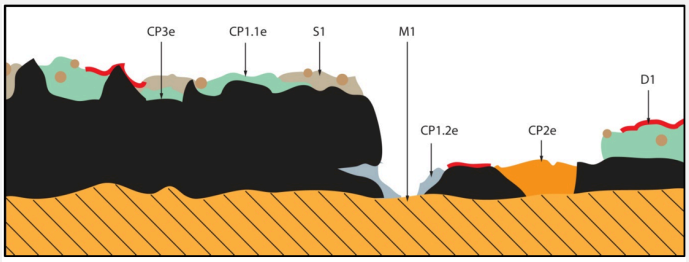
Fig. 3: Stratigraphic representation of the artefact in cross-section by macroscopic observation,

S1: soil (sand and limestone)
D1: red deposit
CP1.1e: outer light green-blue corrosion layer
CP1.2e: outer white-blue-grey corrosion layer
CP2e: outer orange corrosion layer
CP3e/i: outer/inner black brown corrosion layer
M1: metal

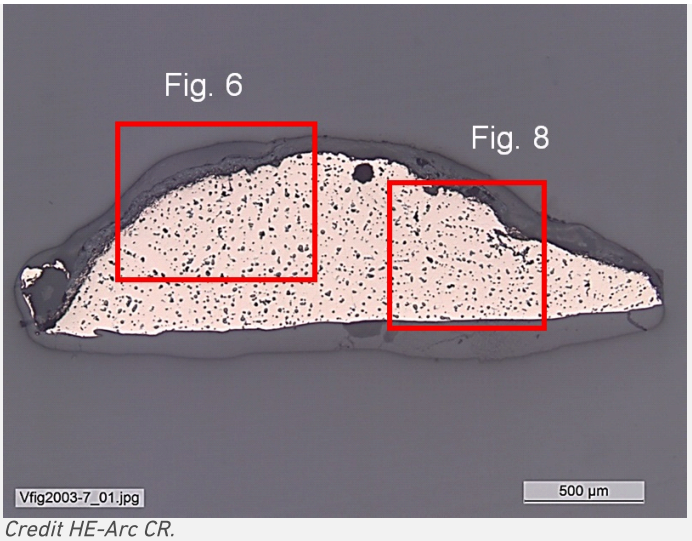
Fig. 4: Micrograph of the cross-section of sample from Fig. 2 of the headrest (or horse bit) showing the location of Figs. 6 and 8,

Description of sample	The sample was cut on the bottom of one of the plates (Fig. 2). On Fig. 4, the top and round shape of the sample is the outer part of the metal. It is covered with corrosion layers. The lower part of the sample corresponds to the cut metal with no corrosion products.
Alloy	Leaded Bronze
Technology	Cast and cold worked (with final annealing?)
Lab number of sample	None
Sample location	HE-Arc CR, Neuchâtel, Neuchâtel
Responsible institution	Bible & Orient Museum, Fribourg, Fribourg
Date and aim of sampling	2014, metallography and chemical analyses

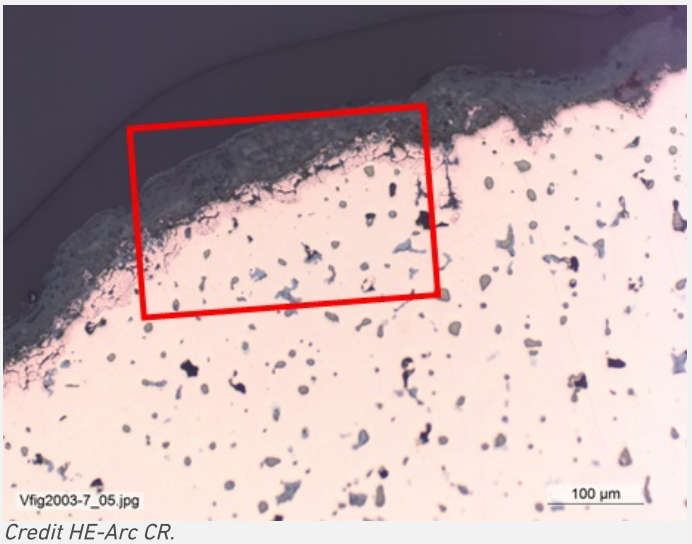
Elements	Cu	Sn	Pb
mass%	85	7	5

Table 1: Chemical composition of the metal. Method of analysis: SEM-EDS, Lab of Electronic Microscopy and Microanalysis, IMA (Néode), HEI Arc.

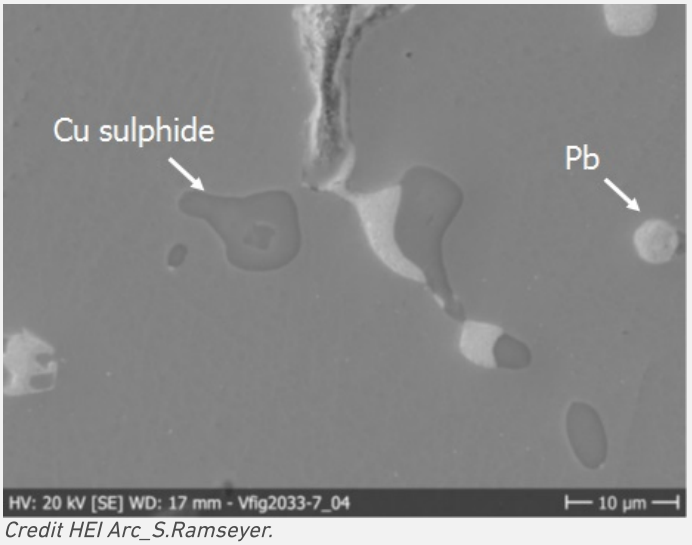
The remaining metal is a leaded bronze (Table 1) containing numerous copper sulphide and lead (Pb) inclusions (Figs. 6 and 7). The porosity is difficult to distinguish since the pores seem to have similar dimensions as the inclusions that could have been removed during the polishing of the sample (Fig. 6). After etching, the structure of the metal appears to be made up mostly of dendrites, but a grain structure seems to have developed on the right side of the sample, with occasional twin lines (Figs. 8 and 9). The twinned grain structure could be the result of cold work and annealing after casting, possibly through the application of an artificial patina under heat.

Fig. 6: Micrograph of the cross-section of sample from Fig. 2 of the headrest (or horse bit) (detail of Fig. 4), unetched, bright field. Light grey copper sulphide and tiny round Pb inclusions as well as "porosities" can be observed. Area of Fig. 10 is marked by a red rectangle,

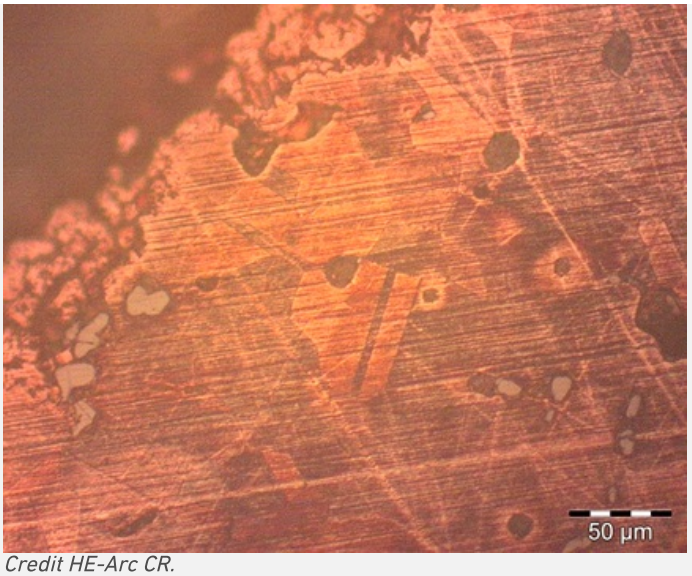
Fig. 8: Micrograph of the metal sample from Fig. 4 showing a dendritic structure and grains,

Fig. 9: Micrograph of a selected area of the metal sample showing grains and twin lines,

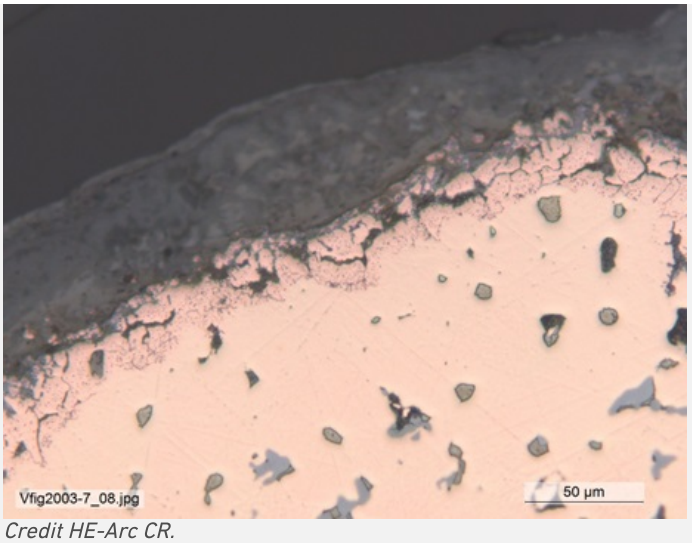
Fig. 10: Micrograph of the metal sample from Fig. 6, unetched, bright field,

The remaining metal seems to have developed intergranular corrosion at the interface metal / corrosion layer (Fig. 10) slightly enriched in Sn (Fig. 12). The outer green corrosion product (CP2) is matte, powdery and mixed with sediments. It looks regular on Figs. 10 and 11 (around 50µm). This corrosion layer is mainly composed of lead (and/or sulphur), oxygen, silicon, chlorine and is depleted in Cu (Fig. 12 and table 2) except in its top part (CP1) where it is Cl, Cu and O-rich (Fig. 12 and table 2). FTIR seems to indicate that it is constituted of atacamite ($Cu_2Cl(OH)_3$, Fig. 13). This is confirmed on the EDS spectra of figure 14 where Pb is clearly detected. The inner black corrosion product (CP3) is a dark brown, matte layer (Figs. 2 and 11). It covers all the surface of the object, and forms a very thin layer. It is sulphur and oxygen-rich (Fig. 15). FTIR analysis could not reveal the presence of a specific corrosion product.

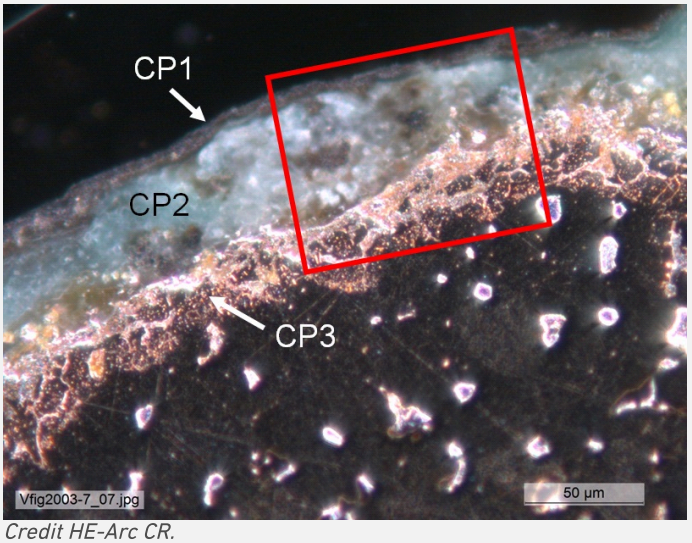
Fig. 11: Micrograph similar to Fig. 10 and corresponding to the stratigraphy of Fig. 5, polarised light. The area selected for elemental chemical distribution (Fig. 12) is marked by a red rectangle,

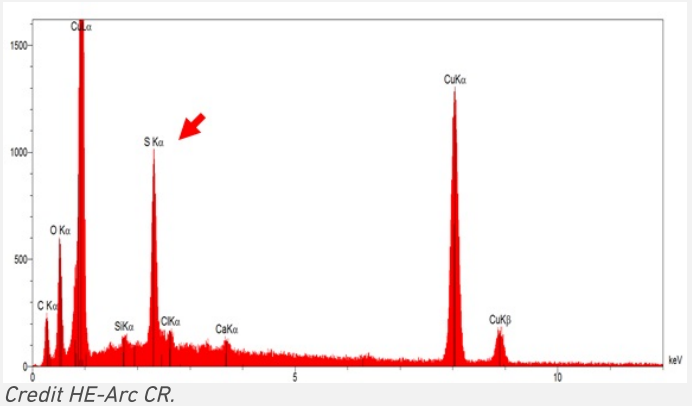
Fig. 14: EDS analysis of the green corrosion powder (Fig. 2). Method of analysis: SEM-EDS, Lab of Electronic Microscopy and Microanalysis, IMA (Néode), HEI Arc,

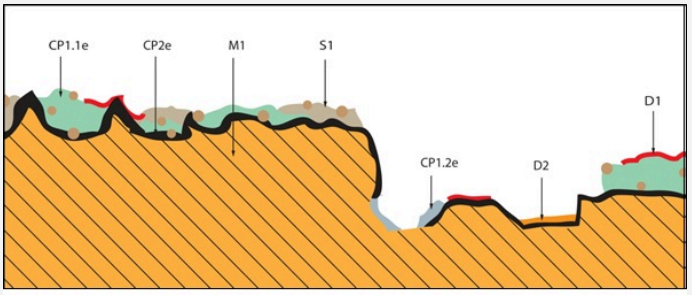
Fig. 16: Improved stratigraphic representation of the headrest from visual observations and analyses (additional mention e or i within the coding correspond to strata in contact with the environment (e) and internal strata (i),

The schematic representation of corrosion layers of Fig. 3 integrating additional information based on the analyses carried out is given in Fig. 16. A thin, black sulphur-rich layer covers the metal surface. A thick green layer has developed on top and seems to be constituted mainly of atacamite enriched in lead with sediments on top.

Strata	Composition
Sediments (S1)	Si, O
Deposits (D1 & D2)	?
Outer green corrosion product (CP1e)	Atacamite
Inner black corrosion product (CP2i)	S, Cu, O
Remnant metal phase (M1)	Bronze (90%Cu, 10% Sn)

The artefact is a cast leaded bronze that has been partially annealed after cold working (surface finishing?). Strangely enough, one of the rolled up ends of the middle bar is filled with metal, testifying that it was cast already rolled-up. Normally it would have been rolled up after inserting the plates. The remaining metal seems to have developed intergranular corrosion limited to the interface metal / corrosion layers. The corrosion crust is constituted of an outer thick, green atacamite layer enriched in Pb and mixed with sediments while the inner thin, black corrosion layer is S, Cu and O-rich. This stratigraphy is unexpected for an archaeological artefact where we would expect chlorine to be at the interface metal / corrosion layer. Similarly, Si should be located on top layers although it was found deep in the outer green layer. Furthermore, S is found next to the metal surface while it should be present in higher concentrations in the top layers. Finally, Sn appears in an irregular and interrupted layer on top of the remaining metal. In an archaeological bronze it should be found as a clearly defined enriched layer. The red spots that looked like cuprite turned out to be paint. Since chlorine and sulphur are commonly used for the artificial patination of bronzes, we tend to conclude that this object is probably a fake produced during the 20th century.
