SHOE NAIL 2637 1370.B. - HYPOEUTECTOID STEEL - ROMAN TIMES - SWITZERLAND

Artefact name	Shoe nail 2637 1370.B.
Authors	Christian. Degrigny (HE-Arc CR, Neuchâtel, Neuchâtel, Switzerland) & Valentin. Boissonnas (HE-Arc CR, Neuchâtel, Neuchâtel, Switzerland) & Vincent Chappuis. (HE-Arc CR, Neuchâtel, Neuchâtel, Switzerland)
Url	/artefacts/523/

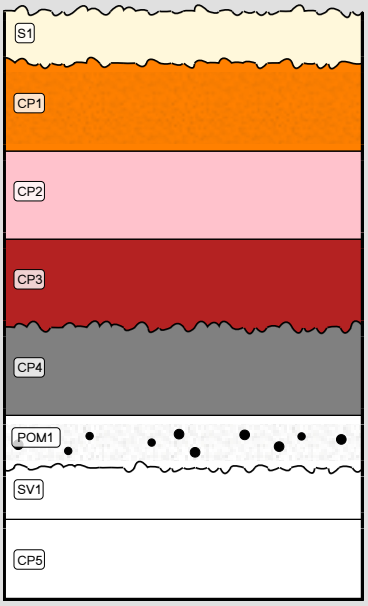
Fig. 5: Stratigraphic representation of the nail in cross-section using the MiCorr application. The characteristics of the strata are only accessible by clicking on the drawing that redirects you to the search tool by stratigraphy representation. This representation can be compared to Fig. 14, Credit HE-Arc CR, V.Chappuis.

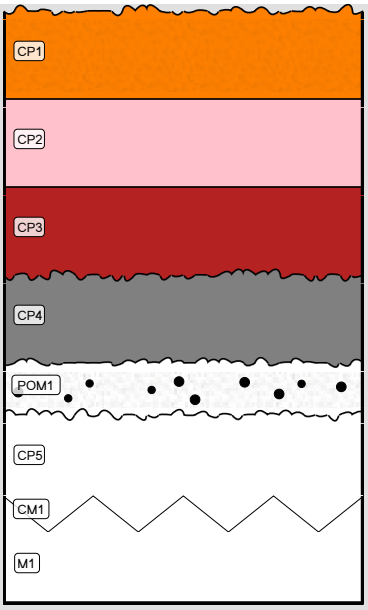
Fig. 6: Stratigraphic representation of the nail in cross-section using the MiCorr application. The characteristics of the strata are only accessible by clicking on the drawing that redirects you to the search tool by stratigraphy representation. This representation can be compared to Fig. 14, Credit HE-Arc CR, V.Chappuis.
