BUST OF AN APPLIQUE 2005.054.F00265.1 – QUARTERNARY BRONZE ALLOY – ROMAN TIMES – SWITZERLAND

Artefact name Bust of an applique 2005.054.F00265.1

Authors Christian. Degrigny (HE-Arc CR, Neuchâtel, Neuchâtel, Switzerland) & Marie. Arnautou (HE-Arc CR, Neuchâtel, Neuchâtel, Switzerland) & Valentin. Boissonnas (HE-Arc CR, Neuchâtel, Neuchâtel, Switzerland)

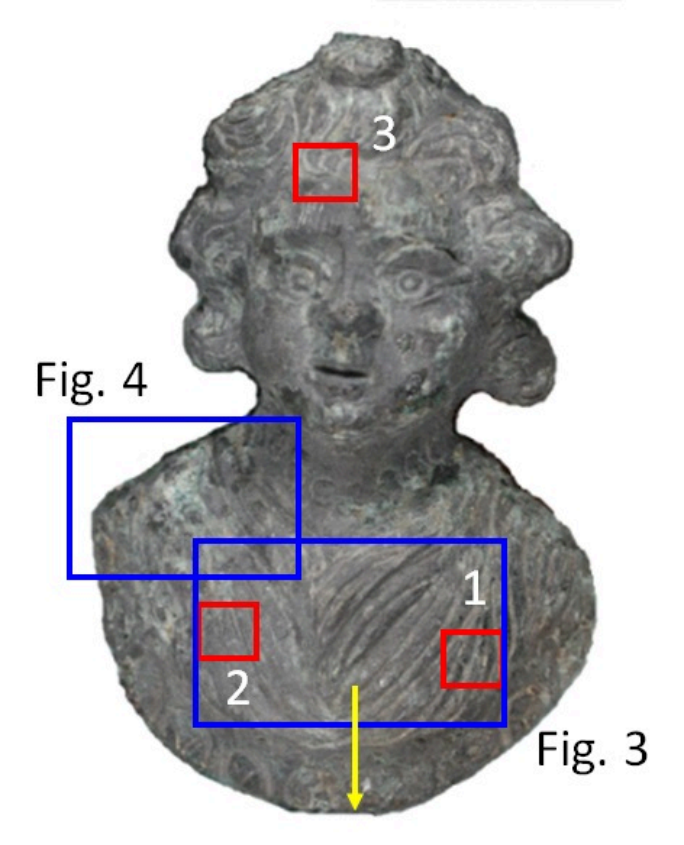
Fig. 1: Bust of an applique as found (left picture) and the bust (right picture),

Description of the artefact Bust representing a love figure from a bronze applique (Fig. 1), covered by a thin dark-grey patina and scattered green corrosion products. Dimensions: L = 6 cm; W = 3.5 cm; T = 3 cm.

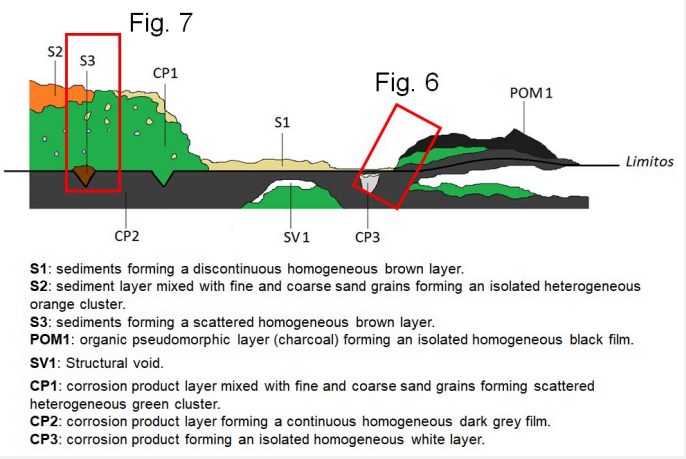
The schematic representation below gives an overview of the corrosion layers encountered on the bust from a first visual macroscopic observation.

Fig. 5: Stratigraphic representation based on visual observation and visualization of the stratigraphies of Figs. 6 and 7.

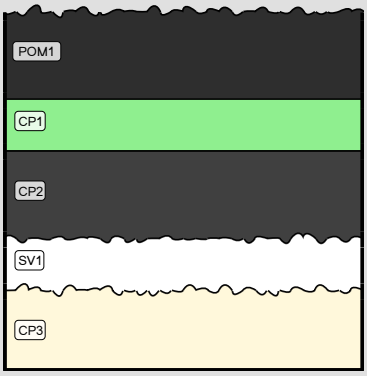
Fig. 6: Stratigraphic representation of the bust in cross-section using the MiCorr application. The characteristics of the strata are only accessible by clicking on the drawing that redirects you to the search tool by stratigraphy representation. This representation can be compared to Fig. 5, Credit HE-Arc CR, C.Degrigny.

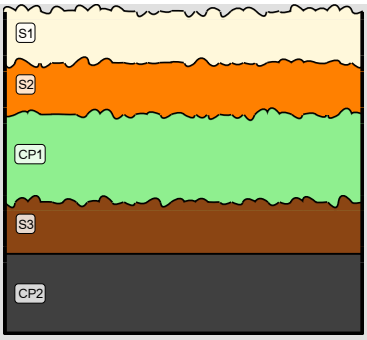
Fig. 7: Stratigraphic representation of the bust in cross-section using the MiCorr application. The characteristics of the strata are only accessible by clicking on the drawing that redirects you to the search tool by stratigraphy representation. This representation can be compared to Fig. 5, Credit HE-Arc CR, C.Degrigny.

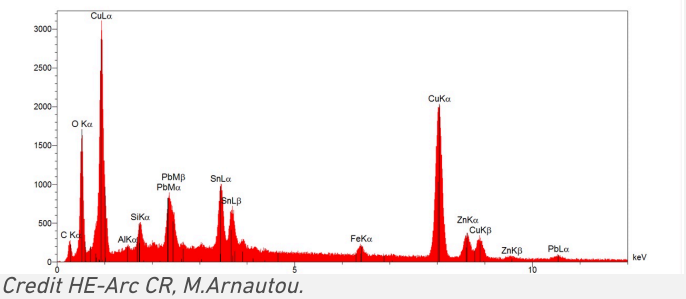
The entire surface of the bust is covered by a dark grey layer directly attached to the remaining metal (CP2) (Fig. 3). The surface analyses (Table 1) performed on the bust have revealed a high amount of Cu, as well as Pb, Sn and Zn. These are elements which can be constituents of the alloy, while elements in minor amount such as Al, Si and Fe are likely to originate from the environment. The qualitative analysis carried out on the dark patina by SEM/EDS (Fig. 8) confirms the XRF results (Table 1), showing the same elements and the presence of O, which probably correspond to copper oxide (cuprite Cu2O or tenorite CuO). The dark patina is covered by an adherent green corrosion layer (CP1) which has developed in scattered clusters (probably copper carbonate). The clusters have a surface area of 2 mm2 to 2 cm2, and have a thickness of 0.5 to 5 millimeters. In some places, the green corrosion layer has formed in the porous blisters of the dark layer (Fig. 5). Charcoal might be found locally (POM1) as well as different sediments: S1 (discontinuous and brown), S2 (mixed with fine and coarse sand grains) and S3 (scattered homogeneous brown layer).

Table 1: Chemical composition of the dark-grey patina of the selected areas of Fig.2 (red squares). Method of analysis: HE-Arc portable XRF.

The metal is probably a quaternary bronze (Cu-Pb-Sn-Zn) according to the qualitative XRF analysis performed on the surface of the bust. The high amount of lead is probably due to its diffusion towards the metal surface caused by exposure to high temperatures. The dark patina (CP2) has developed from a smooth layer to voluminous green crusts (CP1) corresponding to a type 1 corrosion according to Robbiola and al. 1998. The artefact has been excavated from a burial context characterized by burnt soil, which could explain the formation of the black patina (tenorite will form at temperatures above 300/400°C). A green corrosion has developed in the porous blisters of the dark layer. The limit of the original surface is located at the interface of the dark smooth corrosion and the green adherent corrosion product. In certain areas the limit of the original surface has been elevated from its original position.
