SACRIFICIAL ANODE VHS-8339 – ZN ALLOY – MODERN TIMES

Artefact name	Sacrificial anode VHS-8339
Authors	Marianne. Senn (EMPA, Dübendorf, Zurich, Switzerland) & Christian. Degrigny (HE-Arc CR, Neuchâtel, Neuchâtel, Switzerland)
Url	/artefacts/525/

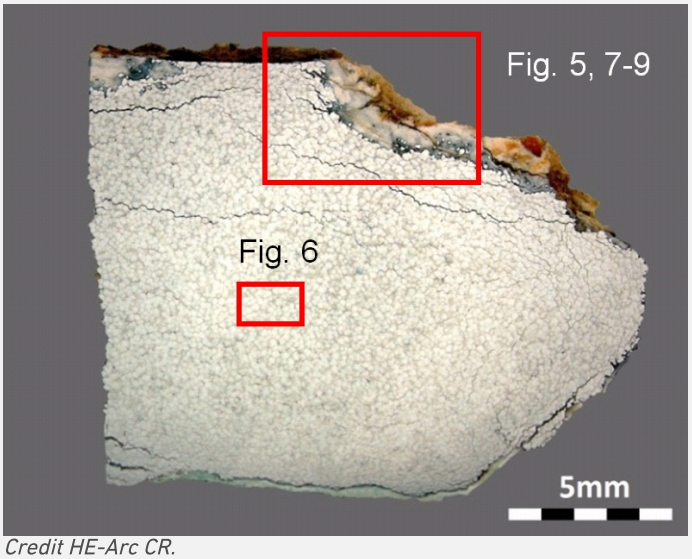
Fig. 2: Location of sampling area,

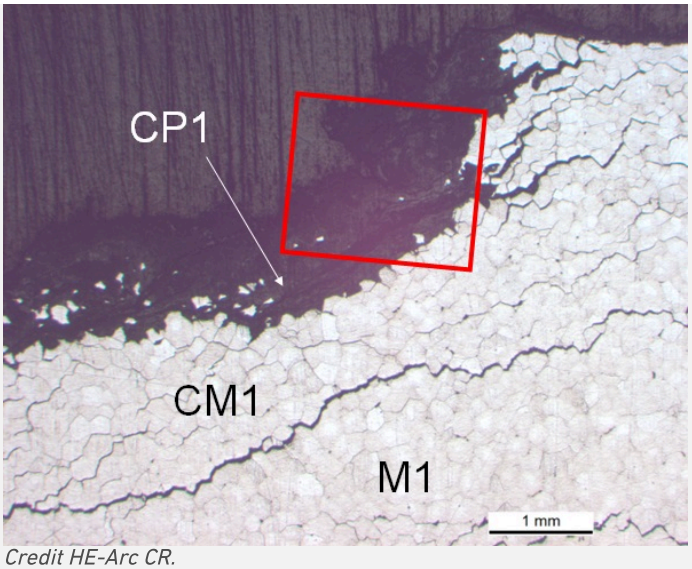
Fig. 3: Micrograph of the cross-section of the fragment sampled from the sacrificial anode showing the location of Figs. 5 to 9,

The sample (Fig. 3) shows a cross-section from the fragment of the sacrificial anode (Fig. 2). The thickness of the corrosion crust is variable. Dimensions: L = 17mm; W = 14mm.

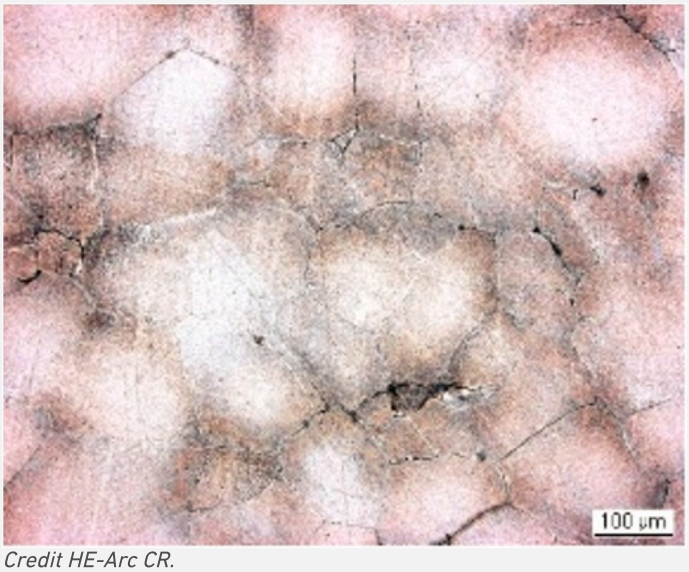
The remaining metal is an almost pure zinc alloy (Table 1). The oxygen content is not from the original alloy, but is due to secondary corrosion. The metal grains are visible without etching and present a polygonal structure (Figs. 5 and 6). The structure is recrystallised after annealing. The recrystallization of zinc alloys begins at room temperature.

Fig. 5: Micrograph of the metal sample from Fig. 3 (reversed picture, detail), unetched, bright field. Extensive intergranular corrosion is visible.The rectangle marks Fig. 7,

Extensive intergranular corrosion / cracking has developed in the metal structure (Figs. 5, 6). The metal is covered by a corrosion crust that is hardly visible in bright field and which contains remnant metal (Fig. 5). On most of the sample the corrosion crust is uniform. In areas we see cracks (Fig. 7) appearing as brown lines separating the corrosion crust (Fig. 8). In bright field the corrosion crust appears grey containing dark-grey zones (Fig. 7). Under polarized light, the corrosion crust appears white with darker parts including remnant metal (Fig. 8). It contains Zn and O as well as S along some cracks (Table 2 and Fig. 9).

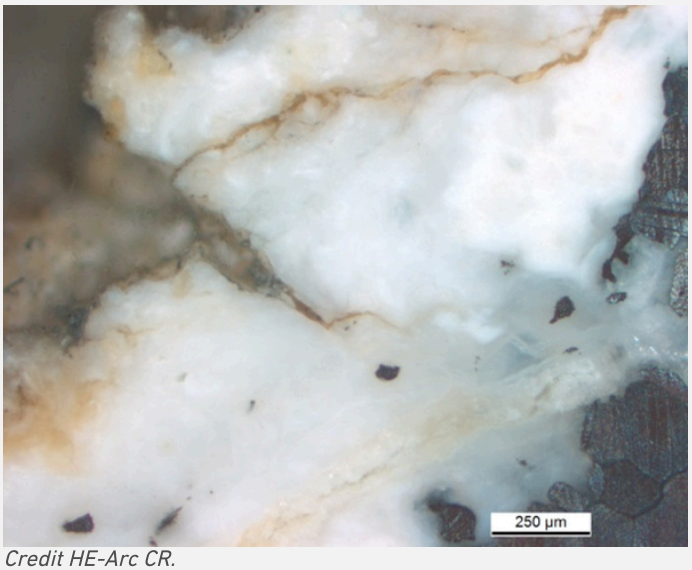
Table 2. Chemical composition (mass %) of the corrosion layer from Figs. 7 and 9. Method of analysis: SEM/EDS, Laboratory of Analytical Chemistry, Empa.

Fig. 7: Micrograph showing the metal - corrosion products interface from Fig. 5 (detail), unetched, bright field,
