OVAL BRACELET WITH A ROUNDED DIAMETER B B3474 - LEADED BRONZE - LATE BRONZE AGE - SWITZERLAND

Artefact name Oval bracelet with a rounded diameter B B3474

Authors Marianne. Senn (EMPA, Dübendorf, Zurich, Switzerland) & Christian. Degrigny (HE-Arc CR, Neuchâtel, Neuchâtel, Switzerland)

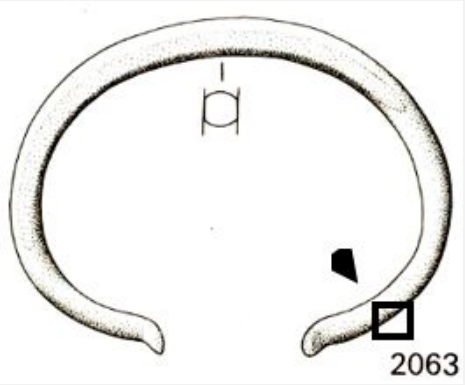
Fig. 2: Location of sampling area,

Description of sample	The sample is a section from one end of the bracelet (Fig. 2). Its dimensions are: L = 2.3mm and W = 0.55mm. The corrosion layer is relatively thin (Fig. 3).
Alloy	Leaded Bronze
Technology	As-cast
Lab number of sample	MAH 77-110-2

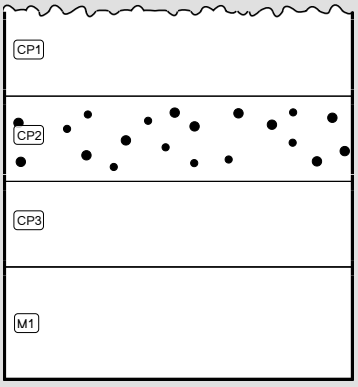
Fig. 4: Stratigraphic representation of the sample taken from the bracelet with round diameter in cross-section using the MiCorr application. The characteristics of the strata are only accessible by clicking on the drawing that redirects you to the search tool by stratigraphy representation. This representation can be compared to Fig. 8, Credit HE-Arc CR.
