FRAGMENT OF A BED STRUCTURE 03 12751-20.2.5 - TIN BRONZE - ROMAN TIMES - SWITZERLAND

Artefact name	Fragment of a bed structure 03 12751-20.2.5
Authors	Marianne Senn. (Empa, None) & Christian. Degrigny (HE-Arc CR, Neuchâtel, Neuchâtel, Switzerland)
Url	/artefacts/528/

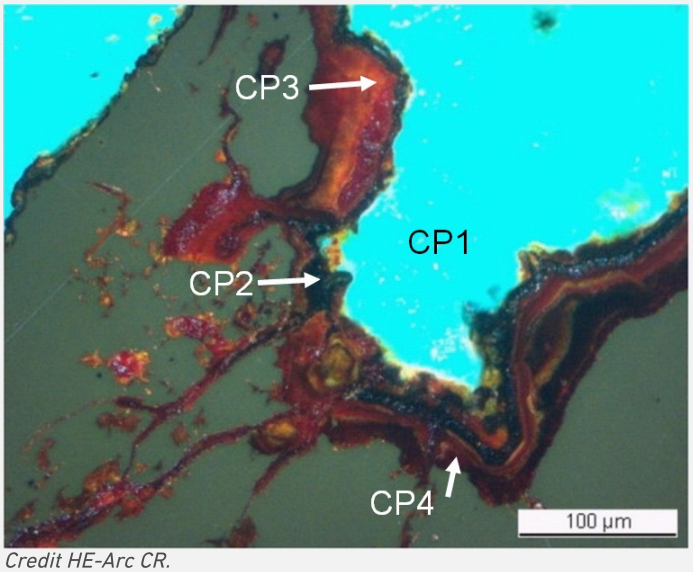
Table 3: Chemical composition (mass %) of the corrosion crust from Fig. 8. Method of analysis: SEM/EDS, Laboratory of Analytical Chemistry, Empa.

Fig. 8: Micrograph showing the metal - corrosion crust interface from Fig. 3 (detail of Fig. 5) and corresponding to the stratigraphy of Fig. 4, polarised light. From bottom left to to right: In grey the metal, in dark-red/orange CP4, in light red CP3, in black (with pores) CP2 and in green-blue CP1,

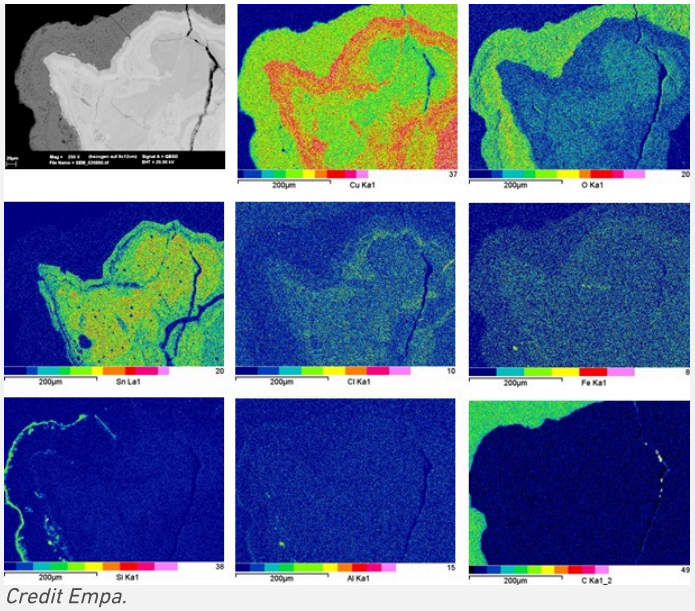
Fig. 9: SEM image, BSE-mode, and elemental chemical distribution of the selected area from Fig. 3 (reversed picture, detail). Method of examination: SEM/EDS, Laboratory of Analytical Chemistry, Empa,

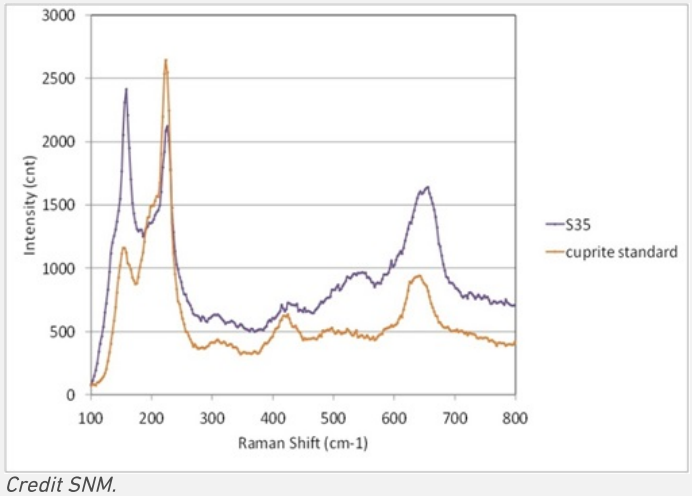
Fig. 10: Raman spectrum of CP3 (S35) from Fig. 8 compared to a cuprite standard spectrum. Settings: laser wavelength 532nm, acquisition time 20s, one accumulation, filter D2 (0.75-0.8mW), hole 1000, slit 100, grating 600. Method of analysis: Raman spectroscopy, Lab of Swiss National Museum, Affoltern a. Albis ZH,

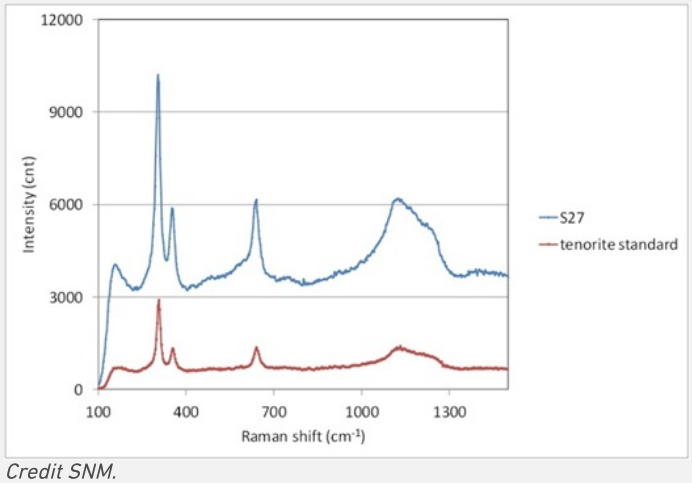
Fig. 11: Raman spectrum of the black layer (CP2) with pores (S27) from Fig. 8 compared to a tenorite standard spectrum. Settings: laser wavelength 532nm, acquisition time 100s, one accumulation, filter D1 (7.5-8mW), hole 500, slit 80, grating 600. Method of analysis: Raman spectroscopy, Lab of Swiss National Museum, Affoltern a. Albis ZH,

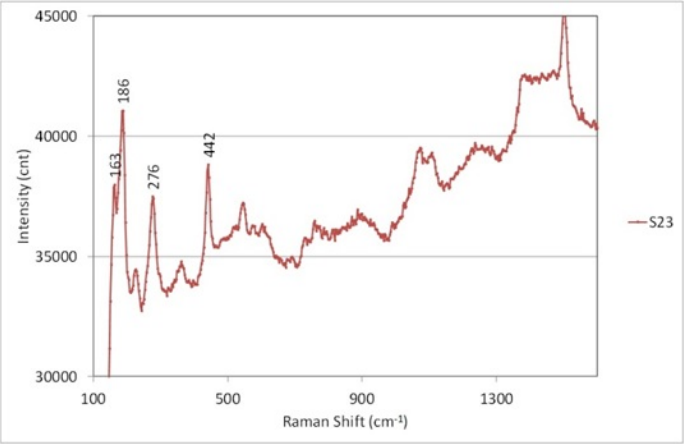
Fig. 12: Raman spectrum of the green outer corrosion layer (CP1) from Fig. 8. Settings: laser wavelength 532nm, acquisition time 80s, one accumulation, filter D2 (0.75-0.8mW), hole 500, slit 80, grating 600. Method of analysis: Raman spectroscopy, Lab of Swiss National Museum, Affoltern a. Albis ZH,

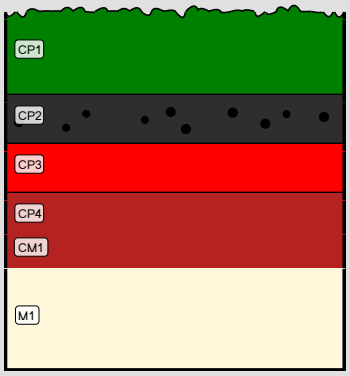
Fig. 4: Stratigraphic representation of the sample taken from the bed structure in cross-section using the MiCorr application. The characteristics of the strata are only accessible by clicking on the drawing that redirects you to the search tool by stratigraphy representation. This representation can be compared to Fig. 8, Credit HE-Arc CR.
