CORRODED METAL SHEET FN 655.13.01 – FE ALLOY – MODERN TIMES – SWITZERLAND

Authors Marianne. Senn (EMPA, Dübendorf, Zurich, Switzerland) & Christian. Degrigny (HE-Arc CR, Neuchâtel, Neuchâtel, Switzerland)

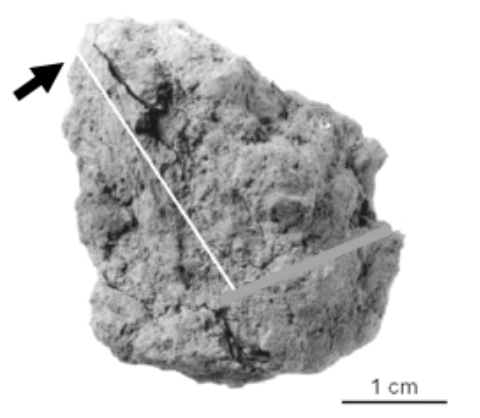
Fig. 1: Metal sheet (after Senn Bischofberger 2005, 137),

Description of the artefact Metal (iron-based) sheet with middle rib. The shape is no longer discernible (Fig. 1). The metal is covered by a thick corrosion crust. Dimensions: L = 4.5cm; WT = 35g.

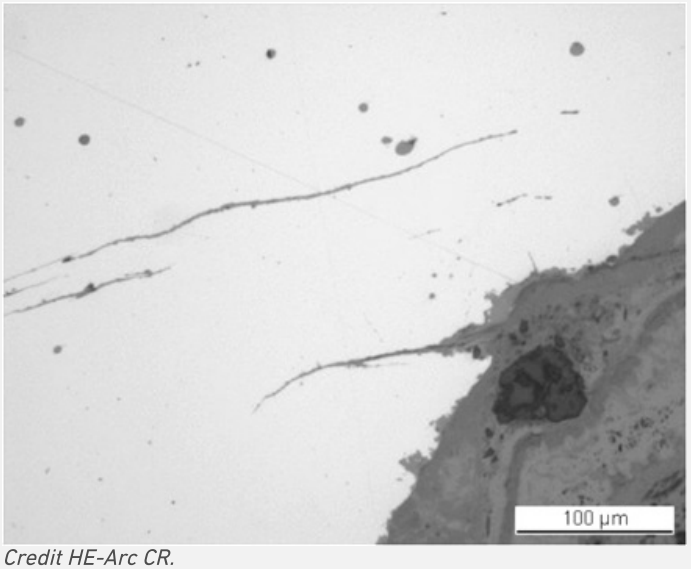
Fig. 6: Micrograph of metal sample from Fig. 3 (detail), etched, bright field. The heavily cold worked metal shows elongated grains with nearly invisible grain boundaries and cracks parallel to the grains,

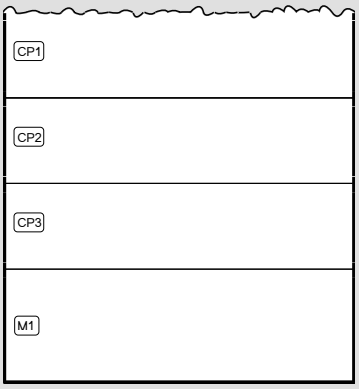
Fig. 4: Stratigraphic representation of the iron-based sheet in cross-section using the MiCorr application. The characteristics of the strata are only accessible by clicking on the drawing that redirects you to the search tool by stratigraphy representation. This representation can be compared to Figs. 7 and 8, Credit HE-Arc CR.

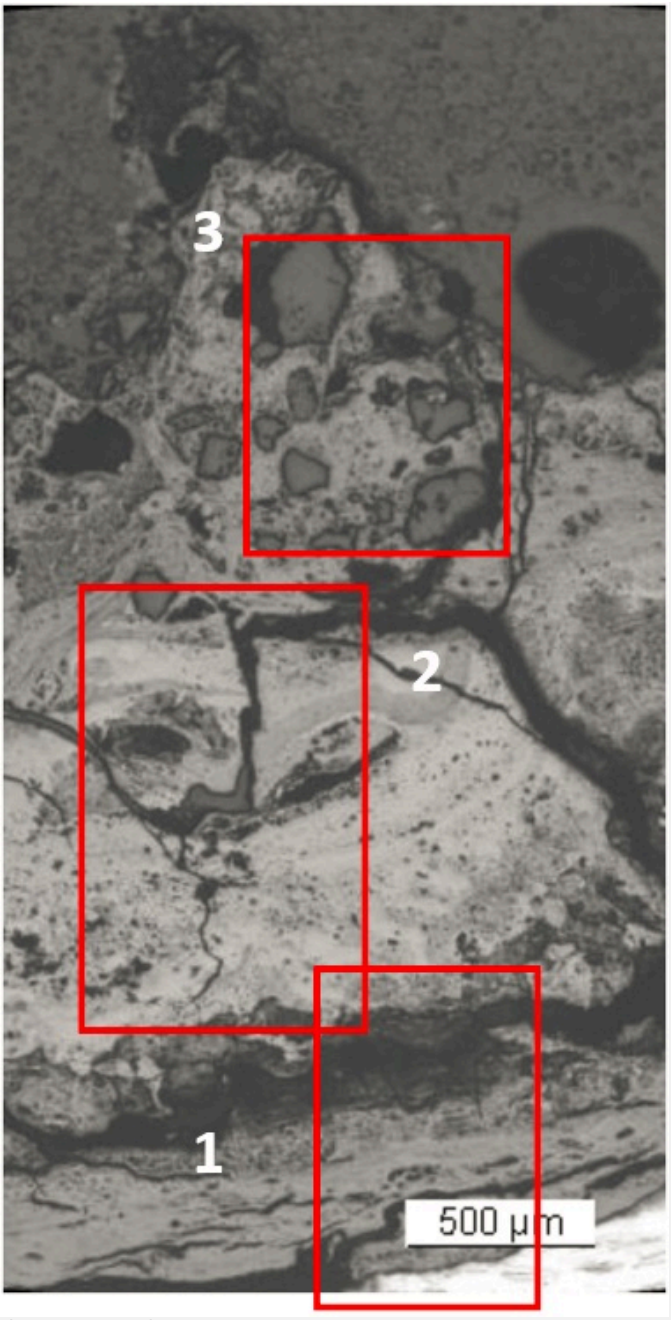
Fig. 7: Micrograph of the corrosion layer from Fig. 3 showing the metal - corrosion crust interface (detail, rotated by 45°) and corresponding to the stratigraphy of Fig. 4, unetched, bright field. The areas 1 (for CP3), 2 (for CP2) and 3 (for CP3) selected for elemental chemical distribution (Fig. 9) are marked by red rectangles,

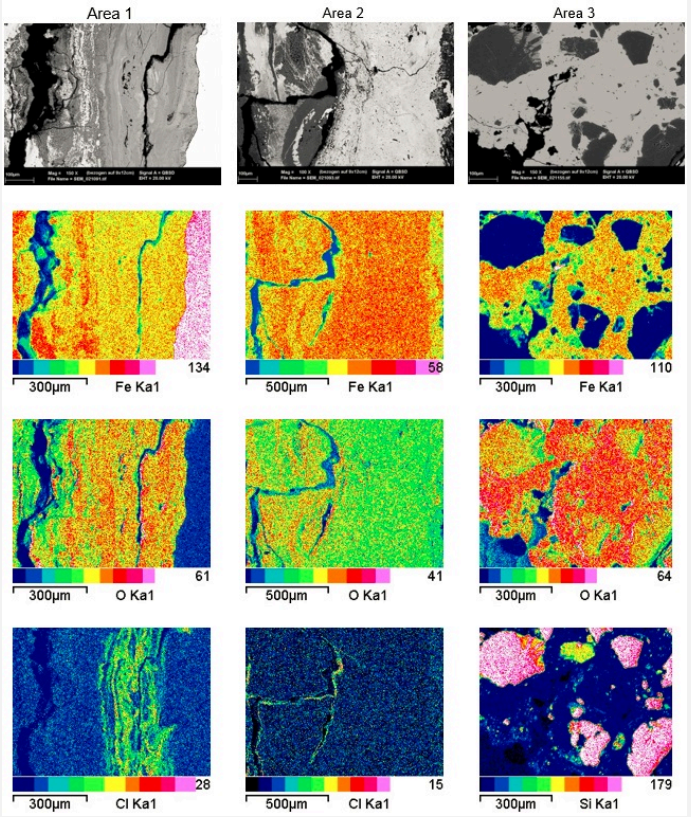
Fig. 9: SEM images, BSE-mode, and elemental chemical distribution of the selected areas from Figs. 7 and 8 (reversed picture rotated by 270°, details). First column: mapping on area 1 (CP3) where an inner layer enriched in Cl appears near the metal surface. 2nd column: area 2 (CP2) where iron oxides prevail. 3rd column: area 3 (CP1) where the outer O-rich layer includes rock fragments rich in Si. Method of examination: SEM/EDS, Lab. Anal. Chem. Empa,

This iron-based sheet is entirely cold worked and hard compared to an annealed metal. The corrosion is massive and masks the shape of the object. The presence of Cl adjacent to the metal surface indicates that the corrosion front is potentially active. The very thick top corrosion layers may have slowed down the corrosion. The object was mentioned as being Roman in Senn Bischofberger 2005, however the chemical composition of the slag inclusions shows that it is a product of the 20th century AD which has been accidentally introduced into a Roman layer.
