CORRODED METAL SHEET FN 655.13.01 – FE ALLOY – MODERN TIMES – SWITZERLAND

Authors Marianne. Senn (EMPA, Dübendorf, Zurich, Switzerland) & Christian. Degrigny (HE-Arc CR, Neuchâtel, Neuchâtel, Switzerland)

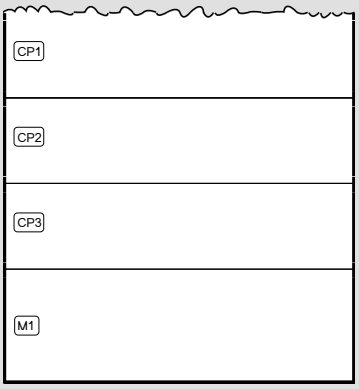
Fig. 4: Stratigraphic representation of the iron-based sheet in cross-section using the MiCorr application. The characteristics of the strata are only accessible by clicking on the drawing that redirects you to the search tool by stratigraphy representation. This representation can be compared to Figs. 7 and 8, Credit HE-Arc CR.
