CHISEL POINT DEV 995 1069 PR – EUTECTOID TO HYPEREUTECTOID STEEL – EARLY MEDIEVAL TIMES – SWITZERLAND

Artefact name Chisel point DEV 995 1069 PR

Authors Marianne. Senn (EMPA, Dübendorf, Zurich, Switzerland) & Christian. Degrigny (HE-Arc CR, Neuchâtel, Neuchâtel, Switzerland)

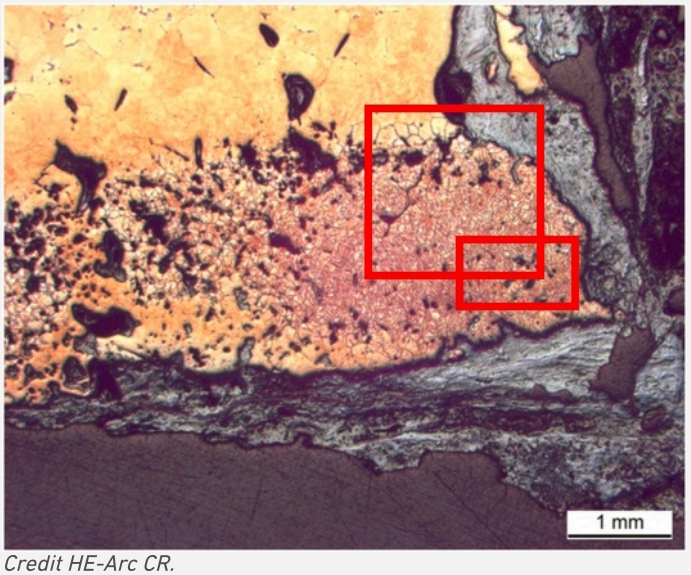
The remaining metal is a eutectoid to hypereutectoid steel (C 0.8-1 mass%) with cracks and porosity (Figs. 5 and 6). Its composition is given in Table 1 (except Fe). Of the trace elements, only Ni reaches a medium concentration (Ni 0.07 mass%). The composition and the high Ni/Co ratio are atypical for iron worked in smithies of the settlement at Develier-Courtételle JU, CH. The few slag inclusions and their chemical composition confirm this (Table 2). The slag is rich in CaO whereas the pisolithic or bean ore worked in the Central Jura smelting district is rich in Al_2O_3. The slag inclusions cannot be smithing slag because the artefact is formed from one piece of metal. The slag probably incorporated while refining the bloom or during the bloom smelting process. The ore from which this metal was smelted cannot yet be identified. Intergranular corrosion has developed, penetrating into the metal structure (Fig. 6). The etched metal shows a dominant martensitic structure, typical of quench hardened steel (Figs. 5, 7, 8 and 9). The characteristic forms of the martensite are non-organised needles (Fig. 8). In restricted areas bainite nodules occur (Figs. 7 and 8). In the centre of the point, hypereutectoid steel is composed of cementite in the grain boundaries and in needle like shapes within the grains (Fig. 10). Hypereutectoid regions also occur in the centre of the shaft and on its left surface (Fig. 5). Here the hypereutectoid steel is composed of martensite and cementite in the grain boundaries and in needle form within the grains (Figs. 6 and 9). Nevertheless, most of the chisel is dominated by eutectoid steel. The average hardness of the quench hardened eutectoid steel is about HV1 690. In the bainite nodules the average hardness drops to about HV1 350, the martensite has an average hardness of HV1 750.

Fig. 5: Micrograph of the metal sample from Fig. 3 (inverted picture, detail), etched, bright field. The metal contains porosity and cracks (in black). The micrographs of Figs. 6 and 9 are marked by the top and bottom rectangles respectively,

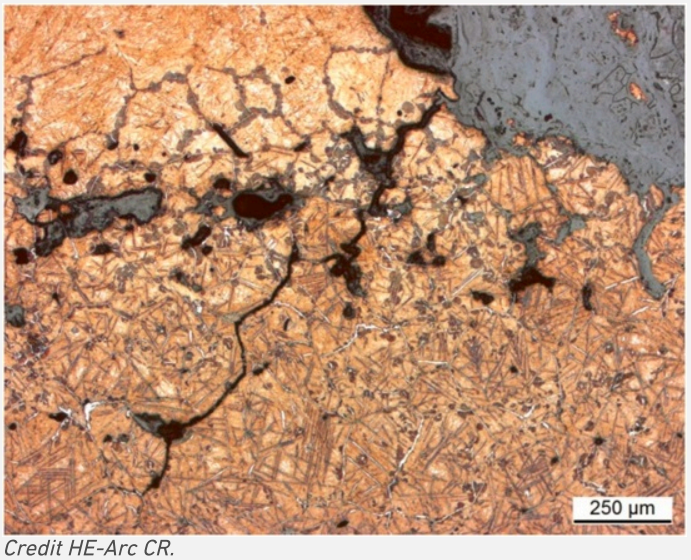
Fig. 6: Micrograph of the metal sample, detail from Fig. 5, etched, bright field. We observe martensite (in orange), cementite (in grey), porosity and intergranular cracks (in black) and corrosion,

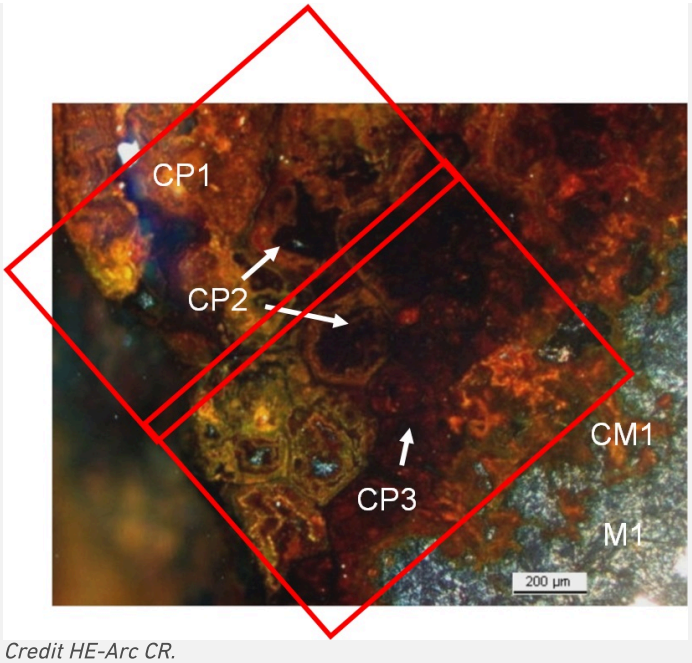
The metal is heavily corroded and the thickness of the corrosion crust is irregular, but averages about 0.5mm. The corrosion products enclose different ghost structures: the corrosion crust has preserved the shape of polygonal grains (Figs. 11 and 13) and cementite needles (Fig. 12). Under polarised light, the corrosion products at the metal - corrosion crust interface are dark-red and form an inner S-rich layer (CP3, Figs. 11 and 13). Cl occurs locally (CP3) and C is present in layers CP2 and CP3 (Fig. 13). The outer layer of the corrosion products (CP1) is orange and contains more O than the inner layer CP3 (Figs. 11 and 14).

Fig. 11: Micrograph showing the metal - corrosion crust interface from Fig. 3 (rotated by 270°, detail) and corresponding to the stratigraphy of Fig. 4, unetched, polarised light. Polygonal grains are visible as ghost structure in the corrosion crust. The selected areas for elemental chemical distribution (Figs. 13 and 14) are marked by two rectangles (bottom: Fig. 13 and top: Fig. 14),

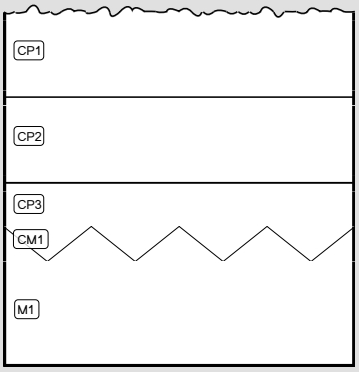
Fig. 4: Stratigraphic representation of the chisel point in cross-section using the MiCorr application. The characteristics of the strata are only accessible by clicking on the drawing that redirects you to the search tool by stratigraphy representation. This representation can be compared to Fig. 11, Credit HE-Arc CR.
