MOIL CHISEL DEV 995 762 PR – STEEL – EARLY MEDIEVAL TIMES – SWITZERLAND

Artefact name Moil chisel DEV 995 762 PR

Authors Marianne. Senn (EMPA, Dübendorf, Zurich, Switzerland) & Christian. Degrigny (HE-Arc CR, Neuchâtel, Neuchâtel, Switzerland)

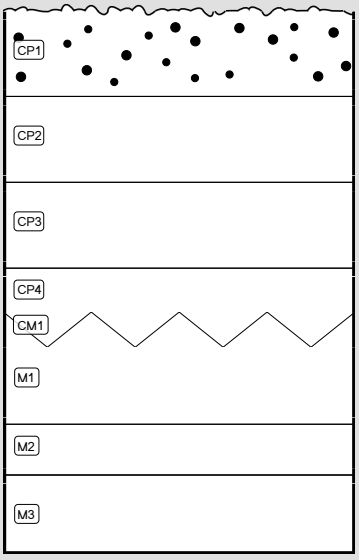
Fig. 4: Stratigraphic representation of sample 2 from the moil chisel in cross-section using the MiCorr application. The characteristics of the strata are only accessible by clicking on the drawing that redirects you to the search tool by stratigraphy representation. This representation can be compared to Fig. 12, Credit HE-Arc CR.
