KNIFE WITH A GROOVE ON BOTH SIDES DEV 995 814 PR – FE ALLOY – EARLY MEDIEVAL TIMES – SWITZERLAND

Artefact name Knife with a groove on both sides DEV 995 814 PR

Authors Marianne. Senn (EMPA, Dübendorf, Zurich, Switzerland) & Christian. Degrigny (HE-Arc CR, Neuchâtel, Neuchâtel, Switzerland)

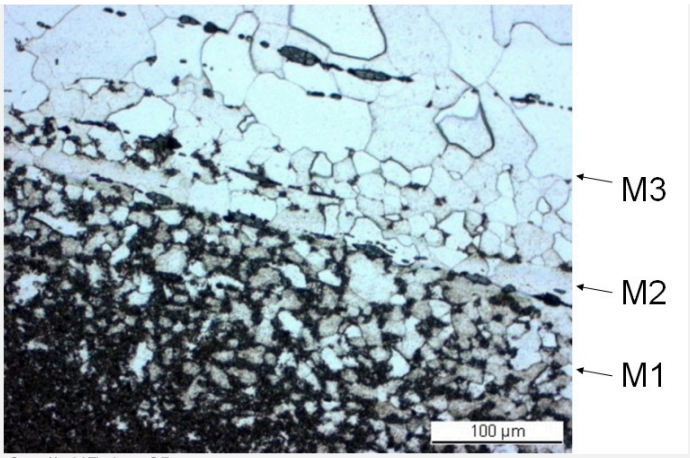
Fig. 7: Micrograph of the metal sample from Fig. 3 (detail), nital etched, bright field. In white we observe the ferrite, in black or dark-grey the pearlite and bainite. The micrograph of Fig. 8 is marked by a rectangle,

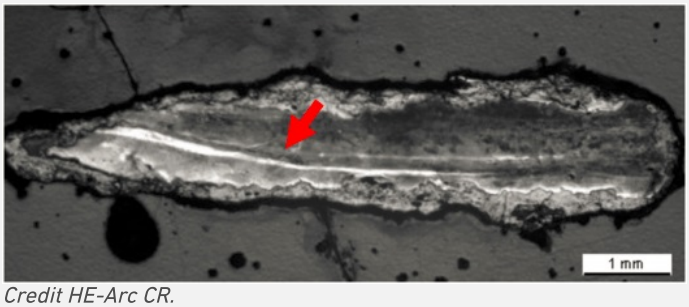
The remaining metal consists of two forged wrought iron bars, one of which includes a carburized tip (M1, Table 1). They are separated by a welding seam (M2, Figs. 9 and 10). The ferritic part (M3) is Cu-rich, whereas the carburized tip has a low and medium content of trace elements (Table 1). The metal contains elongated slag inclusions (Fig. 5) showing a structure of wüstite (FeO) in a glassy matrix (Fig. 6 and Table 2). Most of the slag inclusions are arranged in rows, marking the welding seam (Figs. 5 and 9) and following the forging direction. Their chemical composition differs in the Mn content (Table 2): the latter is higher in the slag inclusions of the carburized tip. The high P content of the slag in the ferritic part must be noted since the metal in general has a medium P content (Tables 1 and 2). Etching with Oberhoffer's reagent solution makes the P distribution visible (Fig. 10). Dark areas are depleted of P whereas P-rich zones, such as those found in the welding seam, appear in white. After nital etching, the very fine steel microstructure of the tip shows the transition from hypoeutectoid to eutectoid steel (ferrite component in white and pearlite component in black, partly bainite, Figs. 7, 8 and 9). The body of the knife is made of wrought iron with an annealed, irregular ferritic structure (Figs. 7 and 8). The average hardness of the wrought iron (HV1 130) is a little higher than expected, whereas the hardness of steel in the hypoeutectoid-eutectoid tip (HV1 360) is an indication of quench-hardening followed by tempering.

Fig. 9: Micrograph of the metal sample from Fig. 3 (rotated by 45°), nital etched, bright field. In white we observe the ferrite, in black or dark-grey the pearlite. The red arrow shows the welding seam,

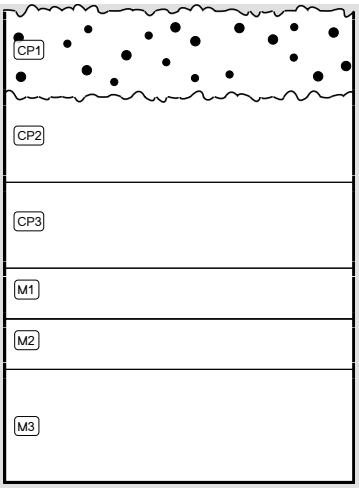
Fig. 4: Stratigraphic representation of the tip of the knife in cross-section using the MiCorr application. The characteristics of the strata are only accessible by clicking on the drawing that redirects you to the search tool by stratigraphy representation. This representation can be compared to Fig. 8 and Fig. 13, Credit HE-Arc CR.
