WEDGE PART OF AN ALTAR CROWN SUSPENSION – P-RICH IRON AND HYPOEUTECTOID STEEL – MODERN TIMES – SWITZERLAND

Artefact name	Wedge part of an altar crown suspension
Authors	Marianne. Senn (EMPA, Dübendorf, Zurich, Switzerland) & Christian. Degrigny (HE-Arc CR, Neuchâtel, Neuchâtel, Switzerland)
Url	/artefacts/535/

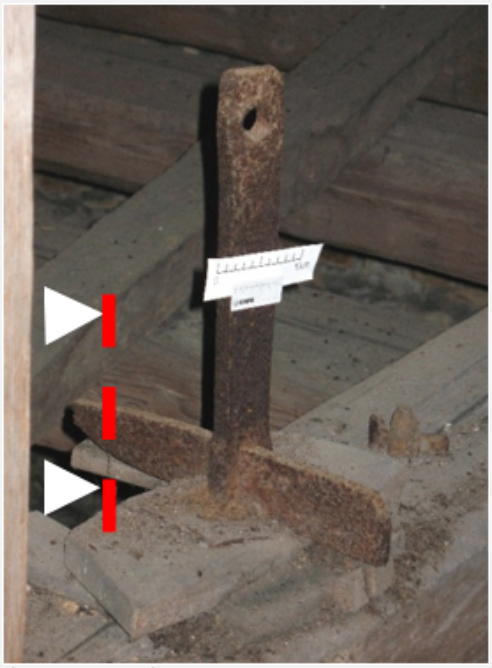
Fig. 2: Location of sampling area,

Description of sample	This sample is a section from the end of the wedge part (Fig. 2). The corrosion crust appears on the top side on Fig. 3.
Alloy	P-rich iron and hypoeutectoid steel
Technology	Annealed after (hot) rolling
Lab number of sample	RHE1-NR
Sample location	Empa (Marianne Senn)
Responsible institution	IWT (Naila Hadzic), Wallisellen, Zurich
Date and aim of sampling	January 2008, material testing and security report

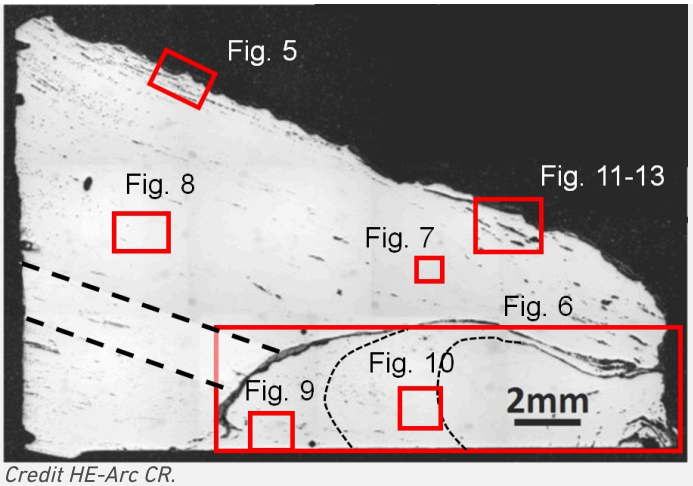
Fig. 3: Micrograph of the cross-section of the sample taken from the wedge part showing the location of Figs. 5 to 13. Steel areas are delimited by black dotted lines,

The remaining metal (M1) is a P-rich iron (0.3-0.45 mass%) with two zones (M3) consisting of soft, hypoeutectoid steel (C content 0.2 mass%) (Fig. 3 and Table 1). The P-rich iron contains many elongated slag inclusions of various sizes forming parallel rows (Figs. 3 and 5). The number of slag inclusions is higher than in bloomery iron and their distribution is typical for rolled metal. A crack, partially filled by hammer scale and corrosion products, indicates a poor quality welding seam (Fig. 3). Below the inclusions the curve produced by forging is highlighted. In good quality wrought iron slag inclusions are small, uniformly distributed and have identical compositions (Boesenberg 2006, 622). This is not the case in this sample, but can be explained by the rudimentary rolling process of the 18th century. The chemical composition of the slag inclusions shows that iron oxides dominate, beside phosphorus oxide, calcium oxide and silica (Table 2). The composition is typical for slag formed by hearth refining of pig iron (Dillmann and

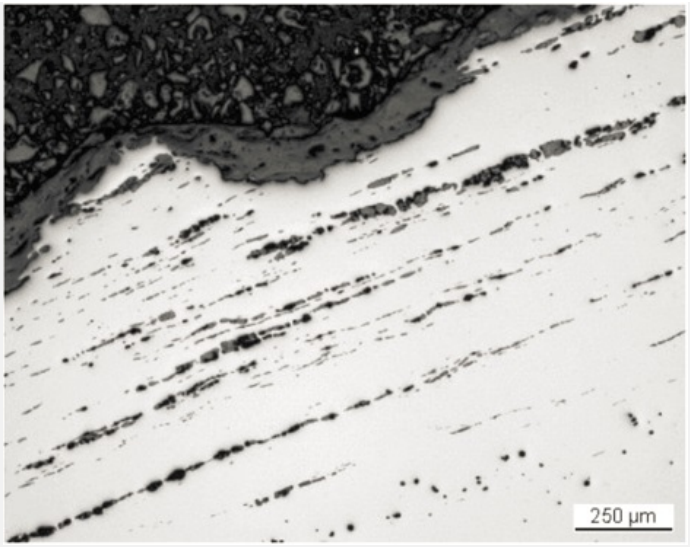
Fig. 5: Micrograph of the metal sample from Fig. 3 (reversed picture, detail), unetched, bright field. In white the metal, in grey the corrosion layer. There are numerous slag inclusions in the metal all orientated to form rows. Some inclusions are empty, probably due to sample preparation,

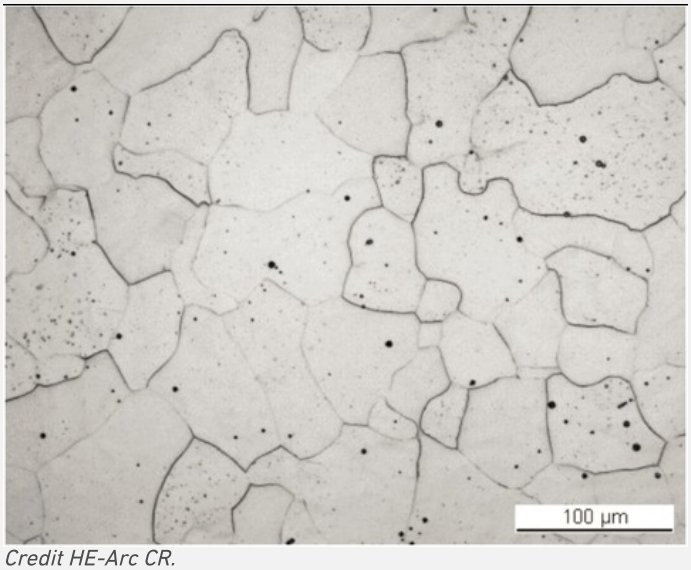
Fig. 7: Micrograph of the metal sample from Fig. 3 (detail), nital etched, bright field. The metal presents a ferritic structure,

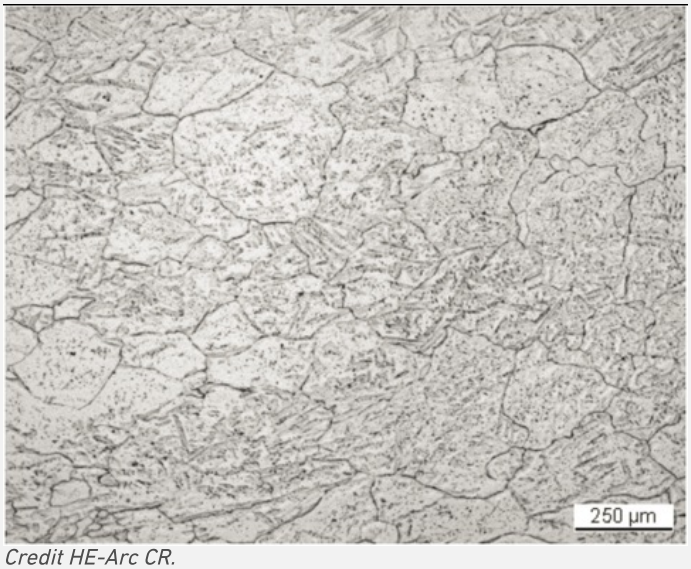
Fig. 8: Micrograph of the metal sample from Fig. 3 (detail), nital etched, bright field. The ferrite shows a ghost structure with needles,

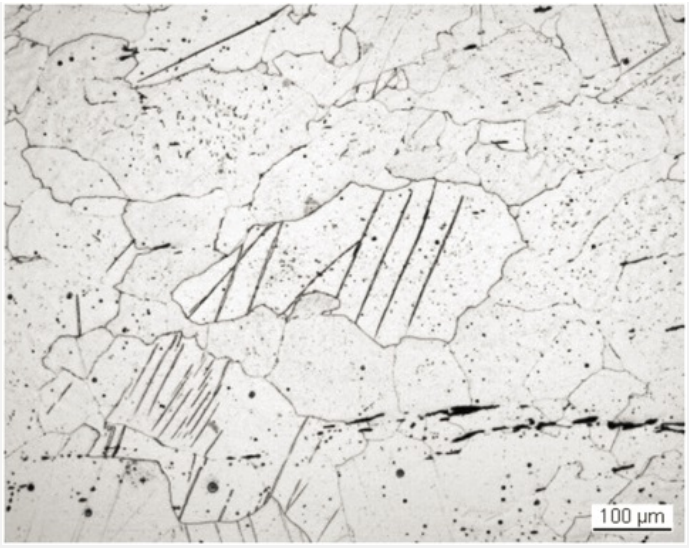
Fig. 9: Micrograph of the metal sample from Fig. 3 (detail), nital etched, bright field. The ferrite grains include Neumann bands,

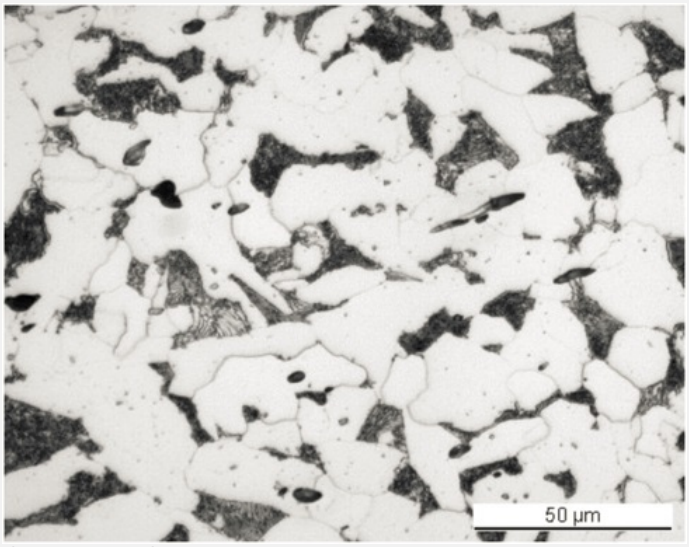
Fig. 10: Micrograph of the metal sample from Fig. 3 (detail), nital etched, bright field. The hypoeutectoid steel is constituted of ferrite in white and lamellar pearlite (in black),

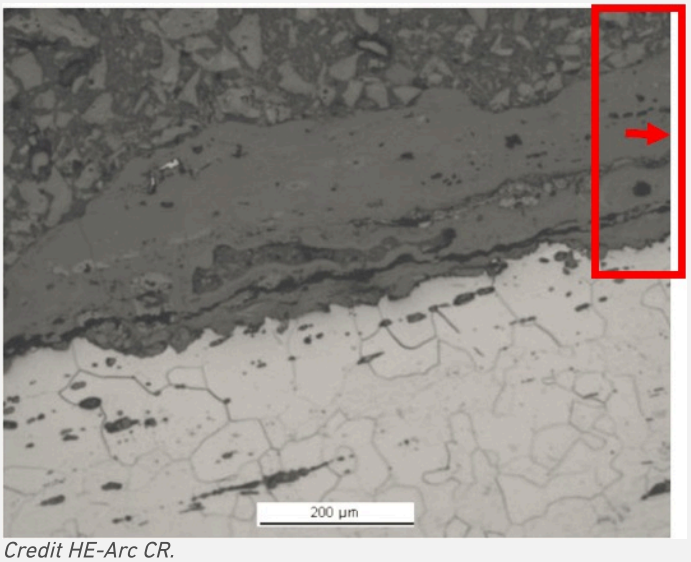
The corrosion crust is thin and irregular. It is restricted to one of the three surfaces. In bright field, the corrosion layer seems homogeneous and appears medium-grey with a fissure parallel to the metal surface (Fig. 11). Under polarised light the corrosion products near the metal surface are mostly red-orange (CP3), whereas in the outer layer they appear orange-brown (CP1) (Fig. 12). A dark-brown zone is visible between them (CP2) and contains bright inclusions with a chemical composition similar to wüstite (Table 3). This corresponds to corroded slag inclusions (internal markers). Chemical analysis (Table 3) and elemental mapping (Fig. 13) do not highlight a difference in composition of the corrosion layers, except for the corroded slag inclusions.

Fig. 11: Micrograph showing the metal - corrosion layer interface from Fig. 3 (reversed picture, detail), unetched, bright field. The grey corrosion layer contains bright inclusion rows. The area selected for elemental chemical distribution (Fig. 13) is marked by the red rectangle which expends beyond the micrograph,

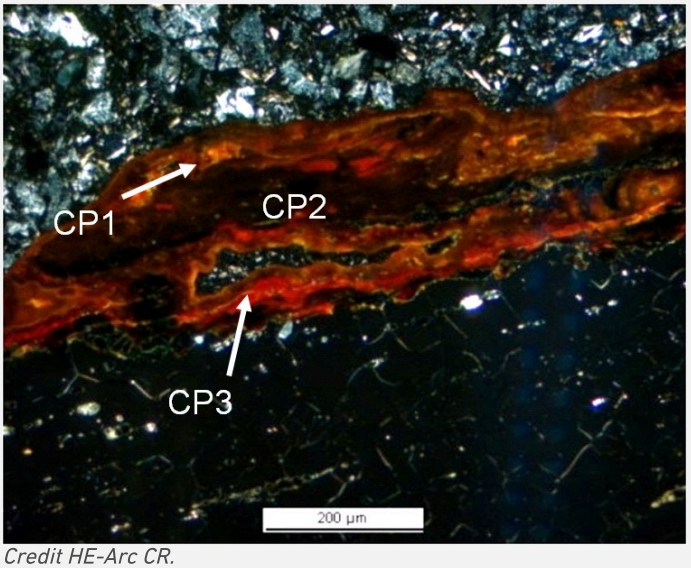
Table 3: Chemical composition (mass %) of the corrosion crust (from Fig. 12). Method of analysis: SEM/EDS, Laboratory of Analytical Chemistry, Empa.

Fig. 12: Micrograph (same as Fig. 11) corresponding to the stratigraphy of Fig. 4, unetched, polarised light. We observe from bottom to top: a red-orange inner corrosion layer (CP3), followed by a dark-brown intermediate layer (CP2) and an orange-brown outer layer (CP1),

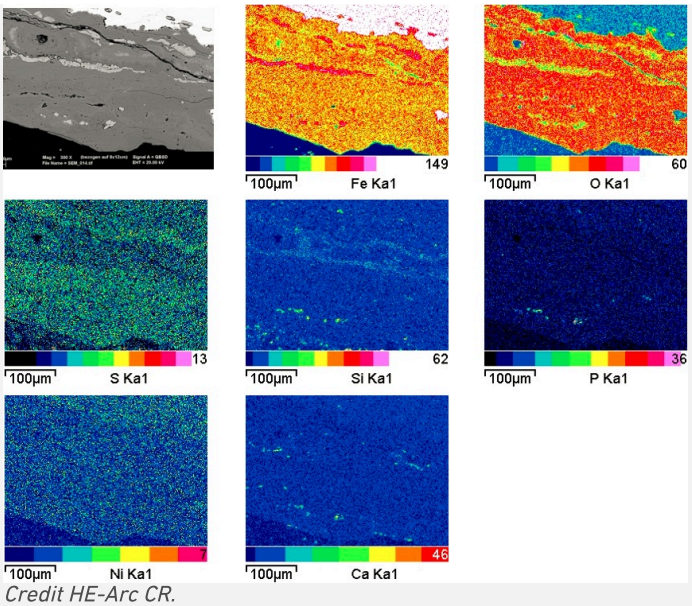
Fig. 13: SEM image, BSE-mode, and elemental chemical distribution of the selected area from Fig. 11 (inversed, detail). Method of examination: SEM/EDS, Laboratory of Analytical Chemistry, Empa,

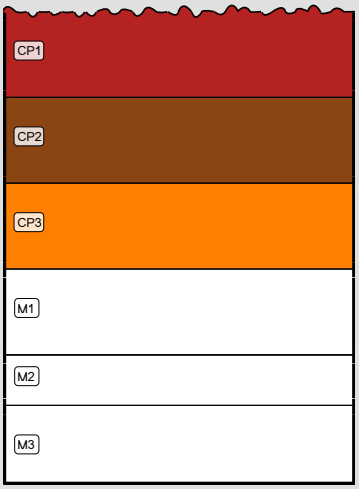
Fig. 4: Stratigraphic representation of the sample taken from the wedge part in cross-section using the MiCorr application. The characteristics of the strata are only accessible by clicking on the drawing that redirects you to the search tool by stratigraphy representation. This representation can be compared to Fig. 12, Credit HE-Arc CR.
