SITULA EMT09-554.665 – TIN BRONZE – IRON AGE – SWITZERLAND

Artefact name	Situla EMT09-554.665
Authors	Christian. Degrigny (HE-Arc CR, Neuchâtel, Neuchâtel, Switzerland) & Marie-Jeanne. Scholl (HE-Arc CR, Neuchâtel, Neuchâtel, Switzerland) & Valentin. Boissonnas (HE-Arc CR, Neuchâtel, Neuchâtel, Switzerland)
Url	/artefacts/538/

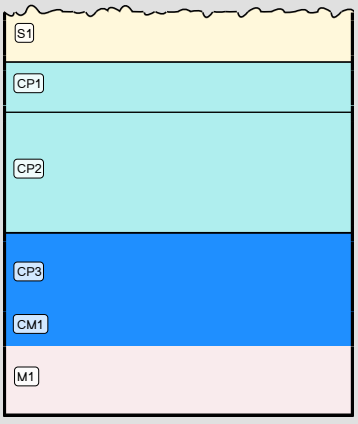
There are 2 stratigraphies (Fig. 5 corresponding to the interior face of the situla and Fig. 6 to its exterior face). The strata are similar in composition but their coding is different: CP1 to CP3 in Fig. 5 correspond to CP3 to CP5 in Fig. 6. Since the stratigraphy of Fig. 6 is more complete, the composition of each of its strata is given below.

Fig. 5: Stratigraphic representation of the sample taken from the detached fragment of the situla in cross-section using the MiCorr application. The characteristics of the strata are only accessible by clicking on the drawing that redirects you to the search tool by stratigraphy representation. This representation shows the exterior face and can be compared to Fig. 10 (bottom red rectangle), Credit HE-Arc CR, M-J.Scholl.

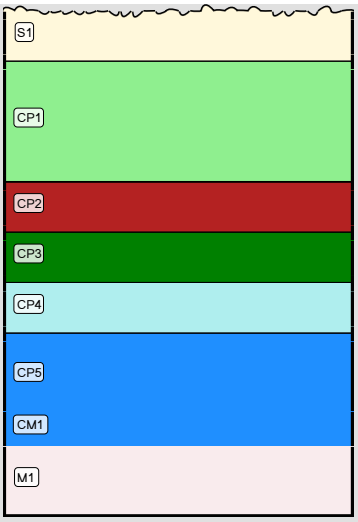
Fig. 6: Stratigraphic representation of the sample taken from the detached fragment of the situla in cross-section using the MiCorr application. The characteristics of the strata are only accessible by clicking on the drawing that redirects you to the search tool by stratigraphy representation. This representation shows the interior face and can be compared to Fig. 10 (top red rectangle), Credit HE-Arc CR, M-J.Scholl.

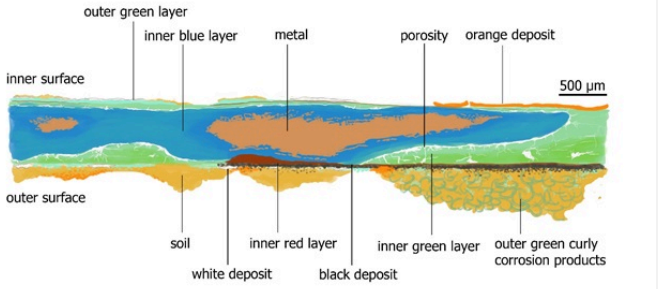
Strata	Composition
Soil (S)	Ca, Si, Al, Fe
Black deposit (D1)	C
Orange deposit (D2)	Ferrous oxides
White deposit (D3)	Ca
Outer green curly corrosion product (CP1e)	Copper carbonates (curly malachite)
Inner red (CP2i)	Copper oxide (cuprite ?)
Outer green layer (CP3i)	Copper carbonates (malachite)
Inner green layer (CP4i)	Copper carbonates (?) + Sn
Inner blue layer (CP5i)	Copper carbonates (?) + Sn
Remnant metal phase (M)	Bronze (90%Cu, 10% Sn)

Fig. 16: Improved stratigraphic representation of the situla from visual observations and analyses,

The metal structure of this low-tin bronze shows extensive cold work and multiple annealing cycles with a final cold work. The total absence of inclusions highlights a highly developed knowledge in bronze metallurgy. The metal is much corroded. Transgranular corrosion is visible. The majority of the internal corrosion products are composed of copper carbonates that have replaced much of the metal. Curly malachite has developed in clusters on the outside of the surface. This pattern is characteristic of a long-term burial period. The presence of inner enriched Sn layers shows a decuprification phenomenon (dissolution of Cu). Because of the friable nature of the inner green layer that supports the limit of the original surface, as well as its cleavage with the blue layer underneath, the original surface has become very fragile. The corrosion is thought to be of type 1 according to Robbiola et al. 1998.
