SITULA EMT09-554.665 – TIN BRONZE – IRON AGE – SWITZERLAND

Artefact name	Situla EMT09-554.665
Authors	Christian. Degrigny (HE-Arc CR, Neuchâtel, Neuchâtel, Switzerland) & Marie-Jeanne. Scholl (HE-Arc CR, Neuchâtel, Neuchâtel, Switzerland) & Valentin. Boissonnas (HE-Arc CR, Neuchâtel, Neuchâtel, Switzerland)
Url	/artefacts/538/

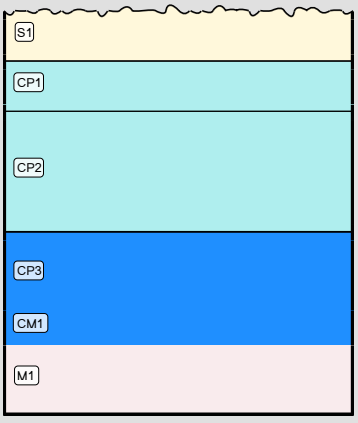
Fig. 5: Stratigraphic representation of the sample taken from the detached fragment of the situla in cross-section using the MiCorr application. The characteristics of the strata are only accessible by clicking on the drawing that redirects you to the search tool by stratigraphy representation. This representation shows the exterior face and can be compared to Fig. 10 (bottom red rectangle), Credit HE-Arc CR, M-J.Scholl.

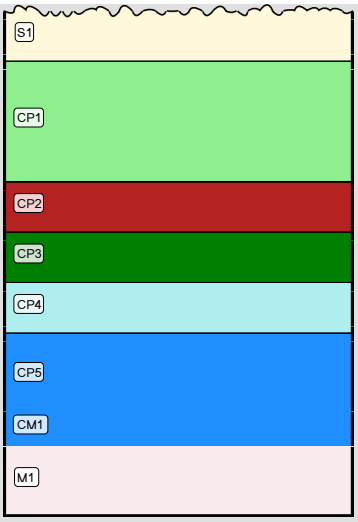
There are 2 stratigraphies (Fig. 5 corresponding to the interior face of the situla and Fig. 6 to its exterior face). The strata are similar in composition but their coding is different: CP1 to CP3 in Fig. 5 correspond to CP3 to CP5 in Fig. 6. Since the stratigraphy of Fig. 6 is more complete, the composition of each of its strata is given below.

Fig. 6: Stratigraphic representation of the sample taken from the detached fragment of the situla in cross-section using the MiCorr application. The characteristics of the strata are only accessible by clicking on the drawing that redirects you to the search tool by stratigraphy representation. This representation shows the interior face and can be compared to Fig. 10 (top red rectangle), Credit HE-Arc CR, M-J.Scholl.
