FRAGMENTS OF OENOCHOE GV132-01 US26-OBJ.10 - TIN BRONZE - ROMAN TIMES - SWITZERLAND

Artefact name	Fragments of oenochoe GV132-01 US26-obj.10
Authors	Christian. Degrigny (HE-Arc CR, Neuchâtel, Neuchâtel, Switzerland) & S. Gillioz (HE-Arc CR, Neuchâtel, Neuchâtel, Switzerland) & Valentin. Boissonnas (HE-Arc CR, Neuchâtel, Neuchâtel, Switzerland)
Url	/artefacts/539/

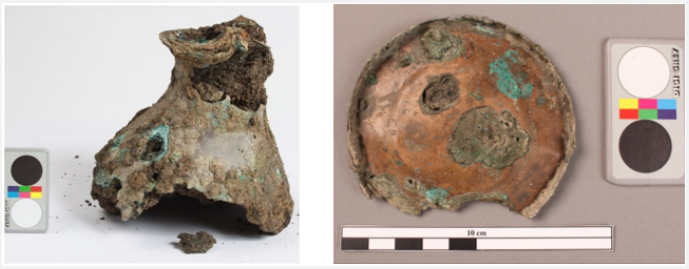
Fig. 1: Oenochoe, belly / neck of the vessel with its base. Only the base is considered in the present file,

Description of the artefact	Base of an oenochoe (Fig. 1). Dimensions: L = 82 mm; W = 74 (after degradation) ; T =6,5 mm; WT = 30,9 g.
Type of artefact	Oenochoe, vessel
Origin	Place Simon-Goulart, Genève, Geneva, Switzerland
Recovering date	Excavation 2012
Chronology category	Roman Times
chronology tpq	20 B.C.
chronology taq	50 A.D.
Chronology comment	
Burial conditions / environment	Soil
Artefact location	Service cantonal d'archéologie, Genève, Geneva
Owner	Service cantonal d'archéologie, Genève, Geneva
Inv. number	GV132-01/US26-obj.10
Recorded conservation data	Not conserved

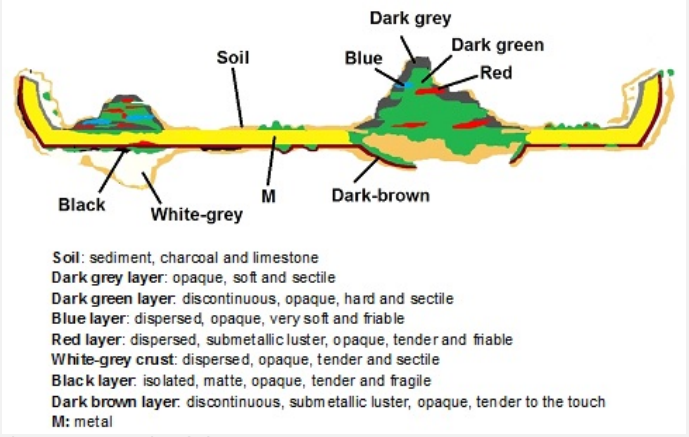
The schematic representation below gives an overview of the corrosion layers encountered on the oenochoe base from visual macroscopic observation.

Fig. 3: Stratigraphic representation of the oenochoe base in cross-section by macroscopic observation,

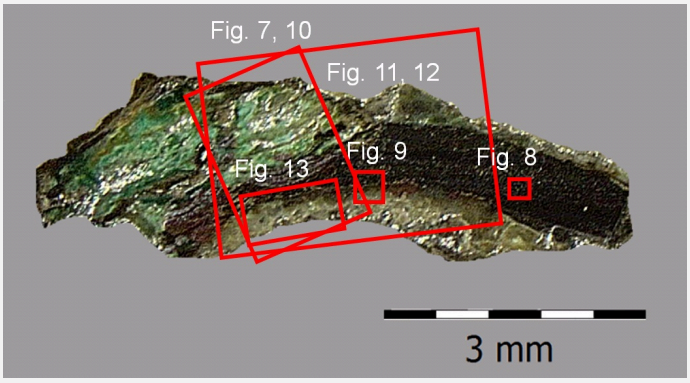
Fig. 4: Micrograph of the cross-section of the sample taken from the oenochoe base showing the location of Figs. 7 to 13,

Description of sample	The sample was cut from the edge shown in Fig. 2. Its dimensions are L = 6.5 mm, W = 1.5 mm. The sample contains some remaining metal covered with a crust and a voluminous pustule corrosion (Fig. 4).
Alloy	Tin Bronze
Technology	Cold worked with repeated annealing and final cold working
Lab number of sample	HECR 1455 – S2
Sample location	HE-Arc CR, Neuchâtel, Neuchâtel
Responsible institution	Musée cantonal d'archéologie et d'histoire, Lausanne, Vaud
Date and aim of sampling	2013, metallography and chemical analyses

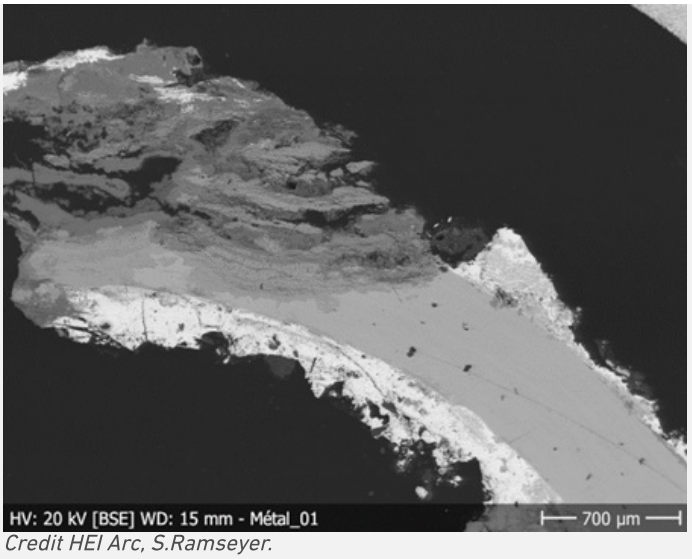
The remaining metal is a tin bronze (Table 1). The etched metal shows a structure of polygonal grains with twinned and strain lines (Fig. 8).

Fig. 7: SEM image of the metal sample from Fig.4 (rotated 30°), BSE-mode,

Fig. 8: Micrograph of the metal sample from Fig. 4, etched, bright field, 50x. Polygonal and twinned grains with strain lines are observed. The dotted surface is the result of over-etching,

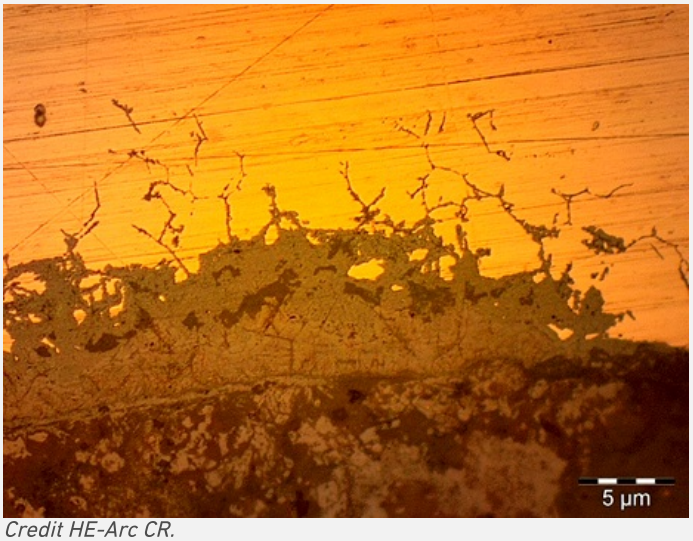
Intergranular corrosion is observed on the edges of the remaining metal (Fig. 9).The sample shows two forms of corrosion: multi-layered pustule corrosion at the left extremity of the sample (Fig. 10, area 1) and a corrosion crust covering the metal (Fig.10, area 2). The multi-layered pustule corrosion has an average thickness of about 1.1 mm (L) and 0.79 mm (W) (Fig.11). It is composed of a sandwich of 7 corrosion products, mainly green, grey, red and blue in dark field. Microscopic observation allows us to highlight new corrosion products that were not detected during the first visual examination (Fig. 11):

Fig. 9: Micrograph of the metal sample from Fig. 4, unetched, bright field, 50x. The grain boundaries are revealed by the intergranular corrosion,

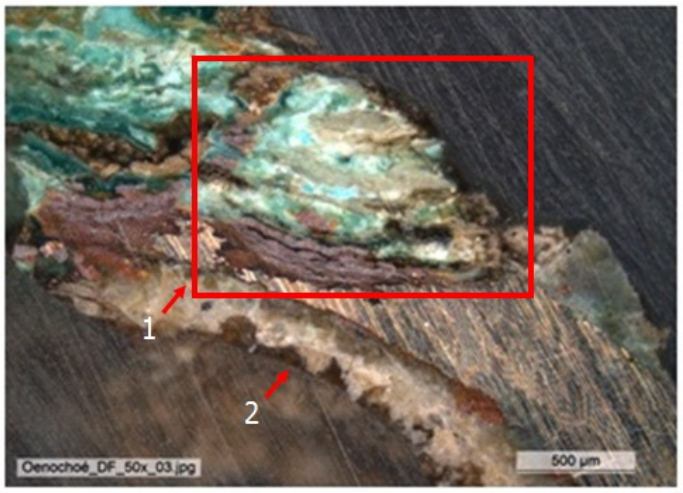
Fig. 10: Micrograph of the metal sample (same as Fig. 7, 30° rotated), unetched, dark field, showing the location of the multi-layered pustule corrosion (area 1 to compare to Fig. 5) and the corrosion crust (area 2 to compare to Fig. 6). The area selected for elemental chemical distribution (Fig. 12) is marked by a red rectangle,

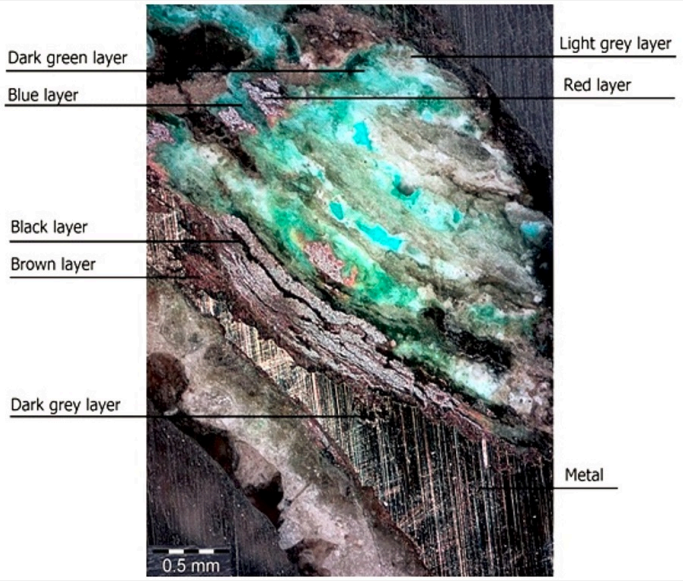
CP1. Light grey layer, containing mainly Sn, O, some Fe, P and a small amount of Pb combined with dark green layer, containing mainly Cu, O and P (Fig. 12, Fig. 5 and table 2)

CP2. Blue layer, containing mainly Cu, Cl (Fig. 12, Fig. 5 and table 2)

CP3. Red layer, containing mainly Cu and O combined with black layer containing mainly Sn and O (Fig. 12, Fig. 5 and table 2)

CP4. Brown layer containing mainly Cu, Sn and O (Fig. 12, Fig. 5 and table 2)

CP5. Dark grey layer containing mainly Cu, Sn and O (Fig. 12, Fig. 5 and table 2)

Fig. 11: Micrograph of the metal sample from Fig. 10 (area 1, 60° rotated) and corresponding to the stratigraphy of Fig. 5, unetched, dark field,

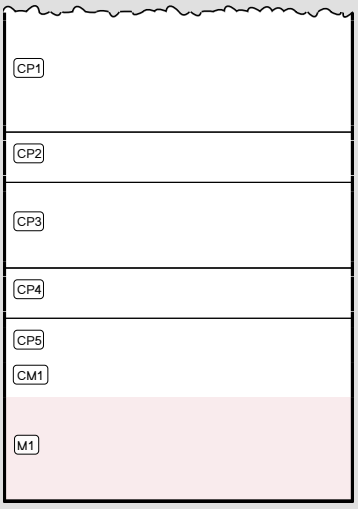
Fig. 5: Stratigraphic representation of the sample taken from the oenochoe base in cross-section using the MiCorr application. The characteristics of the strata are only accessible by clicking on the drawing that redirects you to the search tool by stratigraphy representation. This representation can be compared to Fig. 11, Credit HE-Arc CR, C.Degrigny.

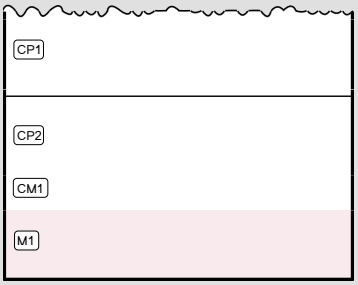
Fig. 6: Stratigraphic representation of the sample taken from the oenochoe base in cross-section using the MiCorr application. The characteristics of the strata are only accessible by clicking on the drawing that redirects you to the search tool by stratigraphy representation. This presentation can be compared to Fig. 13, Credit HE-Arc CR, C.Degrigny.

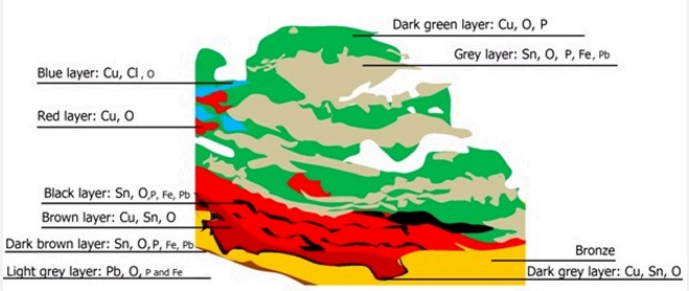
The schematic representation of corrosion layers of Fig. 3 integrating additional information based on the analyses carried out is given in Fig. 14. The addition of "e" and "i" within the coding refers to the location of the strata which are either internal ("i") or in contact with the atmosphere ("e").

Dark green layer (CP1e)	Cu, O, P
Grey layer (CP2e)	Sn, O, P
Blue layer (CP3i)	Cu, Cl, O
Red layer (CP4i)	Cu, O
Black layer (CP5i)	Sn, O
Brown layer (CP6i)	Cu, Sn, O

Fig. 14: Improved stratigraphic representation of the multi-layered pustule form of the oenochoe from visual observations and analyses,
