FRAGMENTS OF OENOCHOE GV132-01 US26-OBJ.10 - TIN BRONZE - ROMAN TIMES - SWITZERLAND

Artefact name	Fragments of oenochoe GV132-01 US26-obj.10
Authors	Christian. Degrigny (HE-Arc CR, Neuchâtel, Neuchâtel, Switzerland) & S. Gillioz (HE-Arc CR, Neuchâtel, Neuchâtel, Switzerland) & Valentin. Boissonnas (HE-Arc CR, Neuchâtel, Neuchâtel, Switzerland)
Url	/artefacts/539/

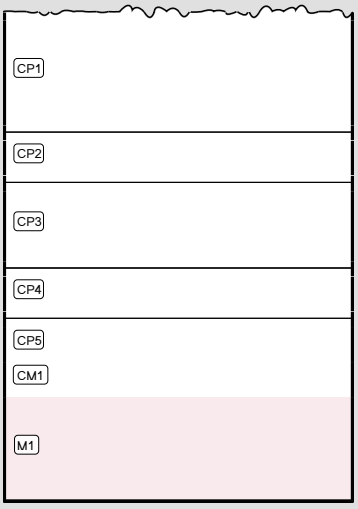
Fig. 5: Stratigraphic representation of the sample taken from the oenochoe base in cross-section using the MiCorr application. The characteristics of the strata are only accessible by clicking on the drawing that redirects you to the search tool by stratigraphy representation. This representation can be compared to Fig. 11, Credit HE-Arc CR, C.Degrigny.

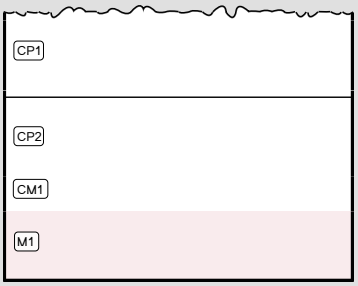
Fig. 6: Stratigraphic representation of the sample taken from the oenochoe base in cross-section using the MiCorr application. The characteristics of the strata are only accessible by clicking on the drawing that redirects you to the search tool by stratigraphy representation. This presentation can be compared to Fig. 13, Credit HE-Arc CR, C.Degrigny.
