SHINGLE OF A ROOF – CU ALLOY – MODERN TIMES – SWITZERLAND

Artefact name Shingle of a roof

Authors Marianne. Senn (EMPA, Dübendorf, Zurich, Switzerland) & Christian. Degrigny (HE-Arc CR, Neuchâtel, Neuchâtel, Switzerland)

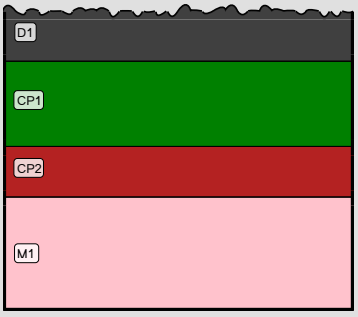
Fig. 4: Stratigraphic representation of the sample taken from the shingle in cross-section using the MiCorr application. The characteristics of the strata are only accessible by clicking on the drawing that redirects you to the search tool by stratigraphy representation. This representation can be compared to Fig. 7, Credit HE-Arc CR.
