FITTING ON BACK PANEL OF A MILITARY CARRIAGE – THOMAS STEEL – MODERN TIMES – SWITZERLAND

Artefact name	Fitting on back panel of a military carriage
Authors	Marianne. Senn (EMPA, Dübendorf, Zurich, Switzerland) & Christian. Degrigny (HE-Arc CR, Neuchâtel, Neuchâtel, Switzerland)
Url	/artefacts/541/

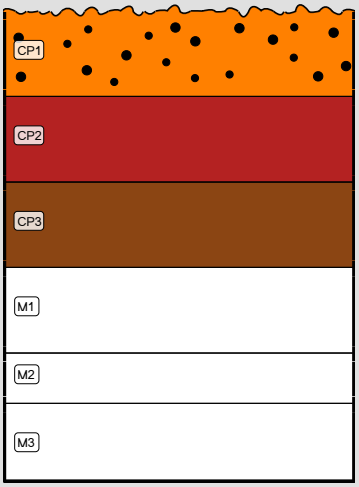
Fig. 4: Stratigraphic representation of the sample taken from the fitting in cross-section using the MiCorr application. The characteristics of the strata are only accessible by clicking on the drawing that redirects you to the search tool by stratigraphy representation. This representation showing for the metal part a welding seam (M2) can be compared to Fig. 10, Credit HE-Arc CR.
