WEDGE PART OF AN ALTAR CROWN SUSPENSION – P-RICH IRON AND HYPOEUTECTOID STEEL – MODERN TIMES – SWITZERLAND

Artefact name	Wedge part of an altar crown suspension
Authors	Marianne. Senn (EMPA, Dübendorf, Zurich, Switzerland) & Christian. Degrigny (HE-Arc CR, Neuchâtel, Neuchâtel, Switzerland)
Url	/artefacts/542/

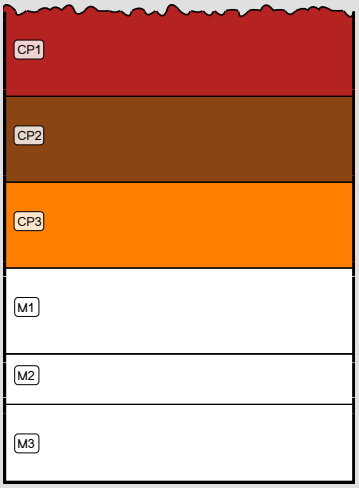
Fig. 4: Stratigraphic representation of the sample taken from the wedge part in cross-section using the MiCorr application. The characteristics of the strata are only accessible by clicking on the drawing that redirects you to the search tool by stratigraphy representation. This representation can be compared to Fig. 12, Credit HE-Arc CR.
