FRAGMENT OF A BED STRUCTURE 03 12751-20.2.5 - TIN BRONZE - ROMAN TIMES - SWITZERLAND

Artefact name	Fragment of a bed structure 03 12751-20.2.5
Authors	Marianne Senn. (Empa, None) & Christian. Degrigny (HE-Arc CR, Neuchâtel, Neuchâtel, Switzerland)
Url	/artefacts/569/

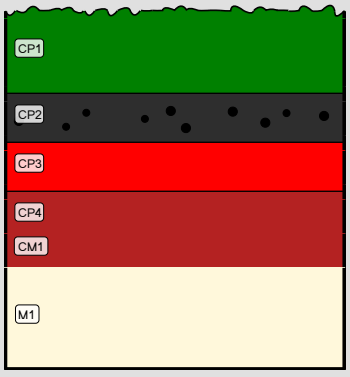
Fig. 4: Stratigraphic representation of the sample taken from the bed structure in cross-section using the MiCorr application. The characteristics of the strata are only accessible by clicking on the drawing that redirects you to the search tool by stratigraphy representation. This representation can be compared to Fig. 8, Credit HE-Arc CR.
