VOTIVE FIGURE OF A BAT IVB4168 – GILDED BRASS – MODERN TIMES

Artefact name Votive figure of a bat IVb4168

Authors Christian. Degrigny (HE-Arc CR, Neuchâtel, Neuchâtel, Switzerland) & Naima. Gutknecht (HE-Arc CR, Neuchâtel, Neuchâtel, Switzerland) & Valentin. Boissonnas (HE-Arc CR, Neuchâtel, Neuchâtel, Switzerland)

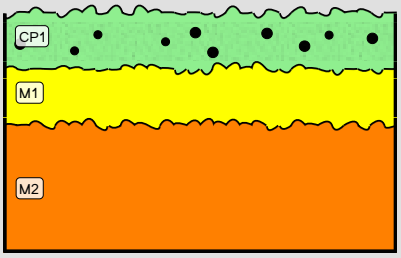
Fig 5: Stratigraphic representation 1 from Fig. 4 using the MiCorr application. The characteristics of the strata are only accessible by clicking on the drawing that redirects you to the search tool by stratigraphy representation, Credit HE-Arc CR, N.Gutknecht.

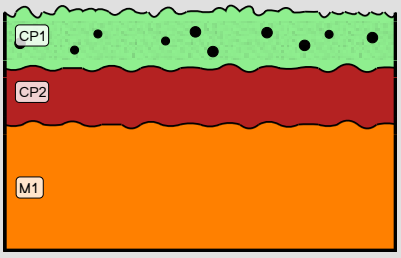
Fig. 6: Stratigraphic representation 2 from Fig. 4 using the MiCorr application. The characteristics of the strata are only accessible by clicking on the drawing that redirects you to the search tool by stratigraphy representation, Credit HE-Arc CR, N.Gutknecht.
