AIRCRAFT REAR FASTENING PLATE VHS-497 - AL ALLOY - MODERN TIMES

Artefact name	Aircraft rear fastening plate VHS-497
Authors	Marianne. Senn (EMPA, Dübendorf, Zurich, Switzerland) & Christian. Degrigny (HE-Arc CR, Neuchâtel, Neuchâtel, Switzerland)
Url	/artefacts/594/

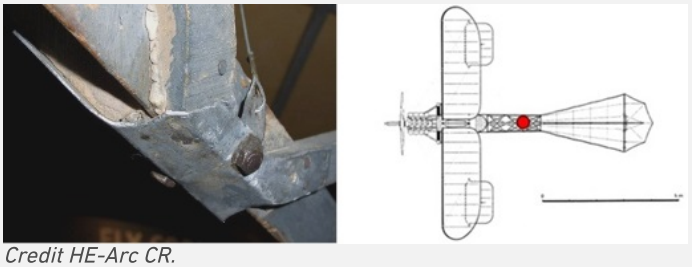
Fig. 1: Fastening plate from the back of the Dufaux IV (left) and top view of the aeroplane showing its location (red dot, right) (www.hepta.aero),

Description of the artefact	Metal fastening plate for the wooden construction of the rear of the aeroplane (Fig. 1) covered with a thin corrosion layer.
Type of artefact	Aeroplane part
Origin	Dufaux IV aeroplane
Recovering date	Biplane built by Henri and Armand Dufaux in 1909/10
Chronology category	Modern Times
chronology tpq	1909 A.D.
chronology taq	1910 A.D.
Chronology comment	
Burial conditions / environment	Outdoor to indoor atmosphere
Artefact location	Swiss Museum of Transport, Luzern, Lucerne
Owner	Swiss Museum of Transport, Luzern, Lucerne
Inv. number	VHS-497
Recorded conservation data	Not known

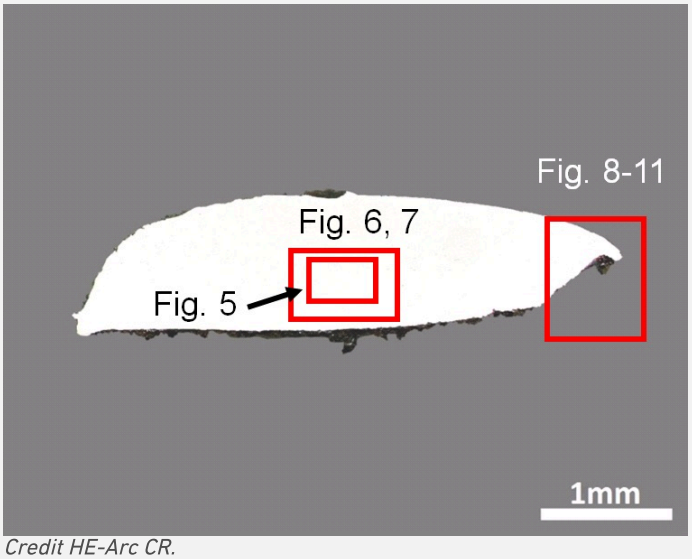
Fig. 3: Micrograph of the cross-section of the sample taken from the back fastening plate showing the location of Figs. 5 to 11,

Sample cut from the corner of the fastening plate (Fig. 2). Dimensions: L = 4mm ; W = 1.2mm.

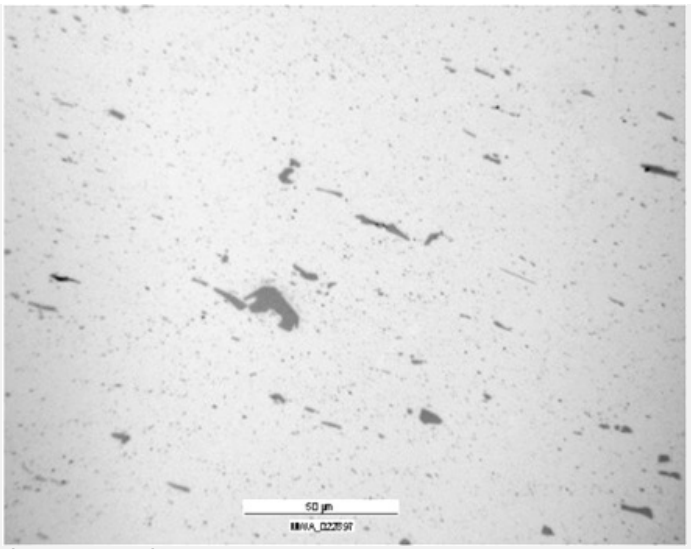
The metal is a relatively pure aluminium alloy with numerous inclusions (Table 1). From the chemical composition of the inclusions they can be interpreted as alpha-AlFeSi intermetallic compounds. In bright field we observe elongated inclusions indicating that the metal was rolled (Fig. 5). The alloy composition is similar to an unalloyed primary aluminium (Al content between 99 and 99.8 mass%). The O content reflects the immediate oxidation of the metal and is not part of the alloy. After etching the organisation of inclusions in rows is more easily seen (Fig. 6). The SEM image shows large grains formed after annealing (Fig. 7). The average hardness of the metal is HV1 40.

Fig. 5: Micrograph of the metal sample from Fig. 3 (detail), unetched, bright field. The metal matrix is in white, the elongated inclusions in grey,

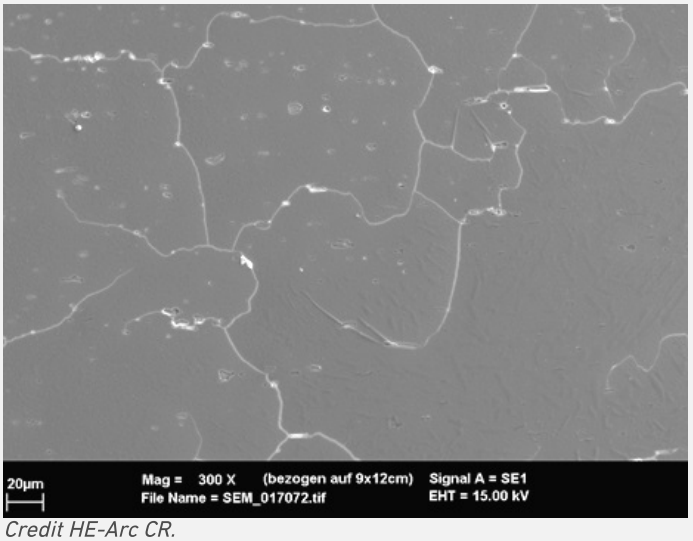
Fig. 6: Micrograph of the metal sample from Fig. 3 (detail), etched, bright field. The metal matrix is in white, the elongated inclusions in dark-grey and black,

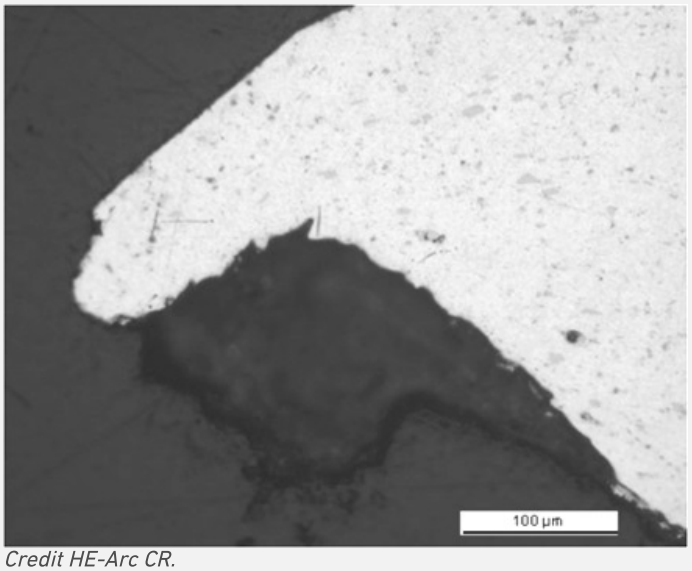
Fig. 7: SEM image of the metal sample from Fig. 3 (detail), SE-mode, etched. We observe the presence of large grains and numerous elongated inclusions,

Microstructure	Recrystallized structure with large grains
First metal element	Al
Other metal elements	Si

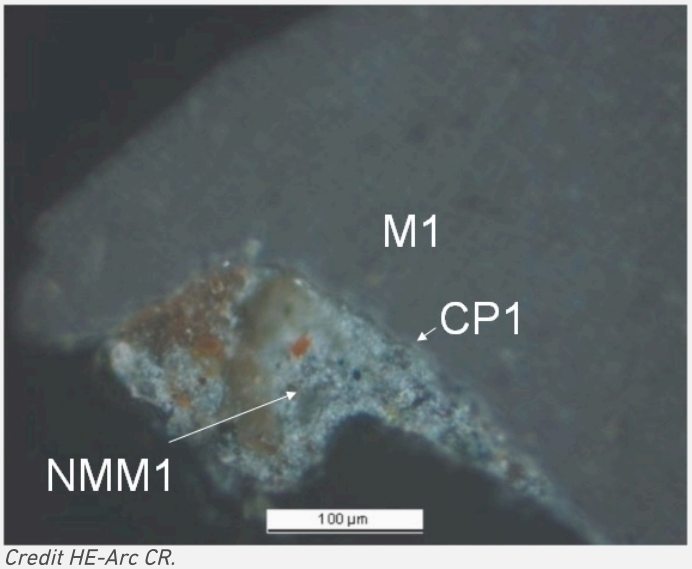
The metal is covered by a very thin corrosion layer (CP1). In addition to this, locally thicker adhering materials can be observed (NMM1, appearing as dark-grey area in Fig. 8). Under polarized light, they appear blue-brown (Fig. 9). Analysis by SEM-EDS indicates that the metal is, as expected, covered by a very thin Al and O-rich layer whereas the particles in the adherent material contain C, O, Si, Ca, Fe, Zn, S and even Ti (Figs. 10 and 11). The location of the adherent material and the presence of both Zn and Ti suggest that it is a residue of a paint coating.

Fig. 8: Micrograph showing the metal - adhering material interface from Fig. 3 (reversed picture, detail), unetched, bright field. We observe in white the metal matrix and dark-grey the adhering material,

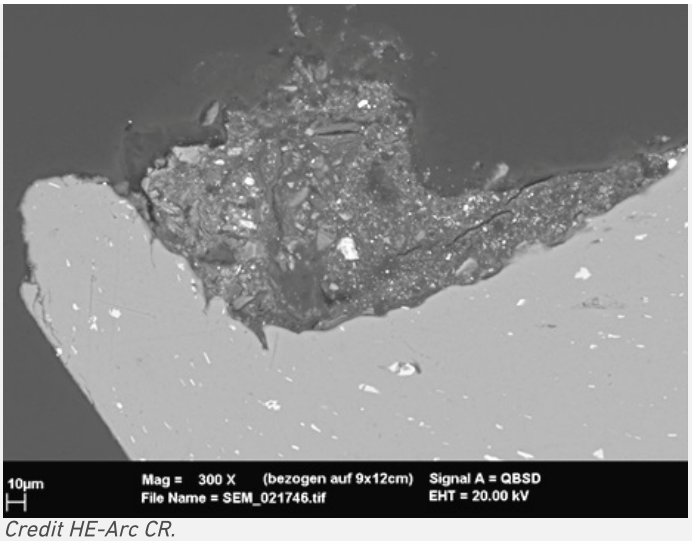
Fig. 9: Micrograph (same as Fig. 8) and corresponding to the stratigraphy of Fig. 4, unetched, polarised light. We observe in grey the metal matrix and blue-brown the adhering material,

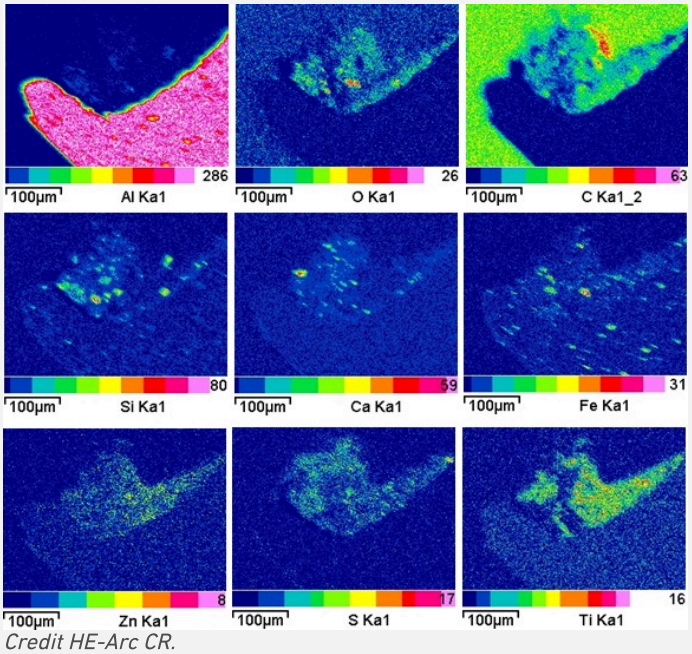
Fig. 10: SEM image (same as Fig. 8, inverted picture, detail), BSE-mode, unetched,

Fig. 11: Elemental chemical distribution of the selected area from Fig. 10. Method of examination: SEM/EDS, Laboratory of Analytical Chemistry, Empa,
