AIRCRAFT REAR FASTENING PLATE VHS-497 - AL ALLOY - MODERN TIMES

Artefact name	Aircraft rear fastening plate VHS-497
Authors	Marianne. Senn (EMPA, Dübendorf, Zurich, Switzerland) & Christian. Degrigny (HE-Arc CR, Neuchâtel, Neuchâtel, Switzerland)
Url	/artefacts/594/

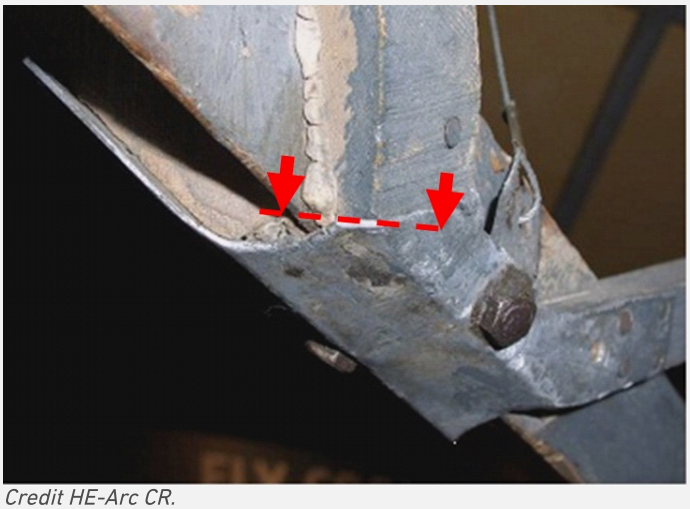
Fig. 2: Location of sampling area,

Sample cut from the corner of the fastening plate (Fig. 2). Dimensions: L = 4mm ; W = 1.2mm.

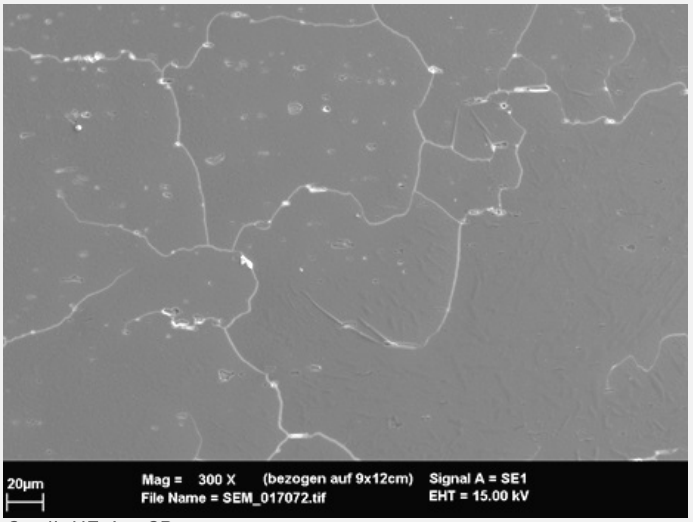
Fig. 7: SEM image of the metal sample from Fig. 3 (detail), SE-mode, etched. We observe the presence of large grains and numerous elongated inclusions,

Microstructure	Recrystallized structure with large grains
First metal element	Al
Other metal elements	Si
