SHOE NAIL 2637 1370.B. - HYPOEUTECTOID STEEL - ROMAN TIMES - SWITZERLAND

Artefact name Shoe nail 2637 1370.B.

Authors Christian. Degrigny (HE-Arc CR, Neuchâtel, Neuchâtel, Switzerland) & Valentin. Boissonnas (HE-Arc CR, Neuchâtel, Neuchâtel, Switzerland) & Vincent Chappuis. (HE-Arc CR, Neuchâtel, Neuchâtel, Switzerland)

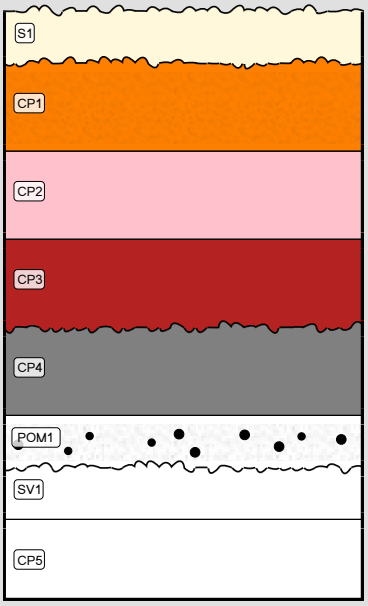
Fig. 5: Stratigraphic representation of the nail in cross-section using the MiCorr application. The characteristics of the strata are only accessible by clicking on the drawing that redirects you to the search tool by stratigraphy representation. This representation can be compared to Fig. 14, Credit HE-Arc CR, V.Chappuis.

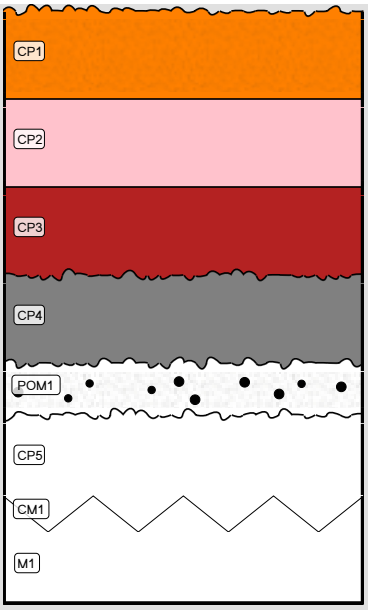
Fig. 6: Stratigraphic representation of the nail in cross-section using the MiCorr application. The characteristics of the strata are only accessible by clicking on the drawing that redirects you to the search tool by stratigraphy representation. This representation can be compared to Fig. 14, Credit HE-Arc CR, V.Chappuis.
