# SHOE NAIL 2637 1370.B. - HYPOEUTECTOID STEEL - ROMAN TIMES - SWITZERLAND

**Artefact name** Shoe nail 2637 1370.B.

**Authors** Christian. Degrigny (HE-Arc CR, Neuchâtel, Neuchâtel, Switzerland) & Valentin. Boissonnas (HE-Arc CR, Neuchâtel, Neuchâtel, Switzerland) & Vincent Chappuis. (HE-Arc CR, Neuchâtel, Neuchâtel, Switzerland)

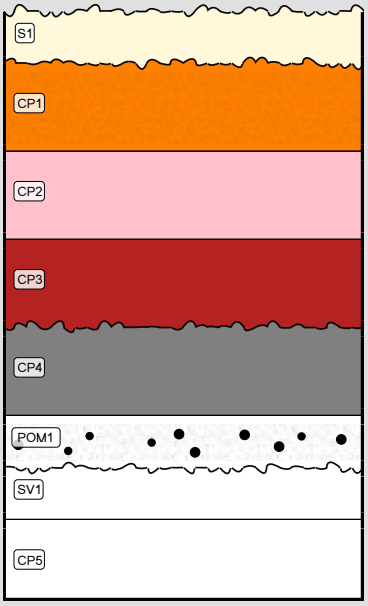
Fig. 5: Stratigraphic representation of the nail in cross-section using the MiCorr application. The characteristics of the strata are only accessible by clicking on the drawing that redirects you to the search tool by stratigraphy representation. This representation can be compared to Fig. 14, Credit HE-Arc CR, V.Chappuis.

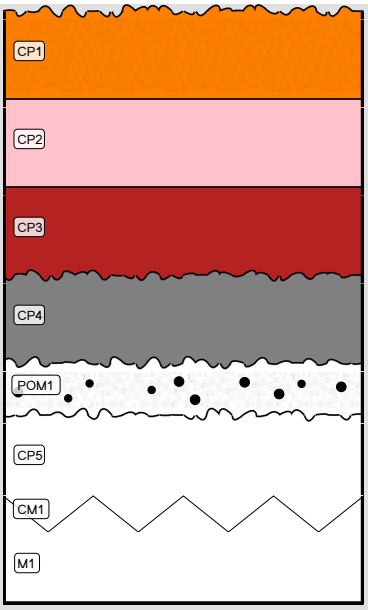
Fig. 6: Stratigraphic representation of the nail in cross-section using the MiCorr application. The characteristics of the strata are only accessible by clicking on the drawing that redirects you to the search tool by stratigraphy representation. This representation can be compared to Fig. 14, Credit HE-Arc CR, V.Chappuis.
